Spike Road Regional Park Vegetation Types and Disturbance History: An Overview Survey

YER Phase II Project August 14-18, 2023

December 2023

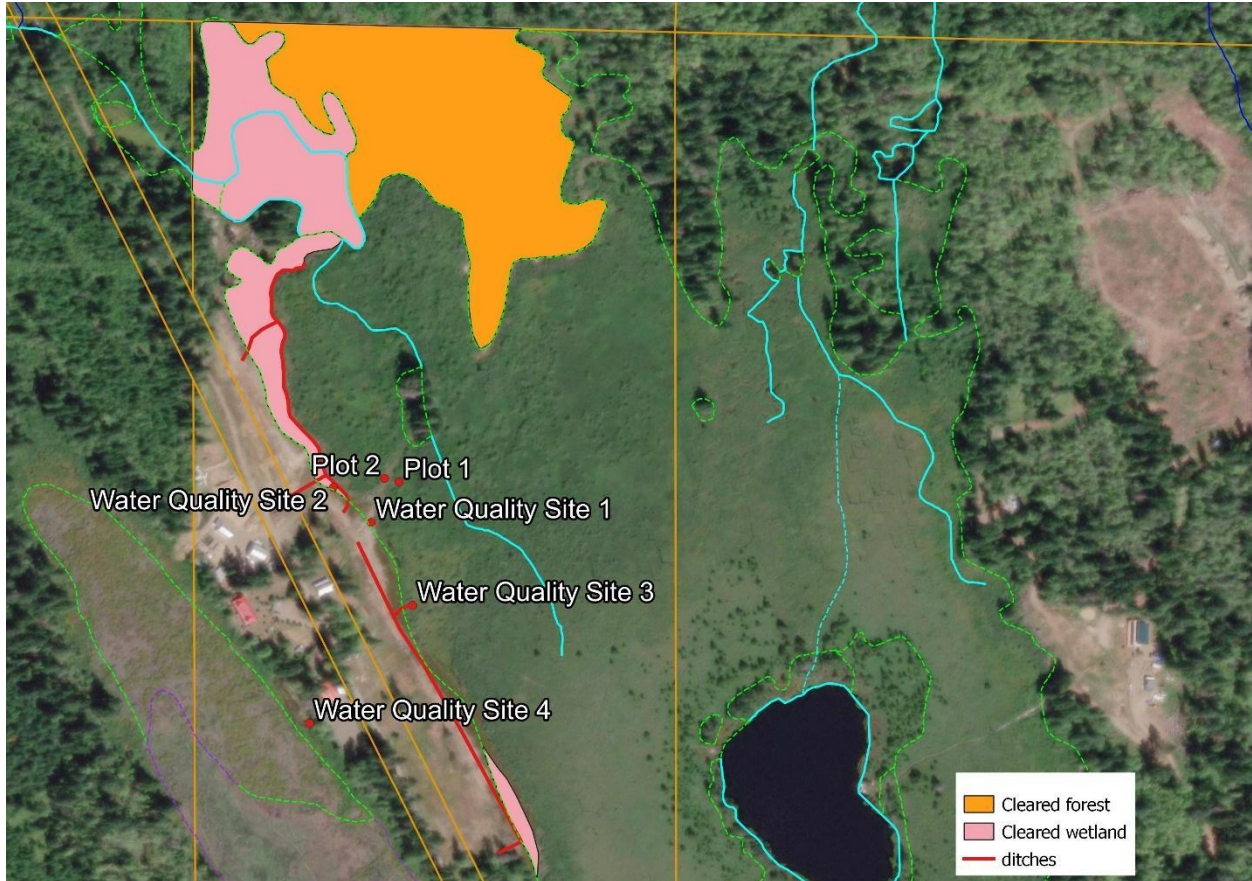
Figure 3: Vegetation plot locations, water quality and aquatic life sampling locations, ditches and cleared areas.

Reconnaissance during the youth program confirmed the recent excavation of ditches as seen in the aerial imagery and confirmed the presence of smaller perimeter and “feeder” ditches in the cleared former wetland in the northern part of the property, on the east side of the ROW – see Figure 3.

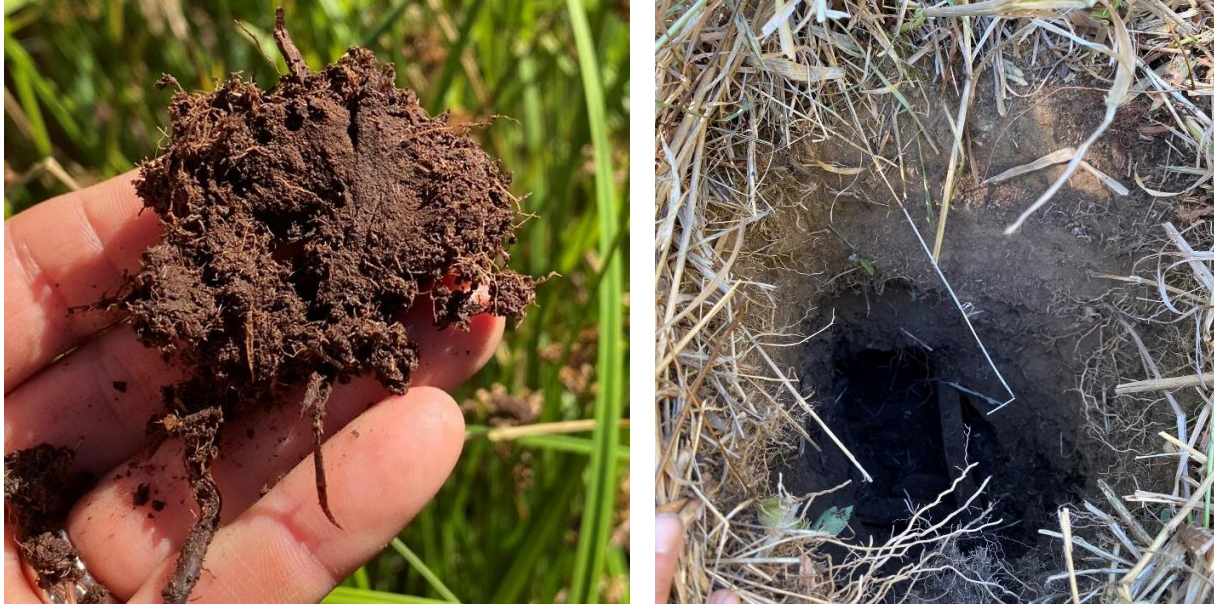
Figure 4: The photo on the left shows a sample of the soil/peat extracted from a pit dug in Plot 1. The right-hand photo shows the soil pit in Plot 2. The soils in these two locations were very different with respect to compaction, organic matter, and moisture.

Plot 2 sampled the road that was built on imported fill. The main vegetative cover consisted of reed canary grass. The plot also included a diverse mix of native shrubs, trees and herbs, and some additional non-native species such as comfrey, oxeye daisy and thistle. A soil pit approximately 0.75 m deep revealed fine, hard packed soils. In contrast to Plot 1, the soil was dry and low in organic matter.

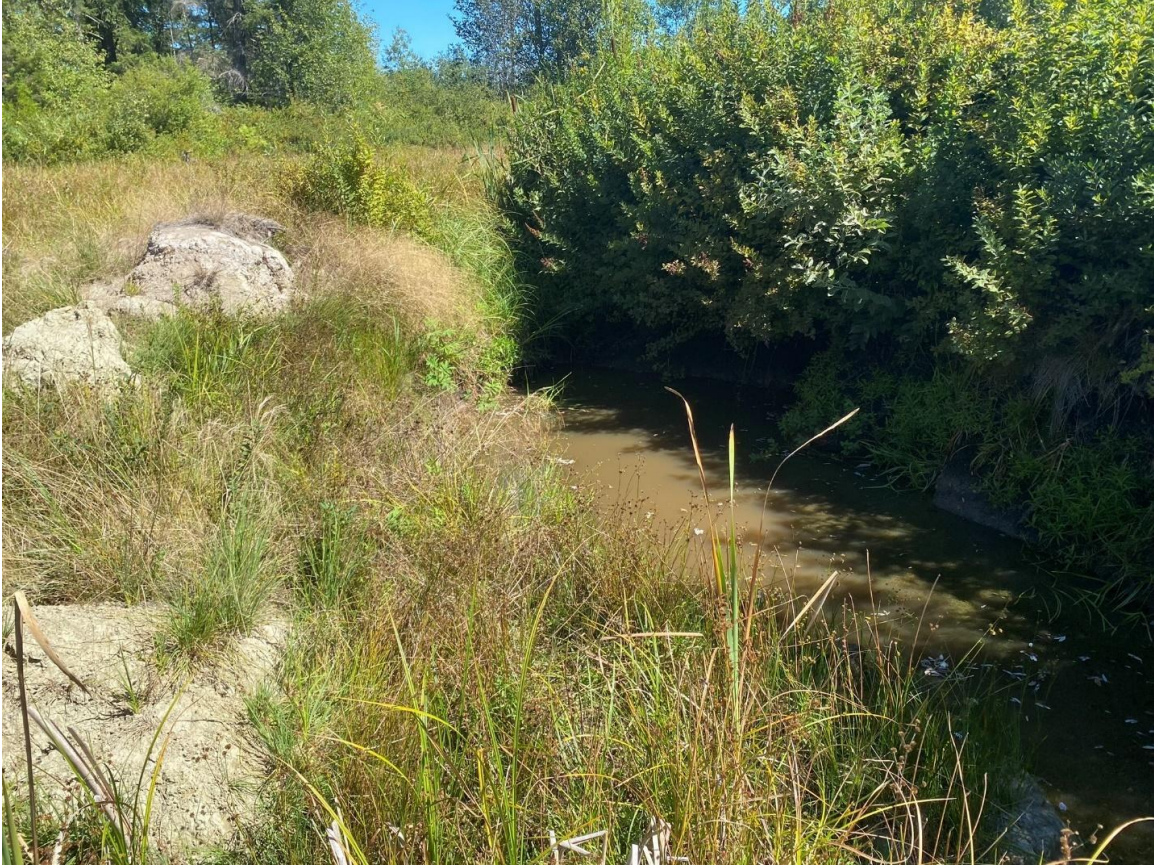
Figure 5: A recently constructed ditch dividing intact wetland from disturbed wetland. The spoil materials are visible and could be used to fill in the ditch.

1. Fill in the ditches along the boundary of the eastern wetland, after removing all aquatic life.
2. Remove the road built into the wetland and use the material to fill in the ditches.
3. Conduct a detailed vegetation inventory of both wetlands.
4. Remove existing fencing and add fencing to both sides of the new trail to prevent public access to the wetlands.
5. Plant trees on the terrestrial elevations outside of the public path and evacuation route, particularly along the eastern wetland margins. See Grantham and Wong (2022) for more detailed information.
6. Assess the logged area in the north of the property to determine how the forest is regenerating.
7. In remaining areas with reed canary grass, undertake reed canary grass control efforts including shading with native plantings.
8. Remove bullfrogs to support the health of native wildlife populations.
