# Upper Millard Creek Headwaters Springs and Seeps Report 2013

30 December 2013

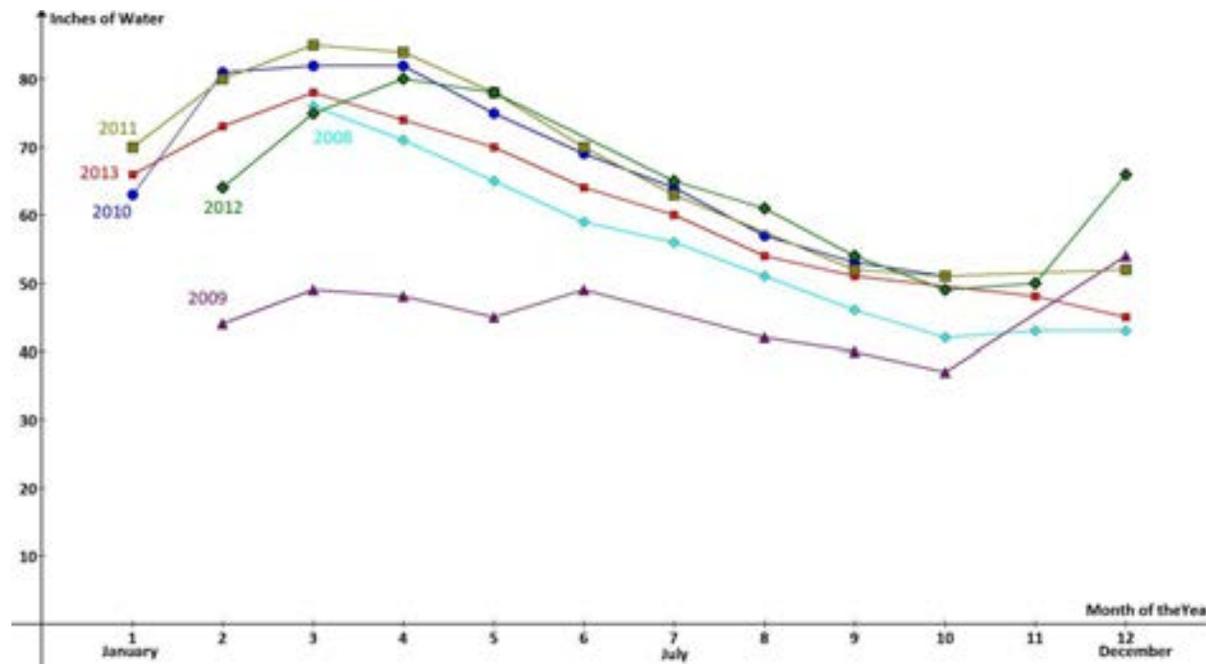
**Figure 1: Well water levels near the Minto Road Forest Study Site from 2008 to the present**

Ground water levels immediately uphill of the Minto Road Forest have been monitored by measuring water levels in a domestic drinking water shallow well for the past six years (Figure 1). With the exception of 2009, where water levels were lower when compared to other years, water levels have followed a similar pattern. Ground water levels are highest in the early spring, March and April, following the seasonal fall and winter rains and then gradually lower through the summer and early fall. At this time there does not appear to be any trend for changes in the water table across the six year of monitoring.

The lower water level in 2009 is of particular interest in that two domestic water wells in the neighbourhood ran dry that year. The Environment Canada weather station on the Puntledge River in Courtenay recorded a total precipitation of 243.8mm in November

2008 through January 2009, 55% lower than the average for the same three months over the past five year (Environment Canada 2013). This shows how important the late fall and early winter rains are in replenishing the shallow groundwater layer of the watershed. Evidence suggests the low water levels in 2009 represent a natural climatic dry period. That two neighbouring wells ran dry demonstrates how changes in the water table can adversely affect local residents and the plants, animals and fish that depend on a constant supply of water. A future comparison of the well water levels with the water flows recorded at the staff gauges installed during this project should give a better understanding of how subtle changes in the groundwater levels can affect the local ecosystem.

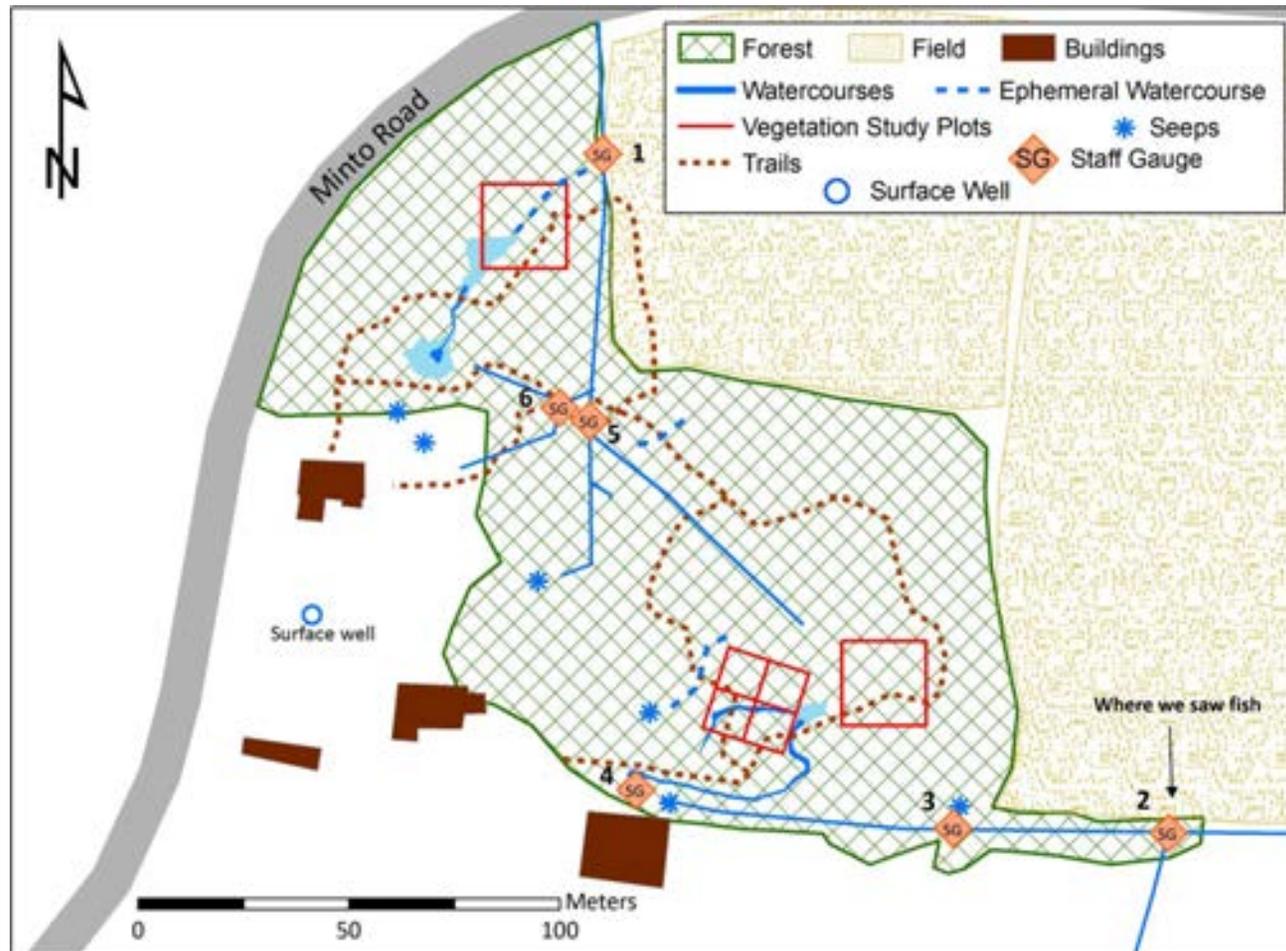
**Map 2: The Minto Road Forest study site, showing the location of the staff gauges set up during this project and also the vegetation study plots from previous projects.**

Stainless steel rulers were placed as permanent staff gauges for monitoring water flow at six locations (Map 2 and Photographs 2 - 7). The locations of the staff gauges were picked by consensus of the group based on observation of the entire forest and then choosing locations that best captured the flow of water where it could be measured. Staff Gauge 1 captured water flow from much of the forest area, including the more upstream locations of Staff Gauges 5 and 6. Staff Gauge 2 captured flow from southern portion of the forest as well as waters flowing from neighbouring properties to the south. Staff Gauge 3 was upstream of Staff Gauge 2 and caught water flow from the west.

Staff Gauge 4, at the forest pool was different in that it was measuring water in a larger fully saturated area. It appears that underground flow from the area of the pool resurfaces downstream both to the north-east (and on towards Staff Gauges 1 and 5) and also as the source of a small watercourse that flows in a shallow ditch along the south margin of the forest towards Staff Gauges 2 and 3.

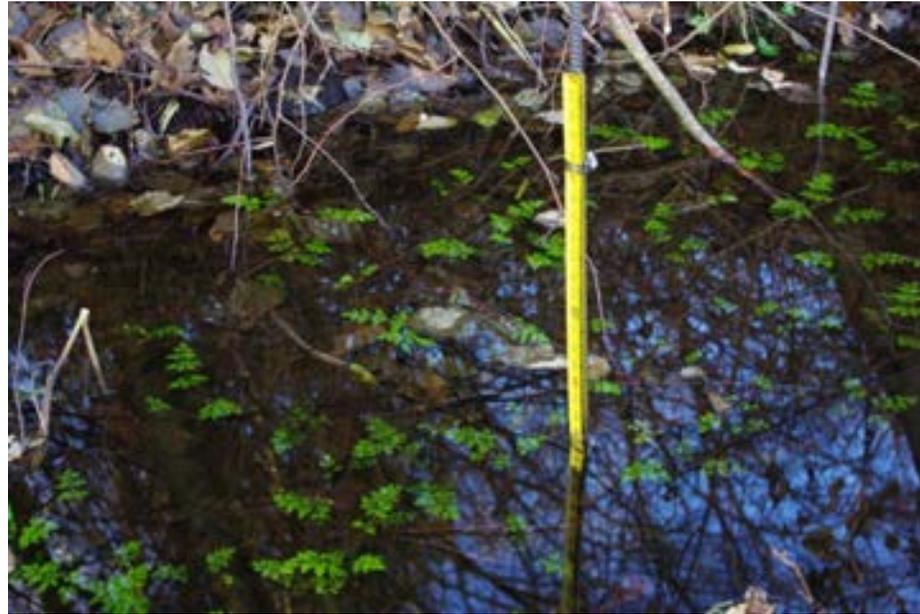
**Photograph 2: Staff Gauge #1 (called Wendy's Bridge) along a drainage ditch at the north east edge of the Forest.**

Six staff gauges were made up of stainless steel metric rulers attached to sections of steel re-bar using hose clamps (Photographs 2 - 7). The staff gauges were hammered into the bed of either a pool or a glide section of a watercourse. The sediment level at the bottom of the ruler was recorded. Water level was the measure of the water read on the ruler, less the initial depth of the sediment.

Following the completion of the YER program Staff Gauge 1 was replaced with a V-Notch Weir (Photograph 2). Water flow at the weir is determined by a table that converts water levels read on the staff gauge to water volume.

<b>SPRING AND SEEP DATA</b>		Day: 14	Month: August	Year: 2013	Staff Gauge # 1
Site Name: Wendy's bridge					
Surveyor(s): Jan, Wendy, Gordon and Darius					
<b>SITE DESCRIPTION</b>					
General Location: Along the east edge of the forest where it meets the field.					
Coordinates:		UTM Zone: 10	Easting: 355781	Northing: 5500775	
Slope: < 5%		Aspect: There is a gentle slope to the north with an open aspect to the east.			
Description of the site: This is a ditch that was most likely dug out to lower the water table in the field to the east. The size of the red alder trees along the edge of the ditch suggest it has been around for about 30 - 40 years.					
Glide Length:		Wetted Width: 155cm	Bankfull Width: 200cm	Staff Gauge Water Level: 37mm	
Substrate (%)	Organic Soil: 70%	Mineral Soil: 30%	Rocks: 0	Bedrock: 0	
<b>WATER CHEMISTRY</b>	Time of Day: 11:45	Air Temperature: 19°C		Water Temperature: 13°C

Total Dissolved Solids (TDS): 73		Dissolved Oxygen (DO): 8.8%		pH: 6.24	
<b>SITE VEGETATION: (within 5m of the spring or seep)</b>					
Trees:		Shrubs:		Herbs:	
Red alder		Salmonberry		Lady fern	
				Horse tail	
				Sword fern	
				Grasses and aquatic plants	
Notes: The bed of the ditch is made up of pale sand, covered by a thin layer of dark organic material. In places with slightly more current the sand has been washed clean.

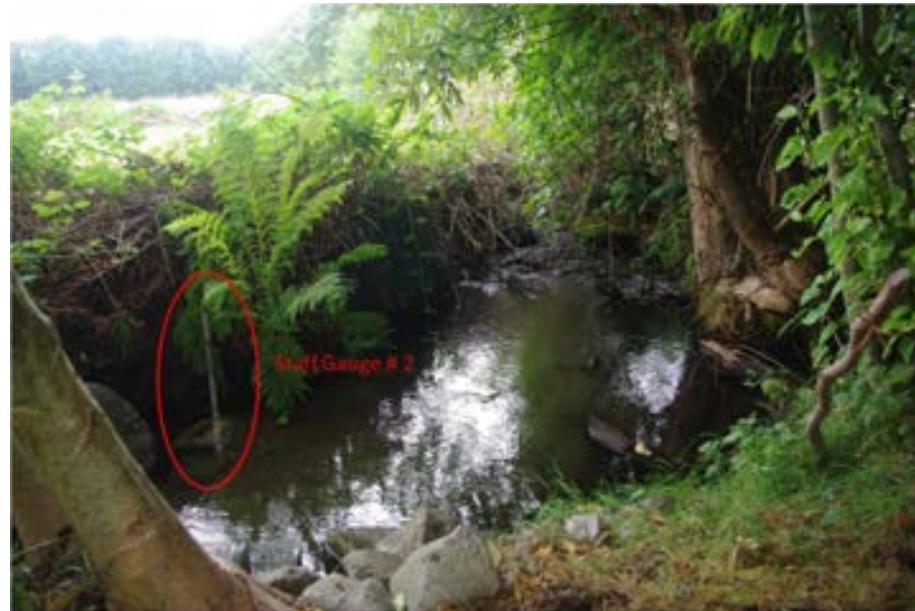
**Photograph 3: Staff Gauge #2 – At the convergence of two creeks (called the Fish Pool) at the south-east edge of the forest.**

We were surprised and pleased to find fish at the site of Staff Gauge #2 (Photograph 3). This was unexpected as this area is above a natural fish barrier. Dave Davies of the Department of Fisheries and Oceans (Personal Communication) was less surprised and noted that in many watersheds fish may be found above what are thought to be impassible barriers, these fish populations are often very old and date back to higher water levels following the past ice age. While it is possible that the fish may have been moved into the upper watershed by human activity, Dave Davies suggests it is more likely this is a natural population. We attempted to catch fish using a minnow trap but were not successful. On 16 September Wendy Kotilla was able to catch two fish and identified them as Cutthroat Trout (55 and 80mm in length).

<b>SPRING AND SEEP DATA</b>		Day: 13	Month: August	Year: 2013	Staff Gauge # 2	
Site Name: Fish Pool						
Surveyor(s): Jan, Wendy, Gordon and Darius						
<b>SITE DESCRIPTION</b>						
General Location: At the easternmost point of hedgerow extending from the forest. At a junction from a watercourse from the forest and from neighbouring lands to the south. 80% of the flowing waters is from the south.						
Coordinates:		UTM Zone: 10	Easting: 355912		Northing: 5500630	
Slope: < 5% - appearance of level ground			Aspect: There is a gentle slope to the east. Open to the east			
Description of the site: At some point in the past rip-rap has been dumped to line the edges of the ditch. The bed of the watercourse is a mix of fine and coarse sands.						
Glide Length:		Wetted Width:		Bankfull Width:		Staff Gauge Water Level: 8cm
Substrate (%)	Organic Soil: 0%		Mineral Soil: 100%		Rocks: 0	Bedrock: 0
<b>WATER CHEMISTRY</b>		Time of Day: 12:41		Air Temperature: 19°C		Water Temperature: 12°C

Total Dissolved Solids (TDS): 87			Dissolved Oxygen (DO): 91%		pH: 5.86	
<b>SITE VEGETATION:</b> (within 5m of the spring or seep)						
Trees:		Shrubs:			Herbs:	
Red alder		Blackberry			Grasses	
Willow species		Salmonberry			Vetch	
					Horse tail	
					Lady fern	
					Cleavers	
Notes: We could see several fish, a salmon species presumably cut-throats trout with a length of between 10 and 14cm. The fish darted under exposed roots of bank-side trees. We set a trap for 24 hours but did not catch any fish.

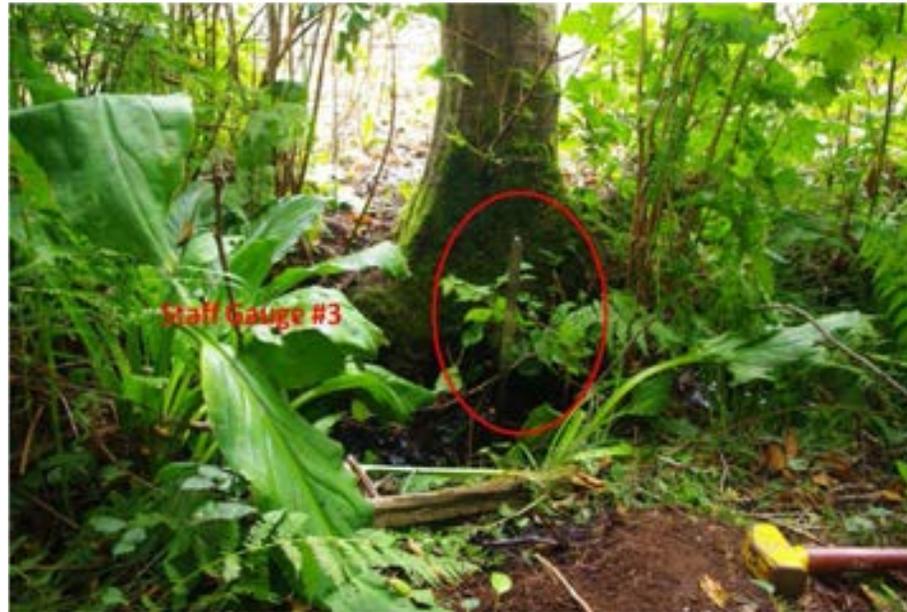
**Photograph 4: Staff Gauge #3 (called the Bird House Trickle) at a spring along the south edge of the forest – near a tree with a birdhouse.**

<b>SPRING AND SEEP DATA</b>		Day: 14	Month: August	Year: 2013	Staff Gauge # 3
Site Name: Bird House Trickle					
Surveyor(s): Ian, Wendy, Gordon and Darius					
<b>SITE DESCRIPTION</b>					
General Location: At the southern edge of the forest with a neighbouring horse paddock to the south. The Staff Gauge is in a shallow ditch like glide immediately south of a trickle of flow from a seep.					
Coordinates:		UTM Zone: 10	Easting: 355858	Northing: 5500630	
Slope: < 5% - appearance of level ground		Aspect: There is a gentle slope to the east. Open to the south			
Description of the site: In a loose tangle of vegetation that if left alone will develop into a hedgerow.					
Glide Length: 5m		Wetted Width: 55cm		Bankfull Width:	
Staff Gauge Water Level: 2.6cm					
Substrate (%)	Organic Soil: 100%	Mineral Soil: 0%	Rocks: 0	Bedrock: 0	
<b>WATER CHEMISTRY</b>		Time of Day: 10:11	Air Temperature: 18°C		Water Temperature: 14°C

Total Dissolved Solids (TDS): 85		Dissolved Oxygen (DO): 68%		pH: 5.56	
<b>SITE VEGETATION: (within 5m of the spring or seep)</b>					
Trees:		Shrubs:		Herbs:	
Western red cedar		Salmonberry		Trailing Blackberry	Bracken
Red alder		Himalayan Blackberry		Horse tail	False Lilly of the Valley
Mountain ash (Rowen)		Huckleberry		Skunk Cabbage	
One tree we could not identify				Lady fern	
Notes: The base of the staff gauge ruler is 5mm into the stream bed sediments

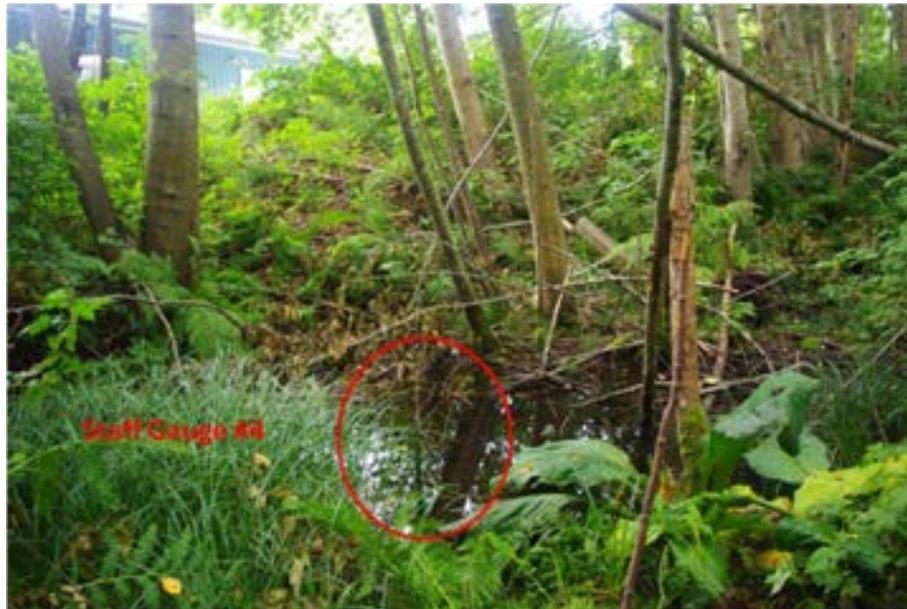
**Photograph 5: Staff Gauge #4 (called The Forest Pool) in a pool along the south edge of the forest.**

All of the locations in the Minto Road Forest where water was emerging from the subsurface had the appearance of seeps, where water was not bubbling up or flowing from a crack in a rock, as might better describe a spring (Photograph 9). The Forest Pool (Staff Gauge 4, Photograph 5) appeared to be the result of several seeps from where soil and fill had been piled up on the neighbouring property to the south-west of the edge of the forest. All of the seep areas had vegetation typically found in moist or wet soils (See Appendix for data sheets for each site).

<b>SPRING AND SEEP DATA</b>		Day: 12	Month: August	Year: 2013	Staff Gauge # 4
Site Name: The Pool					
Surveyor(s): Jan, Wendy, Gordon and Darius					
<b>SITE DESCRIPTION</b>					
General location: Along the south edge of the forest up on a gentle rise to the west.					
Coordinates:	UTM Zone: 10	Easting: 355775	Northing: 5500611		
Slope:		Aspect: The slope of the land is to the east.			
Description of the site: A shallow pool at the southern edge of the forest and just north of the boundary with a neighbouring property. The pool appears to have been created when land was excavated and piled up on the neighbouring property. The size of the red alder trees that surround the pool suggest it had been around for about 30 years.					
Pool Length:	Pool Width:	Pool Depth:	Staff Gauge Water Level:		
Substrate (%)	Organic Soil: 100%	Mineral Soil: 0	Rocks: 0	Bedrock: 0	
<b>WATER CHEMISTRY</b>	Time of Day:	Air Temperature: 20.0 °C		Water Temperature: 17.4 °C

Total Dissolved Solids (TDS): 125		Dissolved Oxygen (DO): 10%		pH: 5.93	
<b>SITE VEGETATION:</b> (within 5m of the spring or seep)					
Trees:		Shrubs:		Herbs:	
Red alder		Salmonberry		Skunk cabbage	
		Devil's club		Horse tail	
				Bracken fern	
				Sedges	
Notes: Overcast after a heavy rain

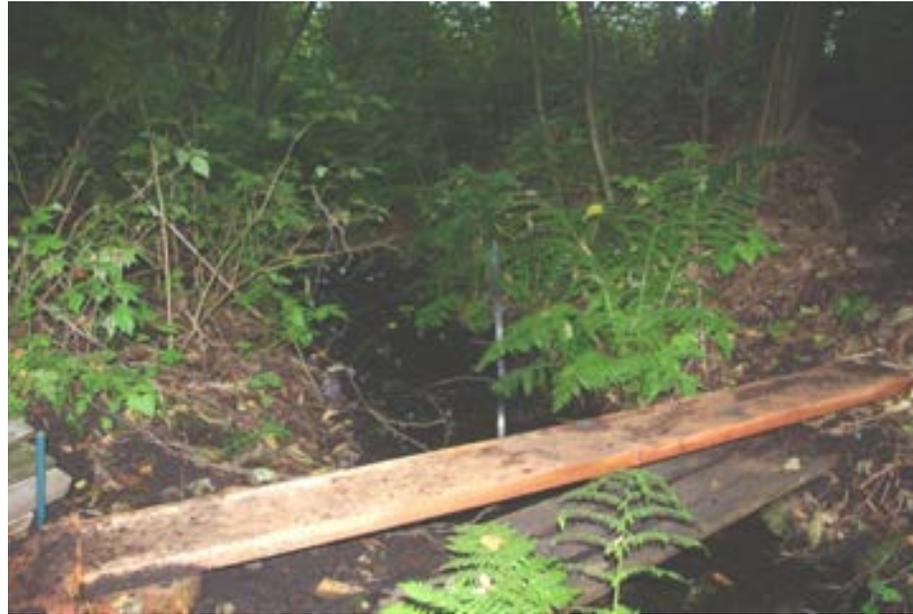
**Photograph 6: Staff Gauge #5 (called Linda's Bridge) near some major seeps along a ditch that drain much of the central area of the forest.**

<b>SPRING AND SEEP DATA</b>		Day: 13	Month: August	Year: 2013	Staff Gauge # 5
Site Name: Linda's Bridge					
Surveyor(s): Jan, Wendy, Gordon and Darius					
<b>SITE DESCRIPTION</b>					
General Location: Near the east edge of the central part of the forest, just inside the forest from the trail over the field.					
Coordinates:		UTM Zone: 10	Easting: 555779	Northing: 5500722	
Slope: < 5% - appearance of level ground		Aspect: There is a gentle slope to the north. The site is enclosed in the forest			
Description of the site: A ditch that was dug 30 to 40 years ago that has naturalised. The base of the watercourse is fine sand with about 50% covered with organic sediments.					
Glide Length: 5m		Wetted Width: 55cm		Bankfull Width:	
Staff Gauge Water Level: 2.6cm					
Substrate (%)	Organic Soil: 50%	Mineral Soil: 50%	Rocks: 0	Bedrock: 0	
<b>WATER CHEMISTRY</b>		Time of Day: 11:15	Air Temperature: 19°C		Water Temperature: 13°C

Total Dissolved Solids (TDS): 75		Dissolved Oxygen (DO):		pH: 5.66	
<b>SITE VEGETATION: (within 5m of the spring or seep)</b>					
Trees:		Shrubs:		Herbs:	
Red alder		Salmonberry		Lady fern	
				Horse tail	
Notes: The base of the staff gauge ruler is 5mm into the stream bed sediments.

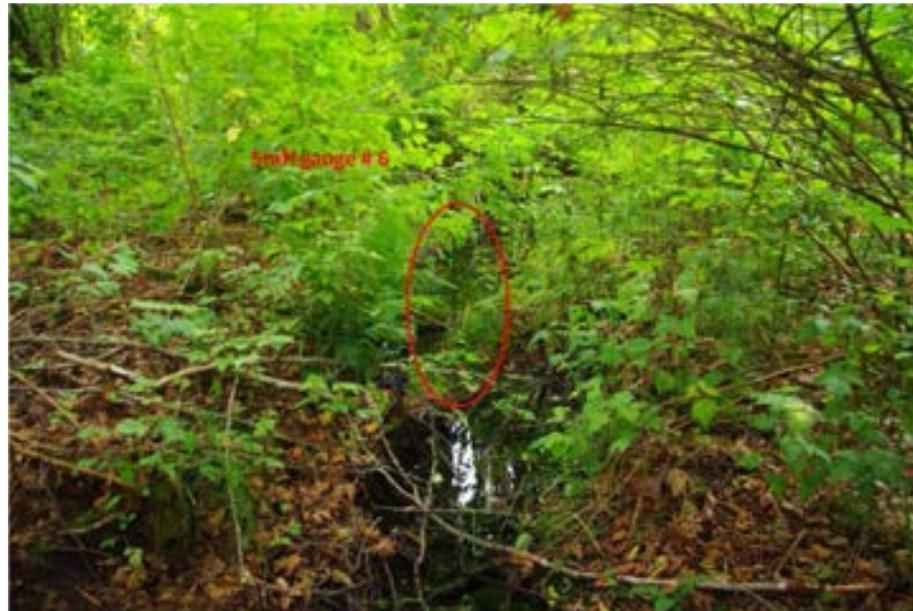
**Photograph 7: Staff Gauge #6 (called the Car Park Spring) at a point of consistent water flow by three cars abandoned in the 1950s.**

<b>SPRING AND SEEP DATA</b>		Day: 13	Month: August	Year: 2013	Staff Gauge # 6
Site Name: The Car-park Spring					
Surveyor(s): Jan, Wendy, Gordon and Darius					
<b>SITE DESCRIPTION</b>					
General Location: Within 10m to the south of the abandoned cars, at a plank bridge over a trickle of water.					
Coordinates:	UTM Zone: 10	Easting: 353775	Northing: 5500611		
Slope: <5%		Aspect: The slope of the land is gentle and to the north-east.			
Description of the site: A narrow trickle of water (less than 1 metre wide) with some flow from the south-west to the north-east.					
Pool Length:	Pool Width: 32"	Pool Depth:	Staff Gauge Water Level:		
Substrate (%)	Organic Soil: 100%	Mineral Soil: 0	Rocks: 0	Bedrock: 0	
<b>WATER CHEMISTRY</b>	Time of Day: 09:51	Air Temperature: 18.0 °C	Water Temperature: 13.0 °C		
Total Dissolved Solids (TDS): 76		Dissolved Oxygen (DO): 53%	pH: 5.53		
<b>SITE VEGETATION:</b> (within 5m of the spring or seep)

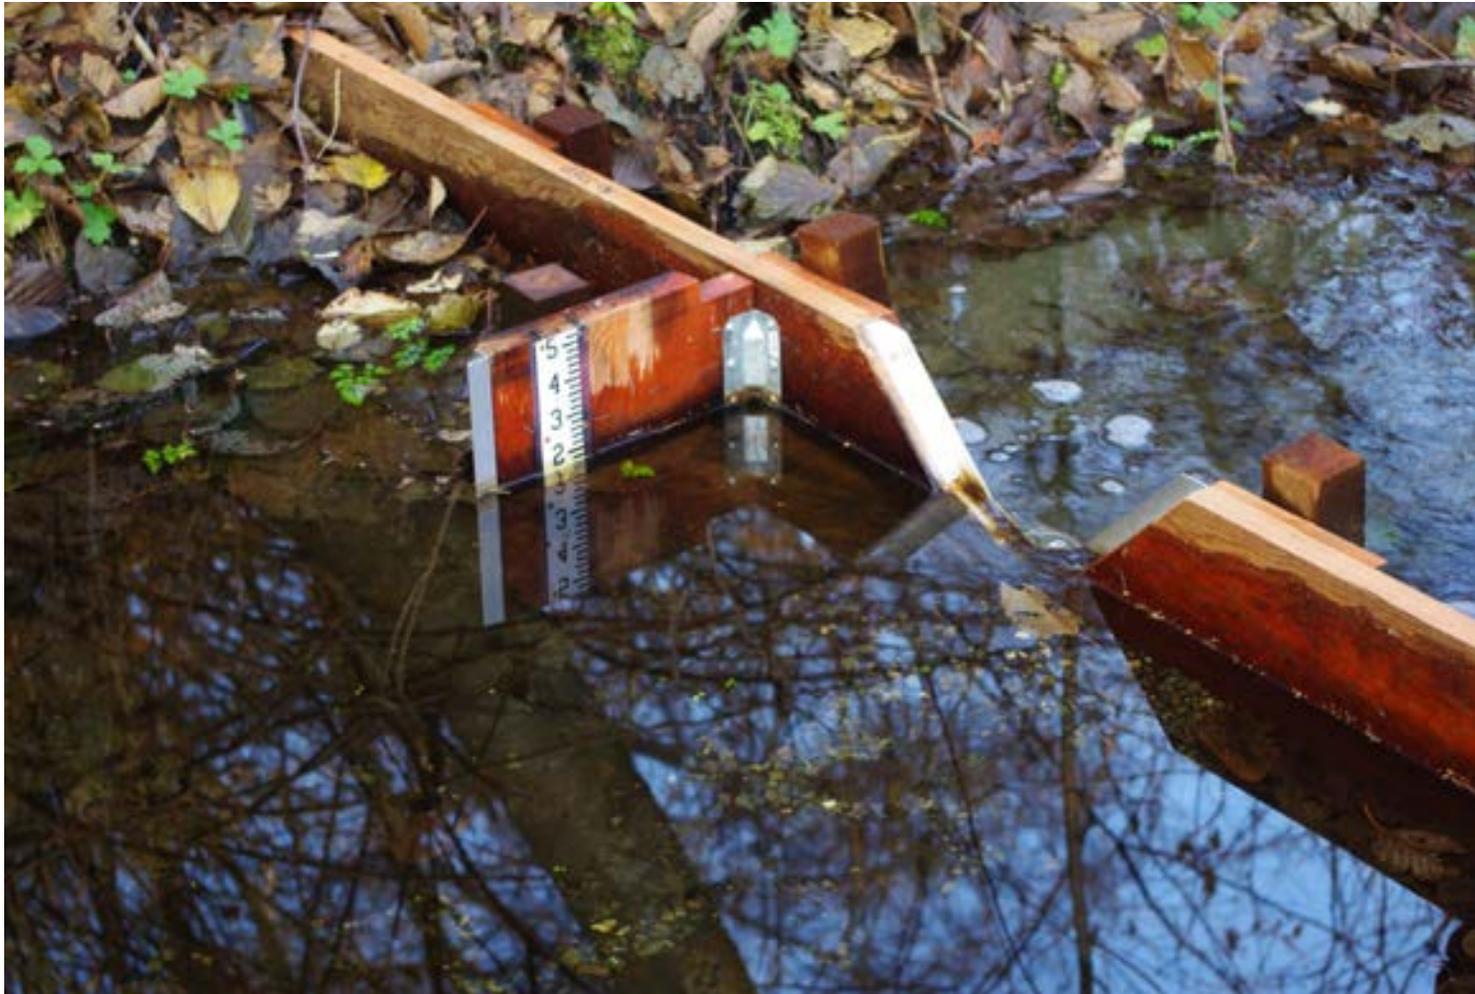
**Photograph 8: V-Notch Weir for monitoring water flow at the site of Staff Gauge #1.**

The six staff gauges installed during this project were a continuation of previous monitoring of groundwater at a nearby surface well (shown on Map 2). Following the YER Phase II program, Staff Gauge # 1 was replaced with a V-notch weir, calibrated to measure water volume (Photograph 8). Starting on 17 September 2013, Wendy Kotilla began recording daily maximum and minimum air temperatures, rainfall amounts, and weather conditions at the Minto Road Forest.

Richard Hart built the V-Notch Weir and worked with Wendy and two YER participants to measure and install it.

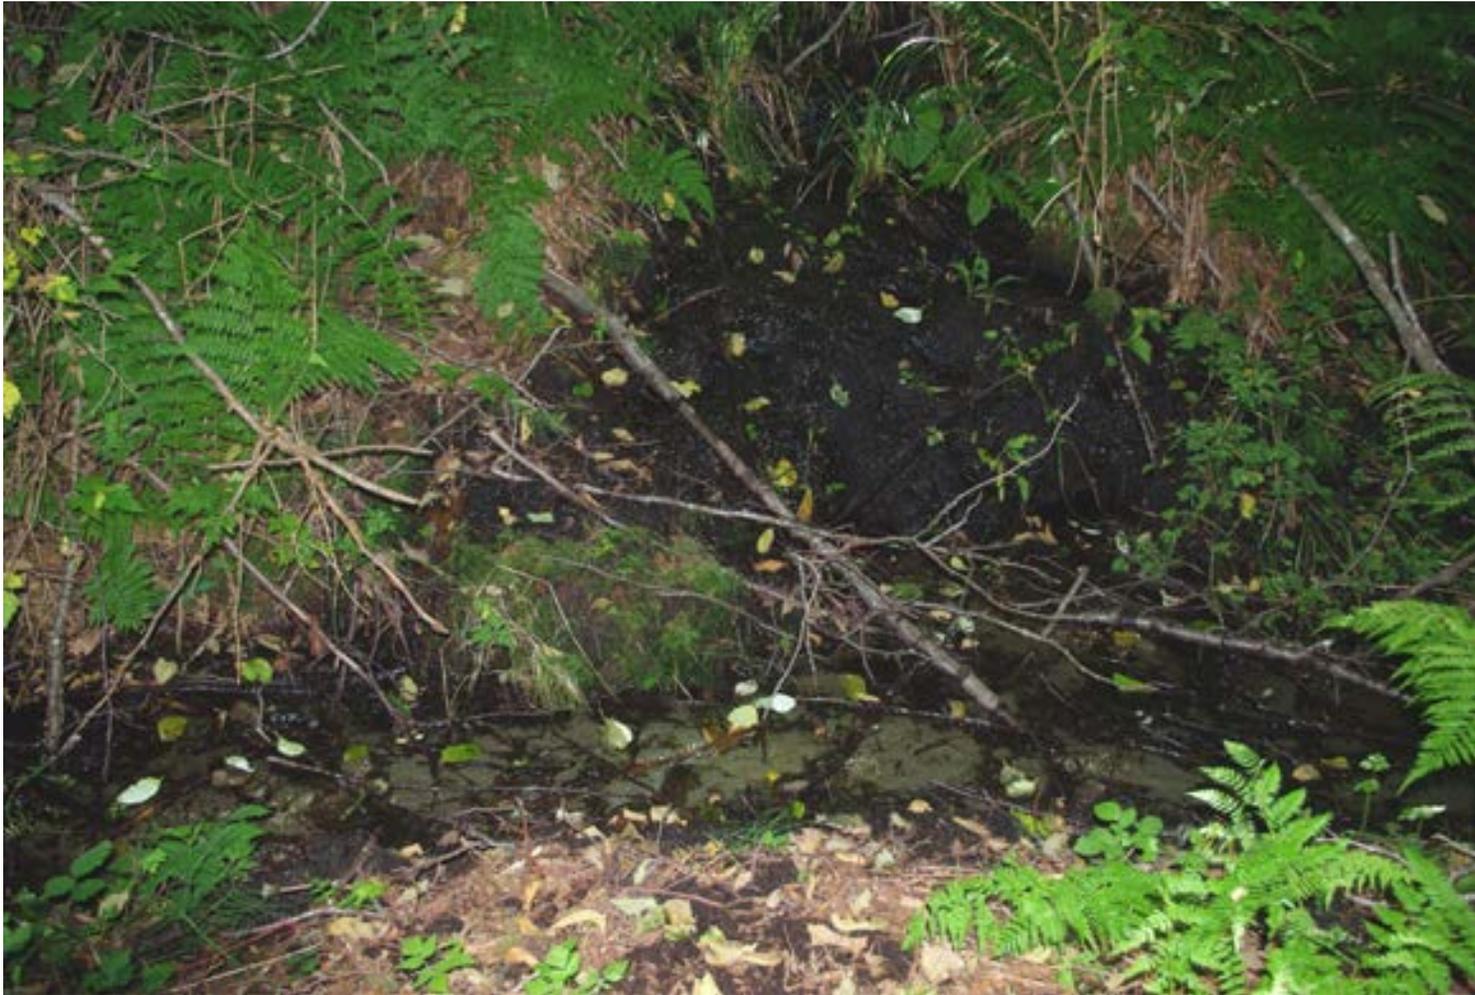
**Photograph 9: A location where water from saturated soil is seeping into a channel of water where there is just enough flow to move organic material and expose some mineral substrate on the bed of the channel. Water in this location would typically be cooler than the surrounding air in the summer, and have a dissolved oxygen level lower than needed to support a healthy fish population (See section III-C). The dissolved oxygen levels will quickly increase as the water is exposed to the air and gets stirred up as it trickles over small riffles and flows downstream.**
