**Youth and Ecological Restoration Program
Ecological Inventory of the Upper Headwaters of the
South Millard Creek tributary**

30 August 2011

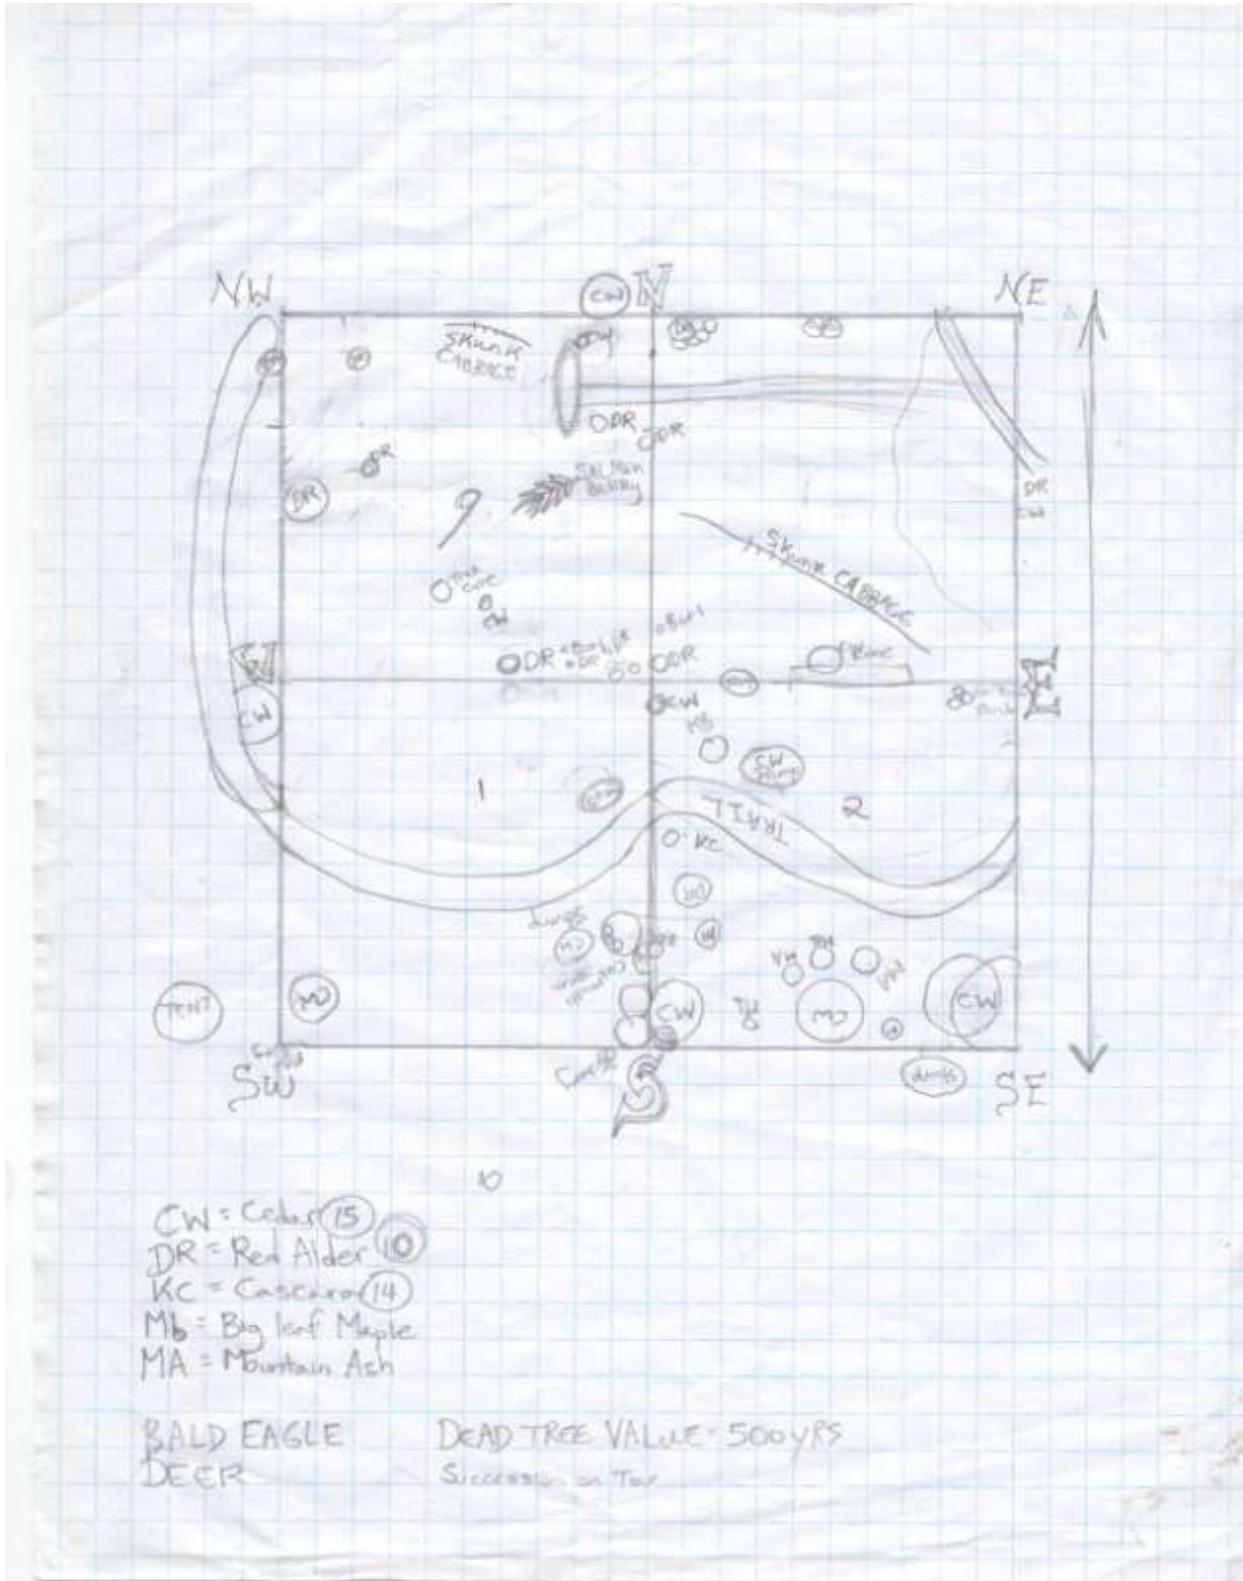
Vegetation map for Study Plot 2 - Example 1

Ecological descriptions of forest lands include both Forest Structural Stage Classifications and site specific soil and moisture regimes leading to mature forest plant community groupings, called Site Series. Our plant inventory data is shown in Appendix 1. Maps of plants in Study Site 2 are shown in Appendix 2. Photographs of Study Plot 1 and 2 are shown in Photographs 2 and 3. By considering the vegetation mix at each of the two study sites and noting that each site represents a young maturing forest we conclude that this area is made up of two plant community site series:

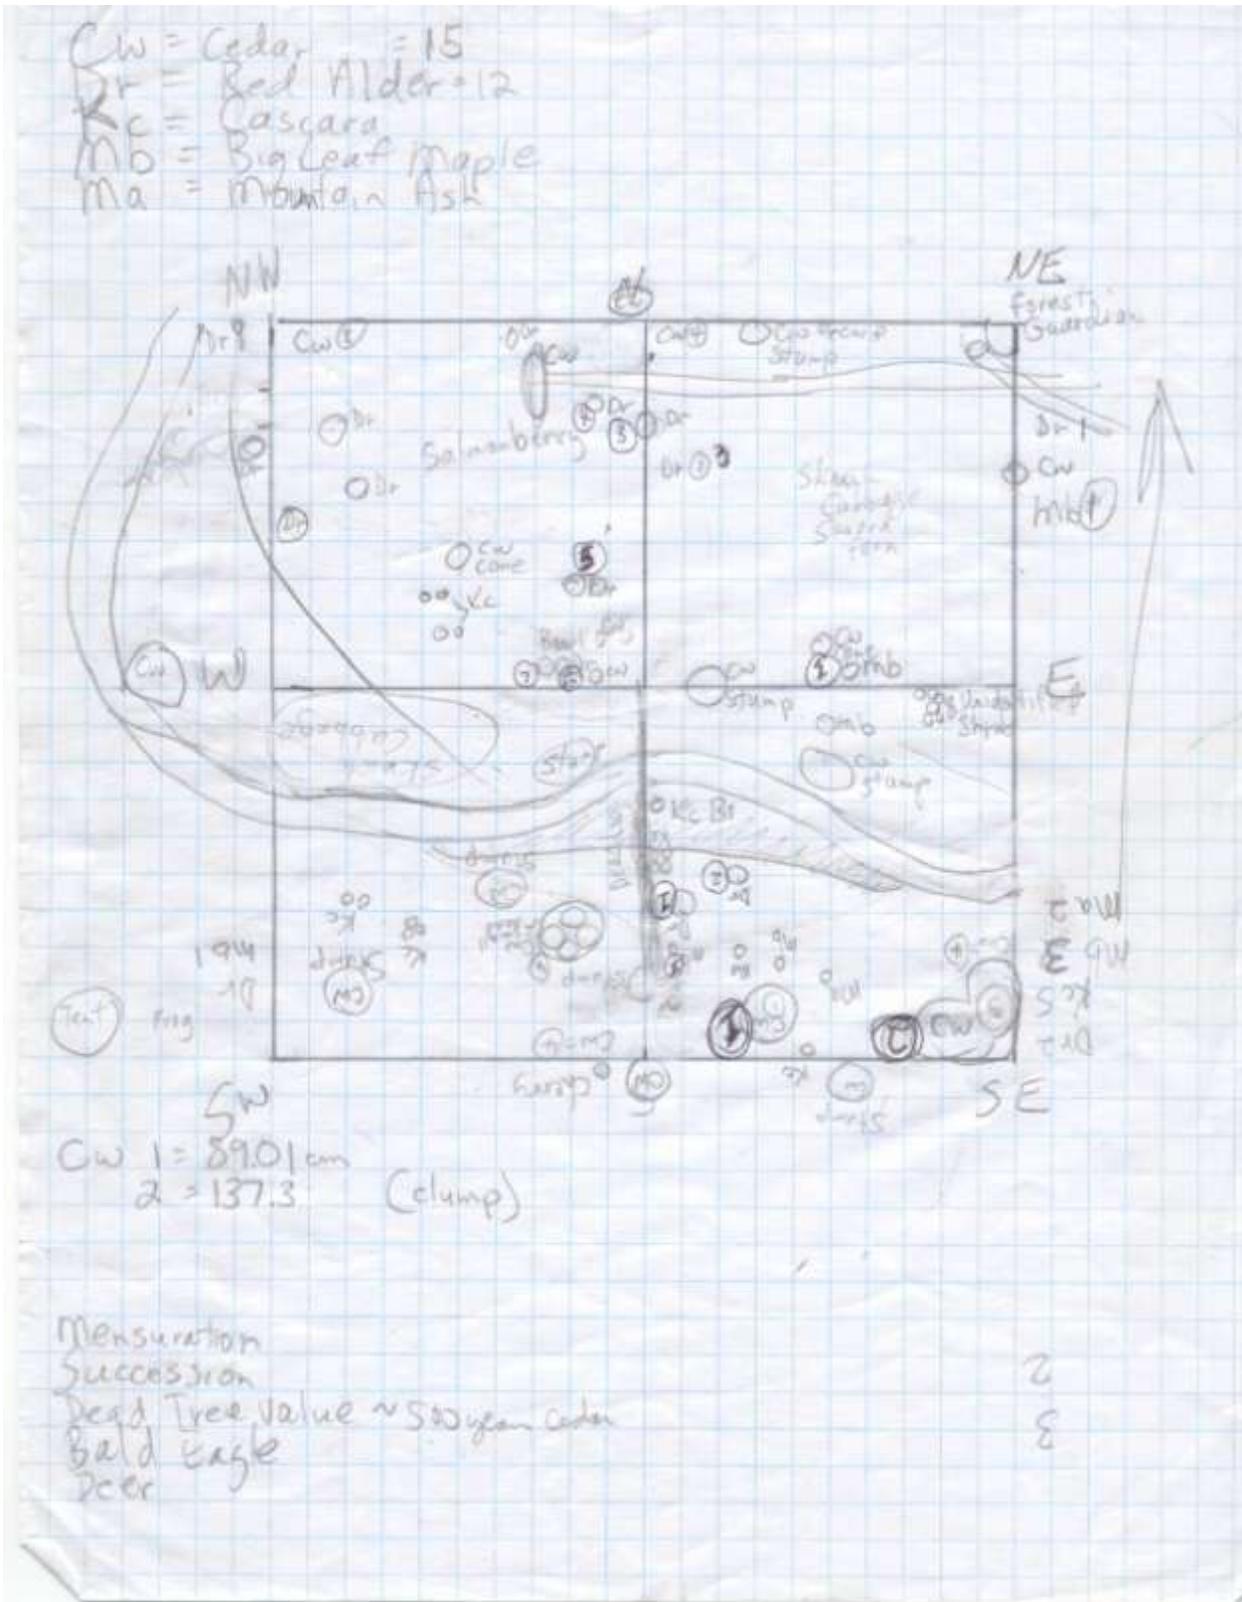
Vegetation map for Study Plot 2 - Example 2

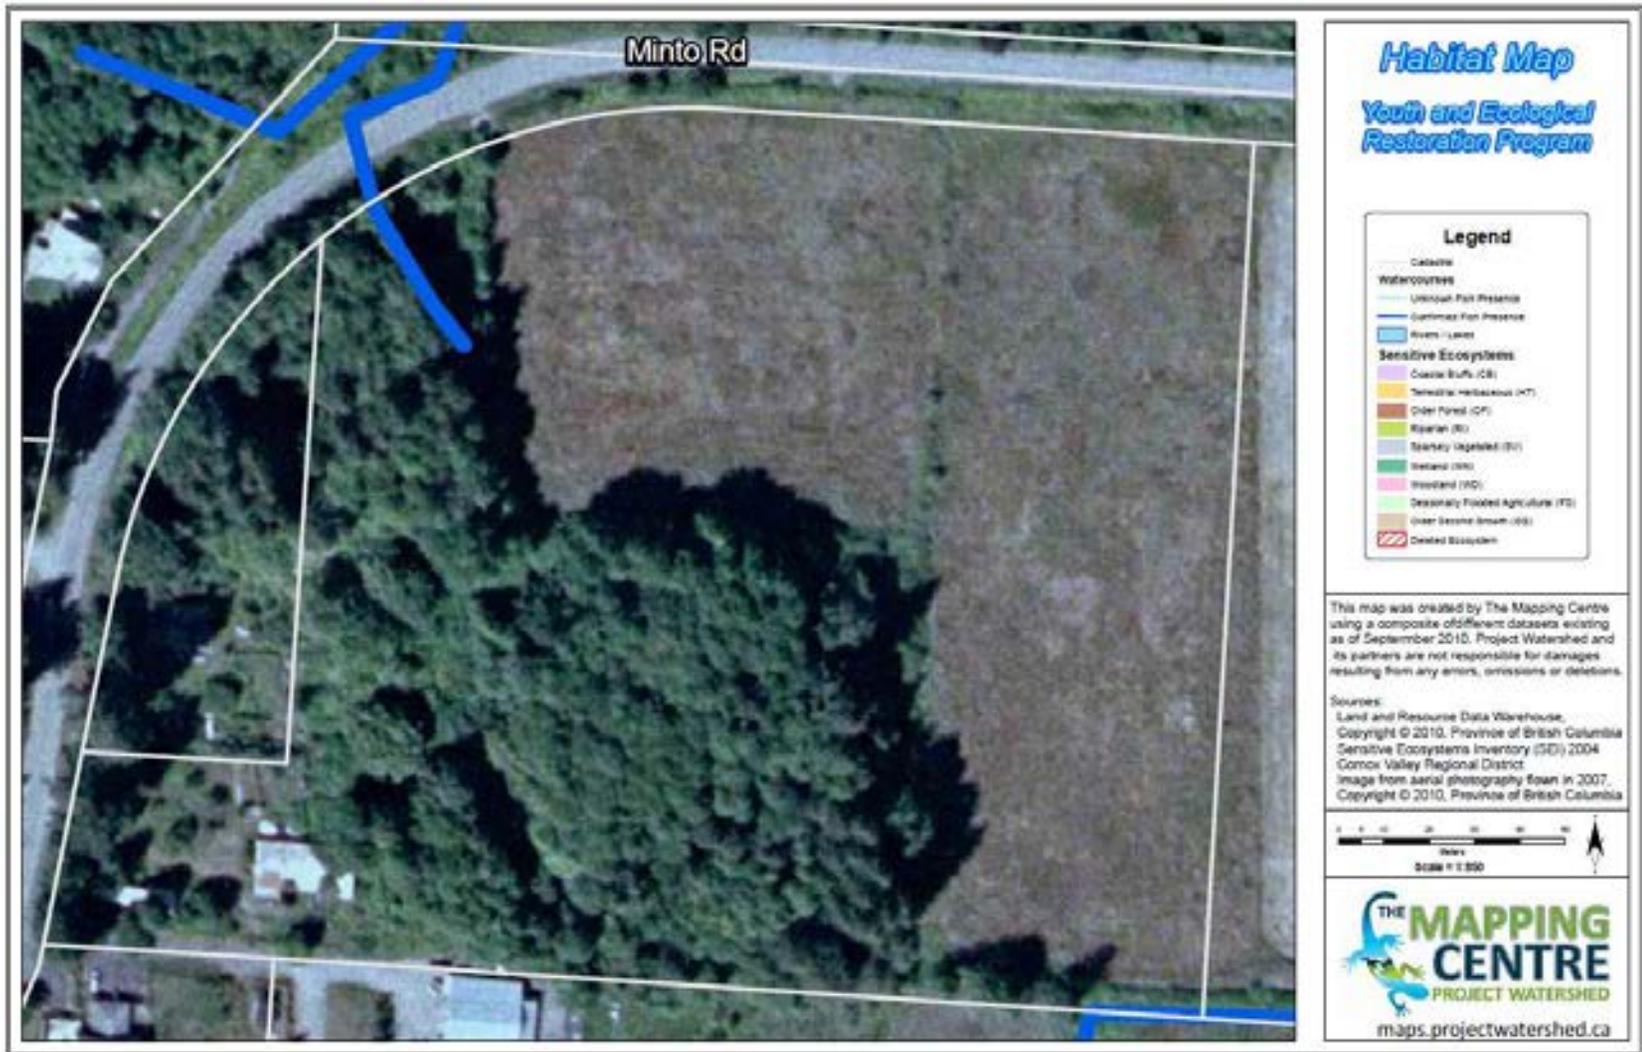
Map 2, provided by Project Watershed and the Mapping Centre shows how the mapped extent of the upper reaches of Millard Creek ends just at the edge of the study site. We used compass bearings and a hip chain to measure out and extend our knowledge of the watercourse position into the study site (Map 3). There are a couple of short sections of visible water that later disappeared underground. These are indicated on Map 3 as ephemeral watercourses. In the time available for this project we were not able to fully map all the smaller sections of watercourse on this site.

Map 2: An aerial view of the study area showing watercourse locations in the Project Watershed map files.

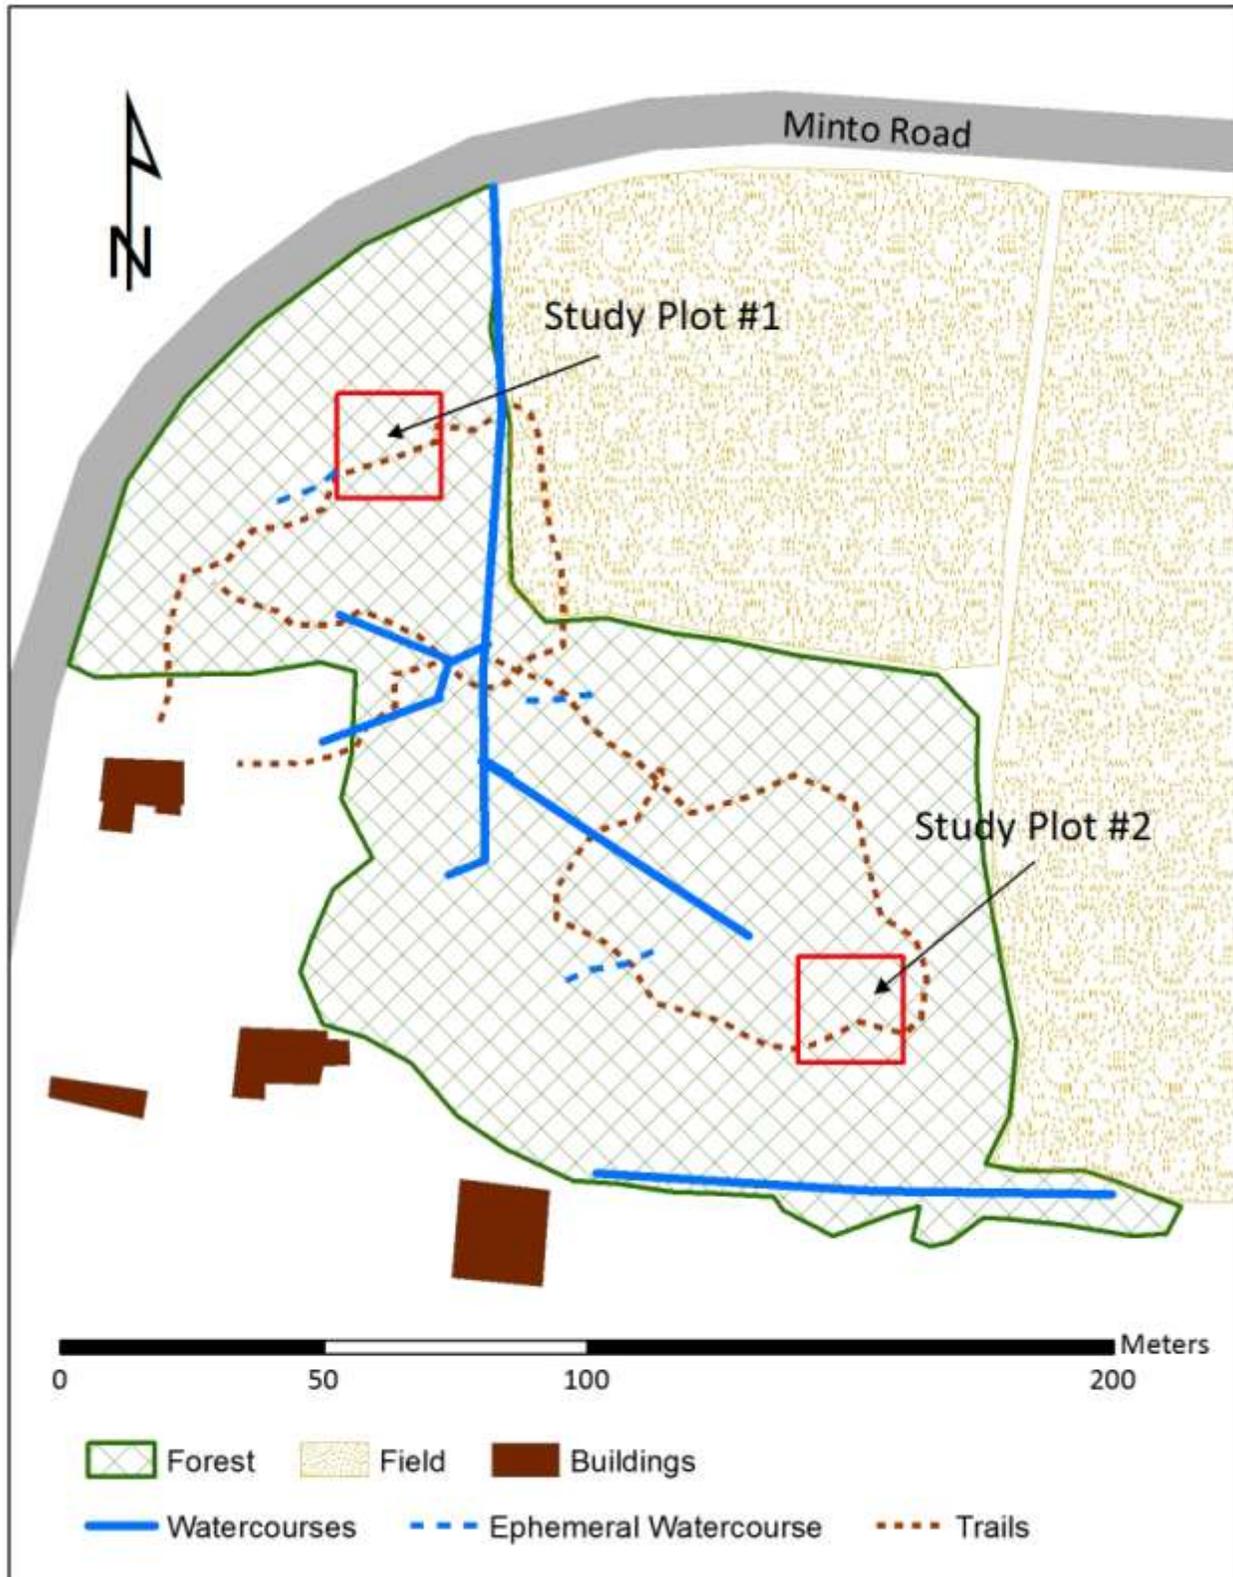
Two 20m by 20m study plots were measured on the ground and marked with flagging tape (Map 3). Plant species within each study plot were inventoried and scored based on relative abundance in each of the forest layers of: Moss/Lichen; Herb; Shrub; and Tree. On day one we assigned relative percentages based on looking at the study plot and the various plants (Appendix 1). On day two we refined our method by actually plotting major vegetation on graph paper maps of the study plot (Appendix 2). On both days we worked together to count the trees and develop relative percentages of vegetation through discussion that resulted in a general consensus of what we were seeing.

Map 2: Location of Study Plots within the South Millard Creek Headwaters Study Site

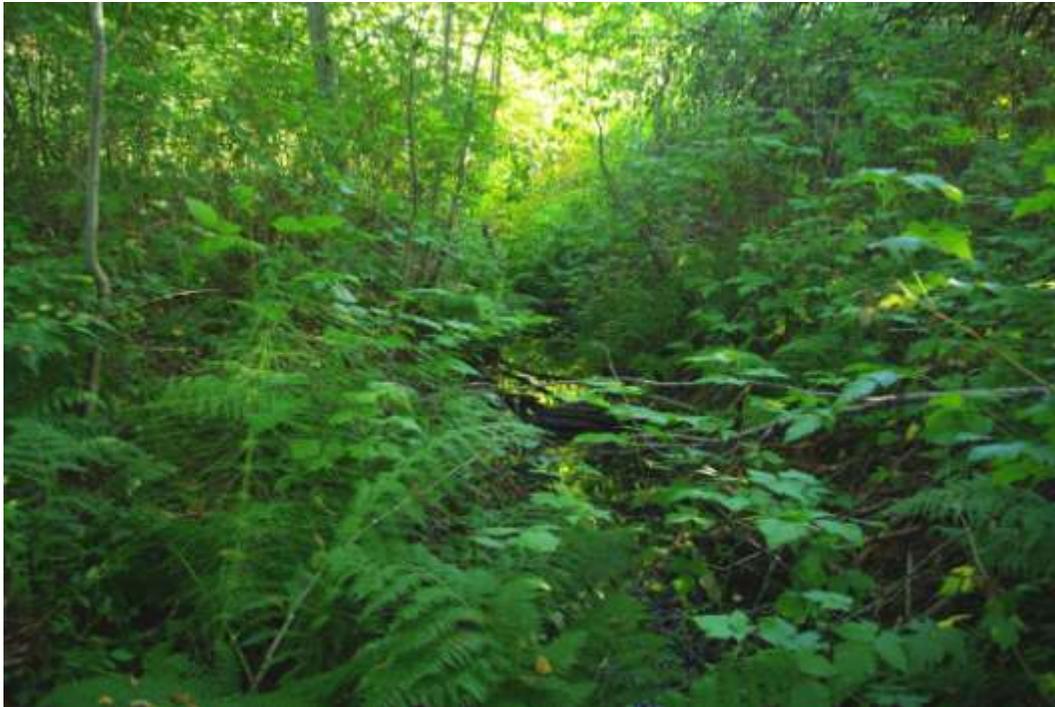
The watercourses on this site are a mix of naturalised ditches (Photograph 4) and natural channels. Many of the watercourses had flowing water and there were noticeable areas of natural seepage (Photograph 5). In some locations, in the driest month of the year, subsurface waterflow could be identified by wet soil and patches of skunk cabbage.

Two available maps of the Millard Creek watershed differ slightly in how the two catchment areas on this study site eventually flow into Millard Creek. A map from the Millard/ Piercy Watershed Management Plan 2001 suggests that flow from the north and central catchment ends up in North Millard Creek while the southern catchment ends up in South Millard Creek. North and South Millard Creek tributaries join approximately 1km downstream along Fraser Road. Map 2 presented here, also from 2001, shows how the two catchment areas may join in a ditch along the north side of Minto Road. Regardless of water flow downstream of Minto Road, the watercourses mapped during this study clearly demonstrate year-round waterflow entering the Millard Creek watershed (Photographs 4 and 5).

Photograph 4: View looking south along a naturalised ditch.

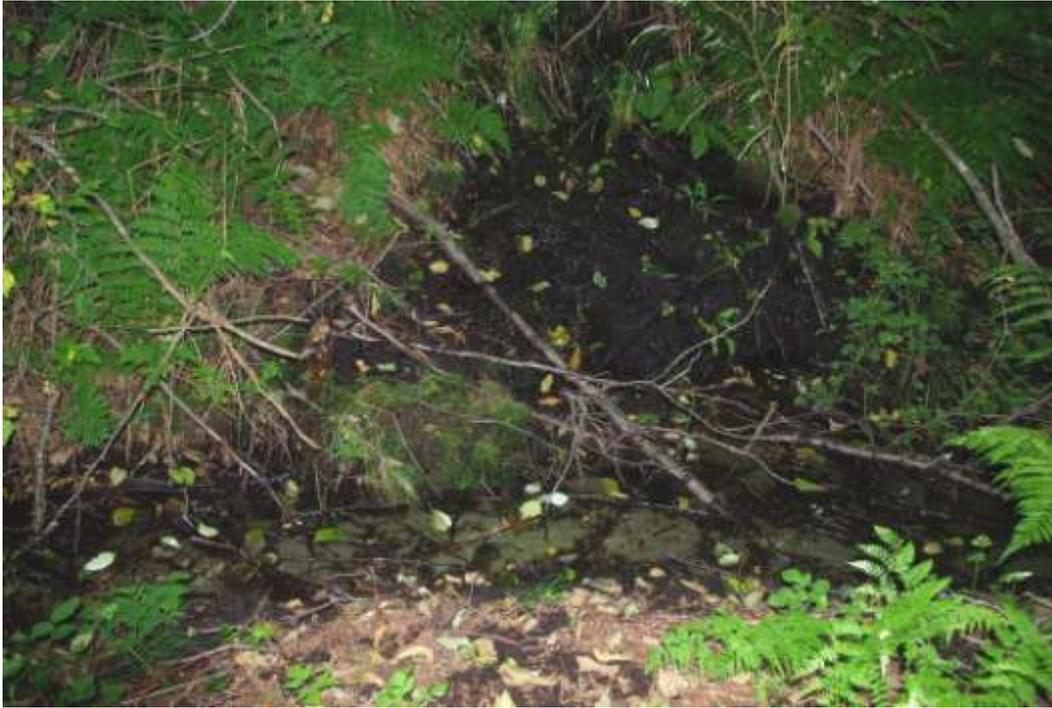
Photograph 5: Natural seepage and water flow along a section of ditch. Note the sand on the bottom of the watercourse channel.

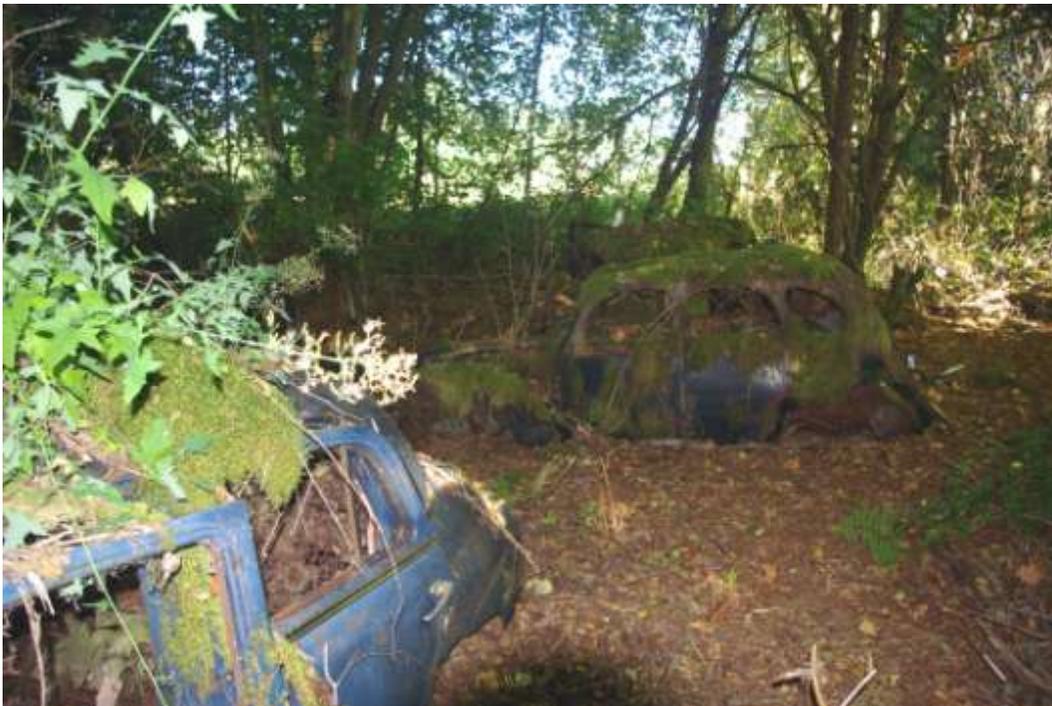
By looking at the stumps of red cedar trees from the original forest we may assume that this area was first logged in the early 1900s. Wrecked cars left at the site are from the 1940s and 1950s (Photograph 6). It may be assumed that the ditches were originally dug to drain the area of the agricultural fields. A pond located near the south-west boundary of the forest appears the result of fill being added on neighbouring land to the south.

Photograph 6: Old cars found on the site

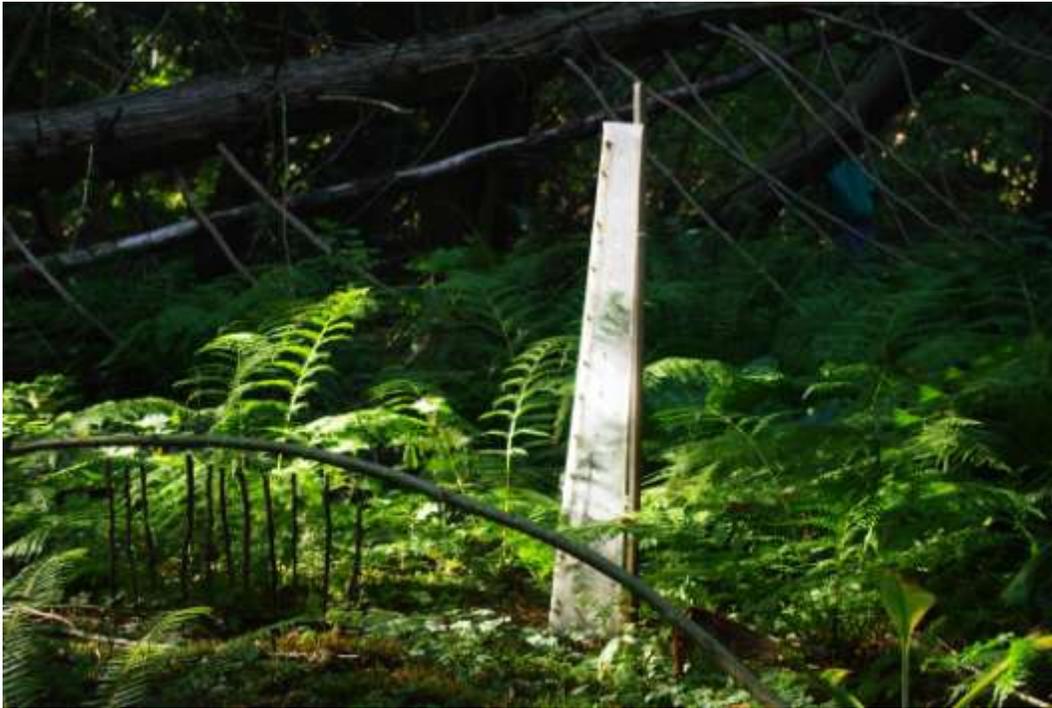
Photograph 7: A white plastic tree cone used to protect young trees from the deer, and a an example of personalisation of the forest area.
