Millard Creek Headwaters Long-term Ecological and Hydrological Study 2018

Comox Valley, BC

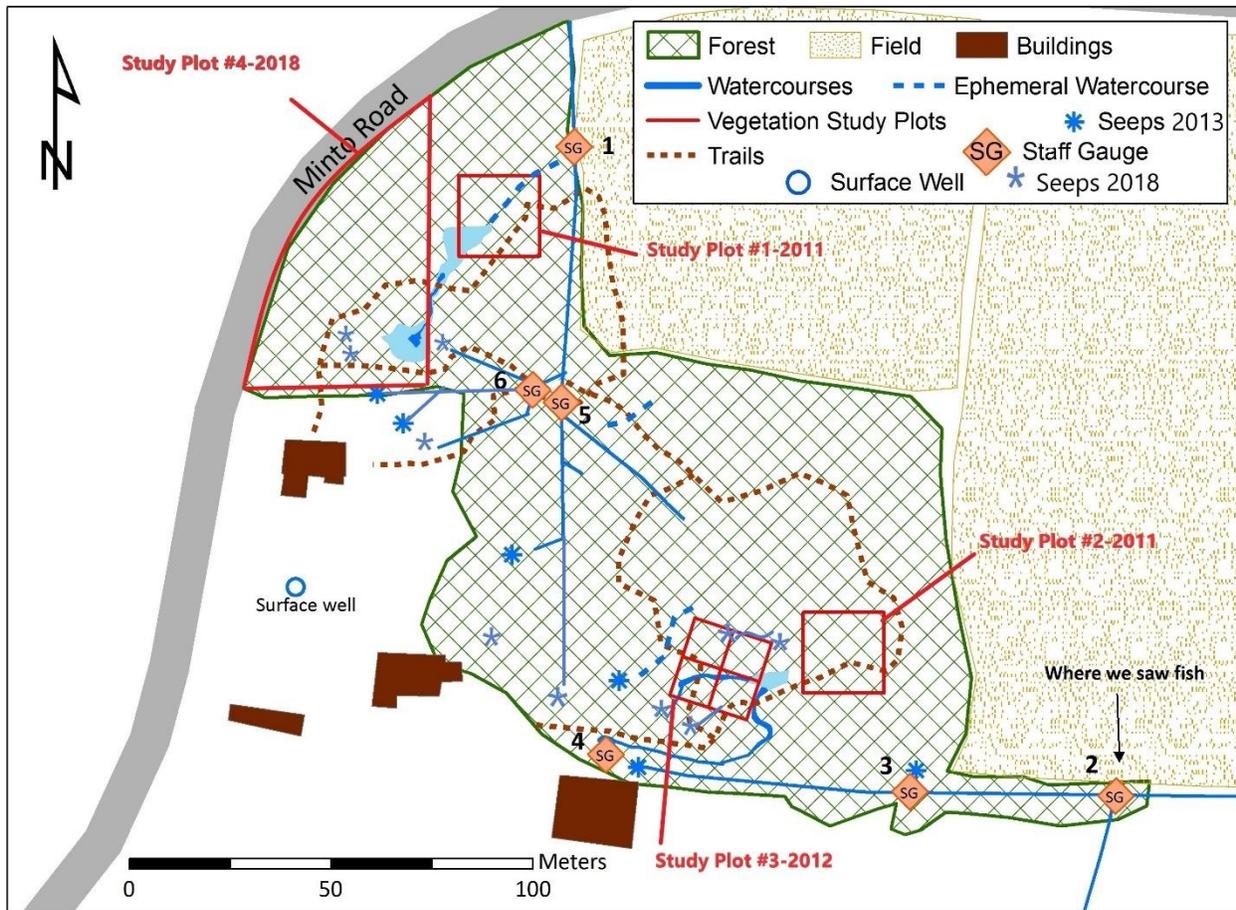
Figure 1. Updated map from Moul and Kotilla (2013) depicting the cumulative features in the study area from 2011 - 2018.

Private land owned by Wendy Kotilla and Sue Minchin was selected as a study area for the 2018 YER Phase II project (Figure 1). The study area contains ecological features of significance within the Millard-Piercy watershed, which is an important rural and urban stream in the Comox Valley. Wendy Kotilla has recorded basic meteorological and hydrological data within the study area for over five years, which was set up under the guidance of GW Solutions Incorporated (Moul and Kotilla 2013). Long-term datasets of this nature are extremely valuable in a variety of applications including land use planning, and monitoring climatic changes taking place within the watershed. Previous YER Phase II projects (Moul and Kotilla 2011, 2012 and 2013) also contributed important information about the study area. This project exposed the youth to those long-term data collection methods, refined previous work completed in 2013 and also included conducting ecological description work not previously undertaken.

The study area (Figure 1) includes two adjacent private lots:

Two minnow traps were used to detect the presence of fish in the upper portions of Millard Creek (Figure 1). The traps were deployed in the same location, a few meters apart. The sampling site was in a naturalized ditch flowing from west to east along the southern boundary of 4333 Minto Rd (49.64099, -124.99574). The traps were in place for a 24-hour period. Fish caught in the traps were identified to species and measured (length) prior to release.

Water quantity was measured using six staff gauges and one V-notch weir that had been previously established in six locations throughout the study area (Moul and Kotilla 2013) (Figure 1). Water quality was also measured at the same six locations (Figure 1). Water temperature, pH, total dissolved solids (TDS) and conductivity were recorded using HANNA instrument HI98129 pH/EC/TDS/Temperature with Only One Tester; and an OxyGuard Handy Beta Portable DO Meter H01B meter was used to document dissolved oxygen. These data were added to a long-term data set that Wendy Kotilla has been recording at these locations on a monthly basis for the past 5 years (Figure 1; Appendix 4). In addition, groundwater was measured in a well located at 4333 Minto Rd. and used for domestic purposes associated with 4327 and 4333 Minto Rd (Figure 1). These data were added to a long-term dataset that Wendy Kotilla has been recording on a monthly basis for the past ten years (Figure 1; Appendix 4).

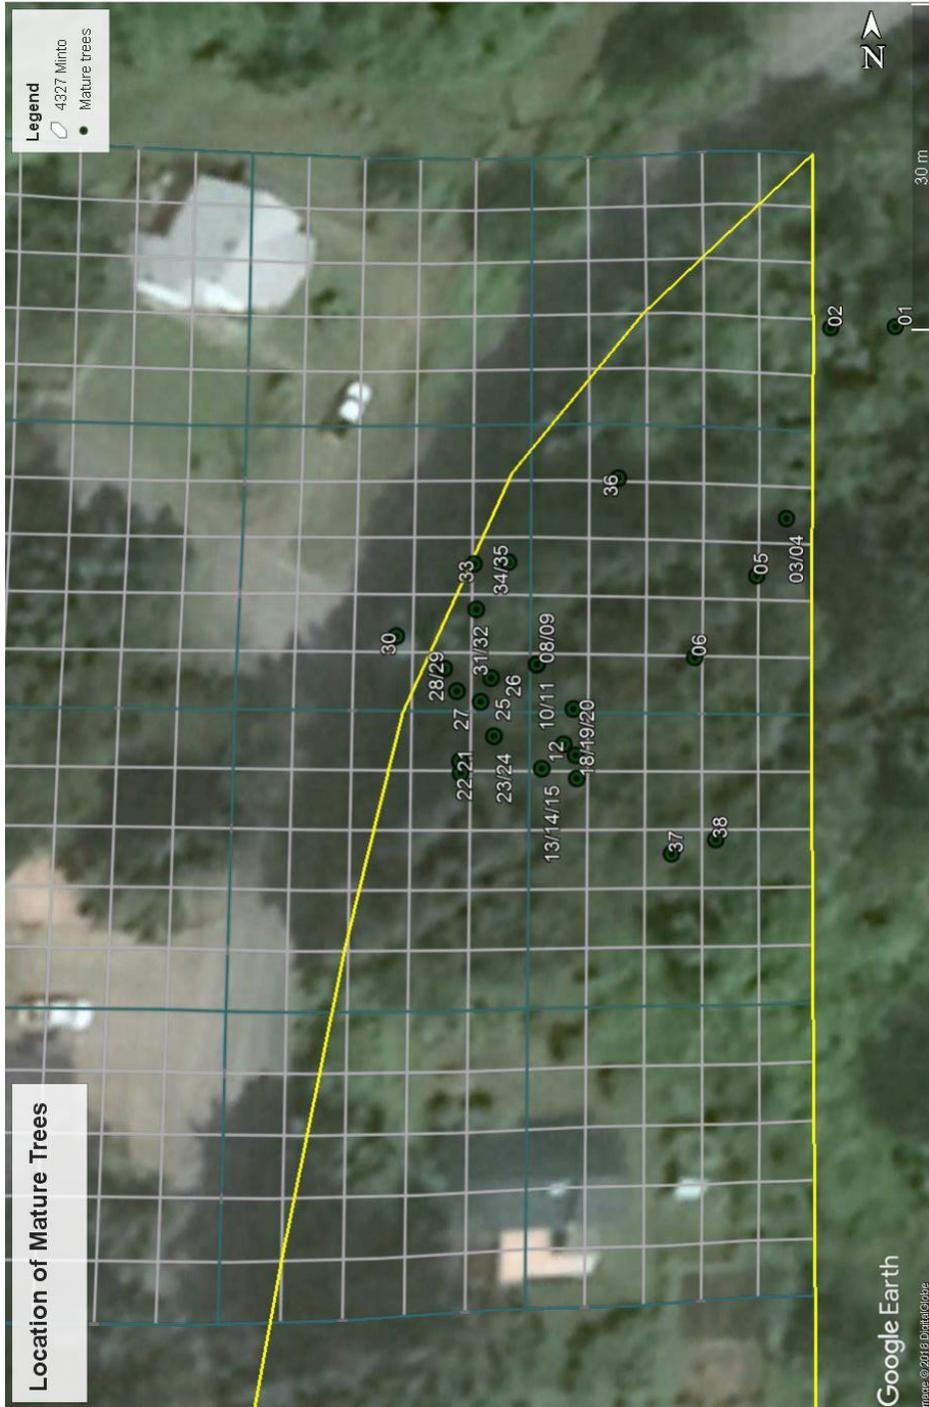
Figure 2. Location of mature trees on 4327 and 4333 Minto

In total 38 dominant canopy trees were mapped in the Western Redcedar grove (Figure 1 and 2). Summary statistics describing the diameter, species mix and age class are provided below (Table 1; Appendix 2). Despite the large diameter of some of the trees in the grove, none were considered to be old-growth (>250 years old). The grove includes several extremely large cedar stumps with spring-board notches, suggesting that the primary forest in the study area was logged sometime around the turn of the last century. Given that the time since disturbance was between 80 and 120 years, the dominant trees in the grove fit the definition of mature, and this was corroborated by our field data and observations.

Most of the mature trees occur on 4327 Minto Rd, while one might occur on the road right of way alongside Minto Rd., two are located on 4333 Minto Rd. and another two may be on the boundary between the two properties (Figure 1 and 2). Given the accuracy of the field mapping conducted in this study, a legal survey would be required to bring certainty should this become an important land-use issue in the future.

The cedar health assessment suggests that the cedars in the grove (Figure 1 and 2) are in excellent health overall. None of the trees expressed discoloured (orange) foliage that can be indicative of flagging, drought stress or leaf blight. No trees were found to have conks, or dead tops, and very few were found to have sign of wood-boring insects, or scars. Woodpecker holes, however, occurred on approximately half of the trees. A preliminary assessment by Verna Mumby indicates that the cedar trees are about 75% healthy (Appendix 3).

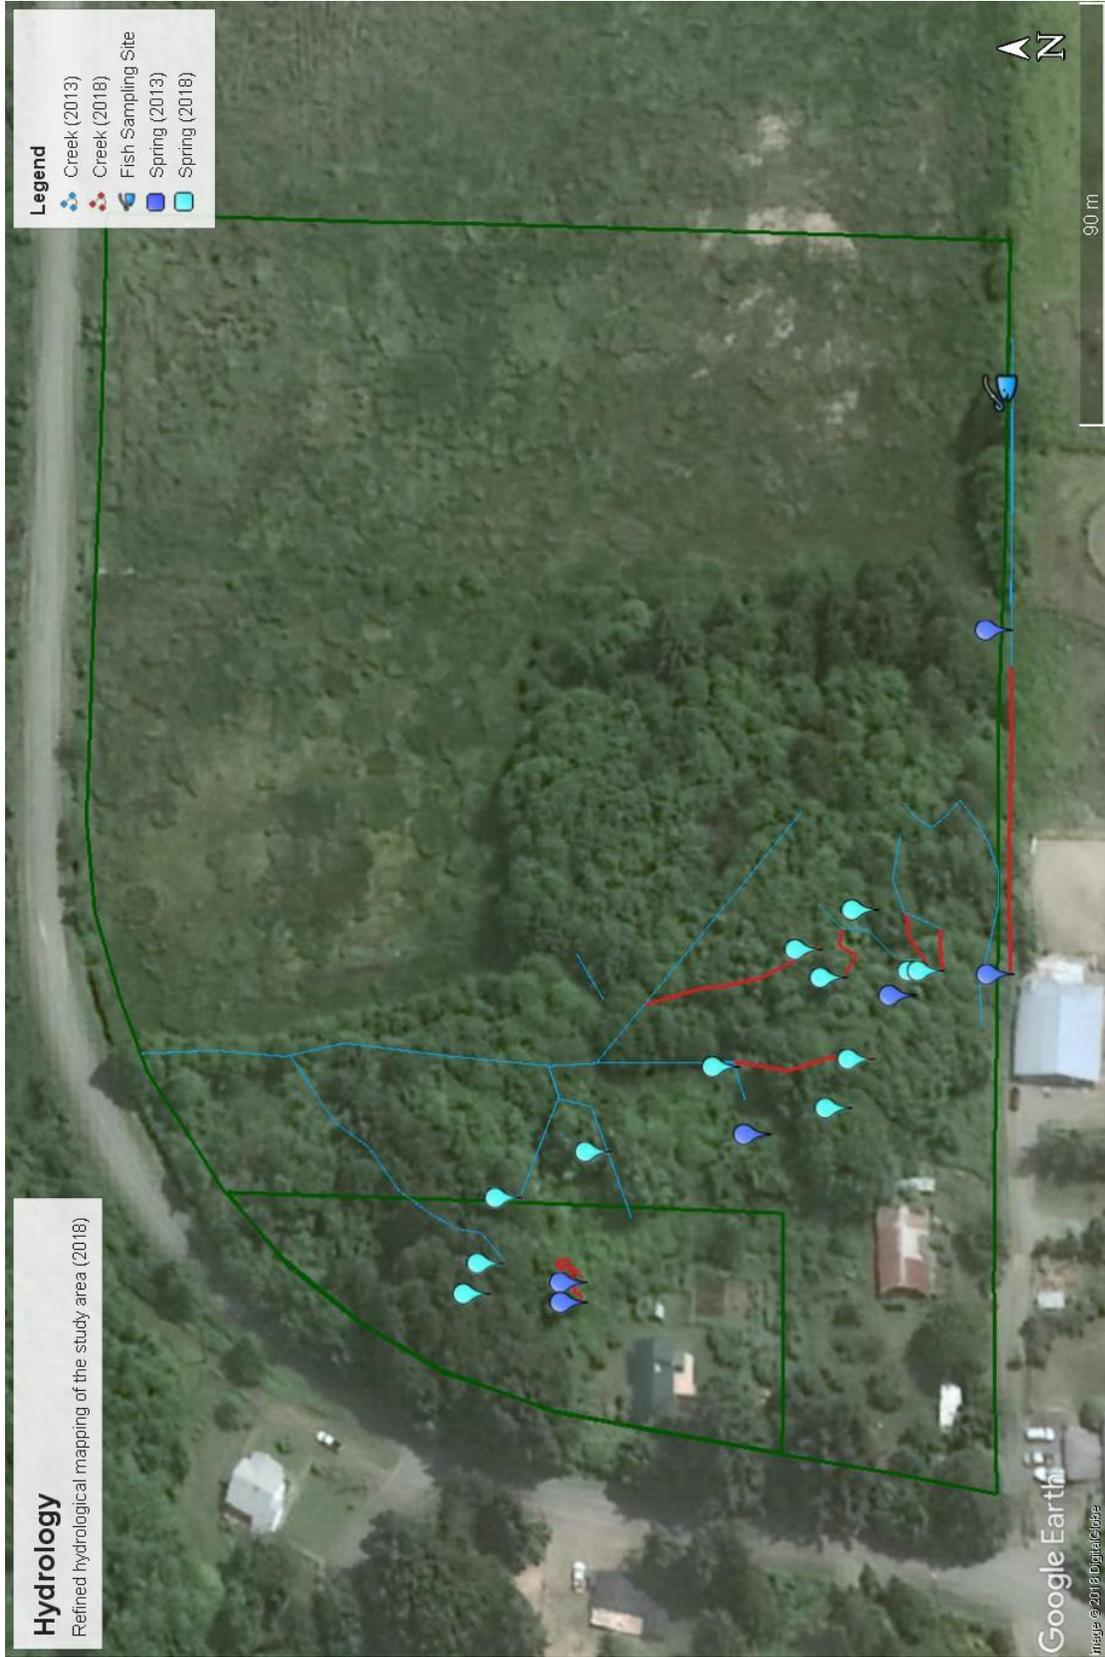
Figure 3. Hydrological map of study area

Mapping springs and watercourses resulted in the identification of additional features beyond those that were identified in the 2013 study. The 2013 study mapped 5 springs and 362 m of watercourses. In this project, an additional 9 springs and 127 m of watercourses were mapped (Figure 1 and 3).

Groundwater tends to be warmer than surface water in the winter and cooler than surface water in the summer. In the study area (Figure 1 and 3) the temperature of the spring-fed watercourses typically fluctuates from approximately 5 to 15 degrees Celsius between winter and summer respectively Appendix 4). In addition, the watercourses have not demonstrated a propensity to dry up completely during the summer months (Appendix 4) as has been observed in the upper and middle reaches of other streams nearby (e.g., Perseverance Creek). Therefore, the relatively stable, cool and abundant water associated with spring-fed headwater systems is ideal to support fish species such as Cutthroat Trout. Cutthroat are a species at risk in BC (CDC 2018), and other salmonids are also a conservation concern.

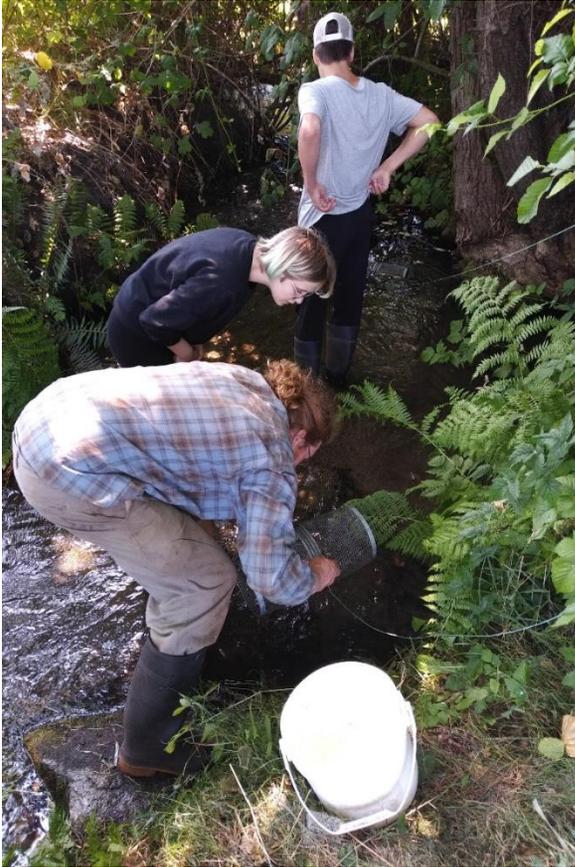
Photo 3: Checking the minnow traps in Millard Creek.

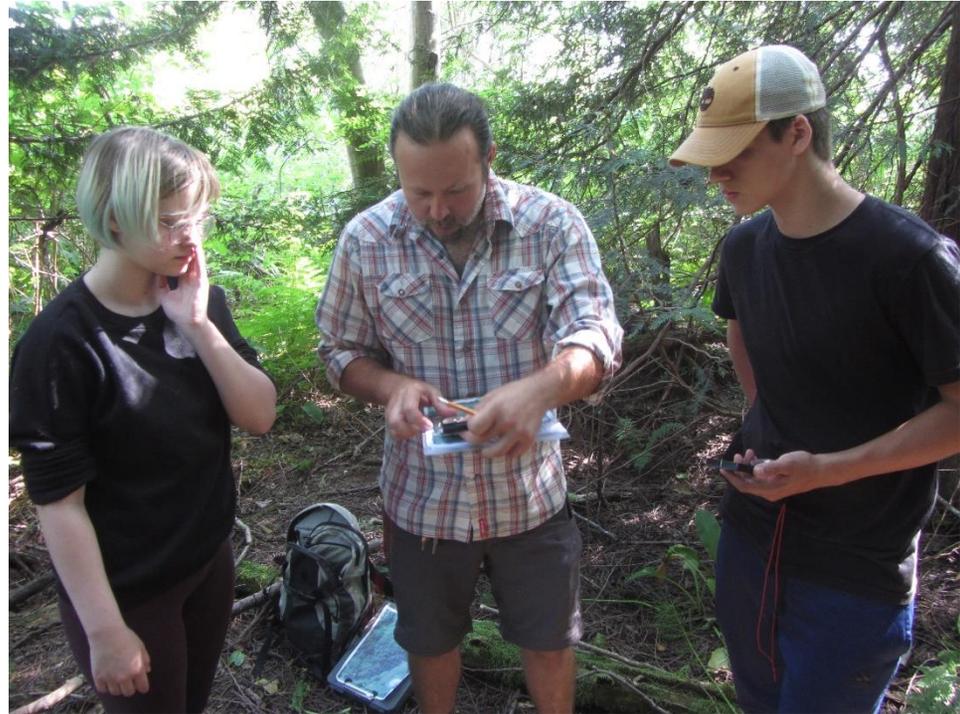
Photo 4: Learning how to use a compass to map the mature trees in the cedar grove.

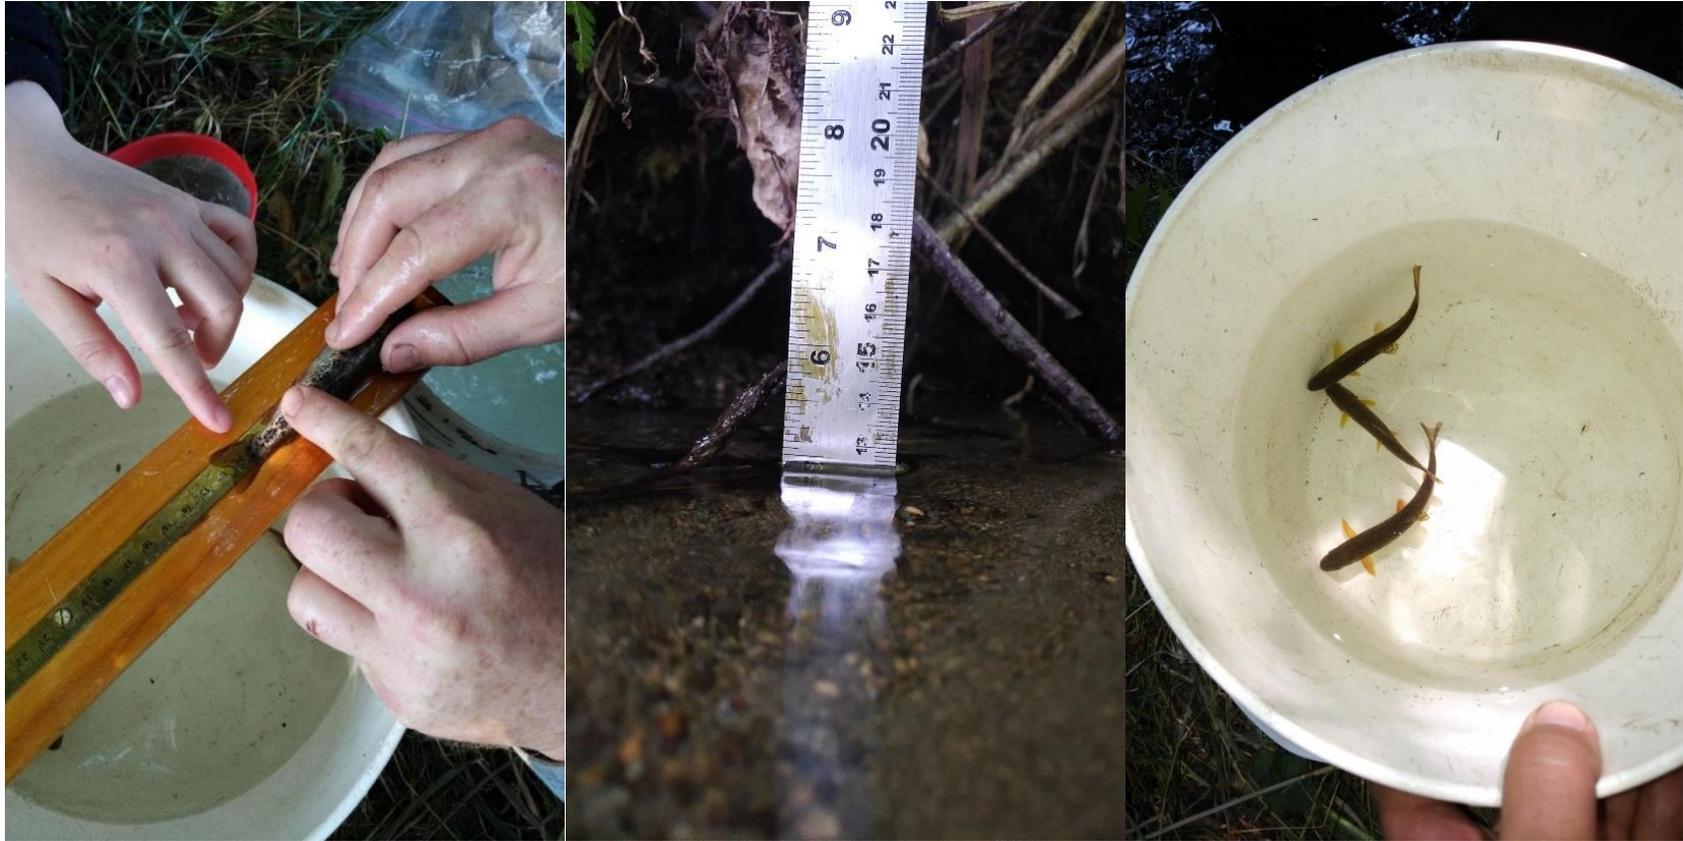
Photo 6: Measuring the length of Cutthroat trout and the stage (level) of the water in Millard Creek.

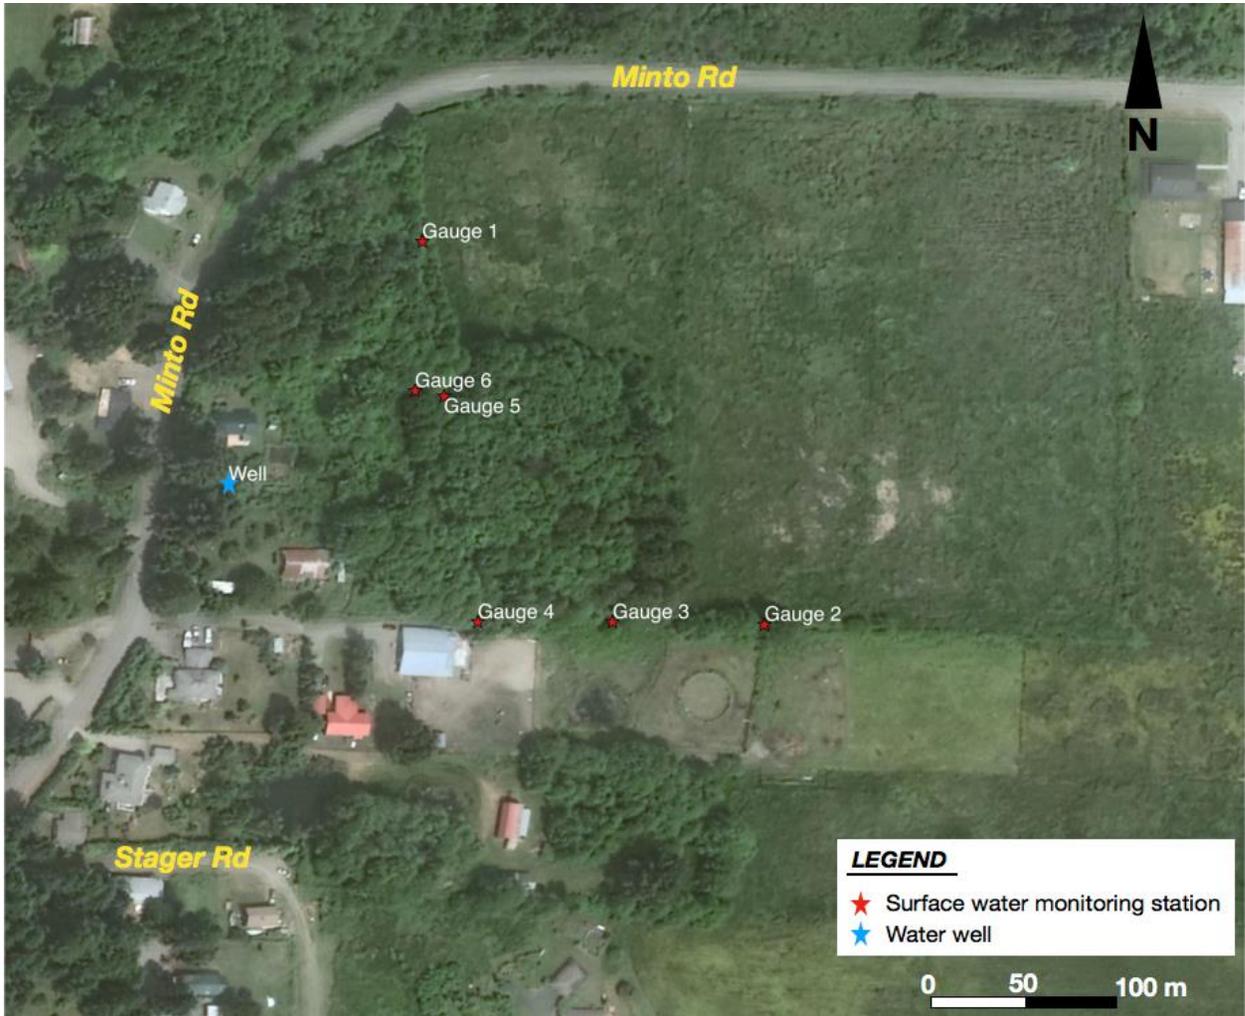
Figure 3: Study area and the location of monitoring stations

Since September 2013, the water levels at the six stations (Figures 2 to 7) have been measured twice monthly, and the maximum and minimum air temperature, rainfall amount and the weather conditions at the study area have been recorded, daily.

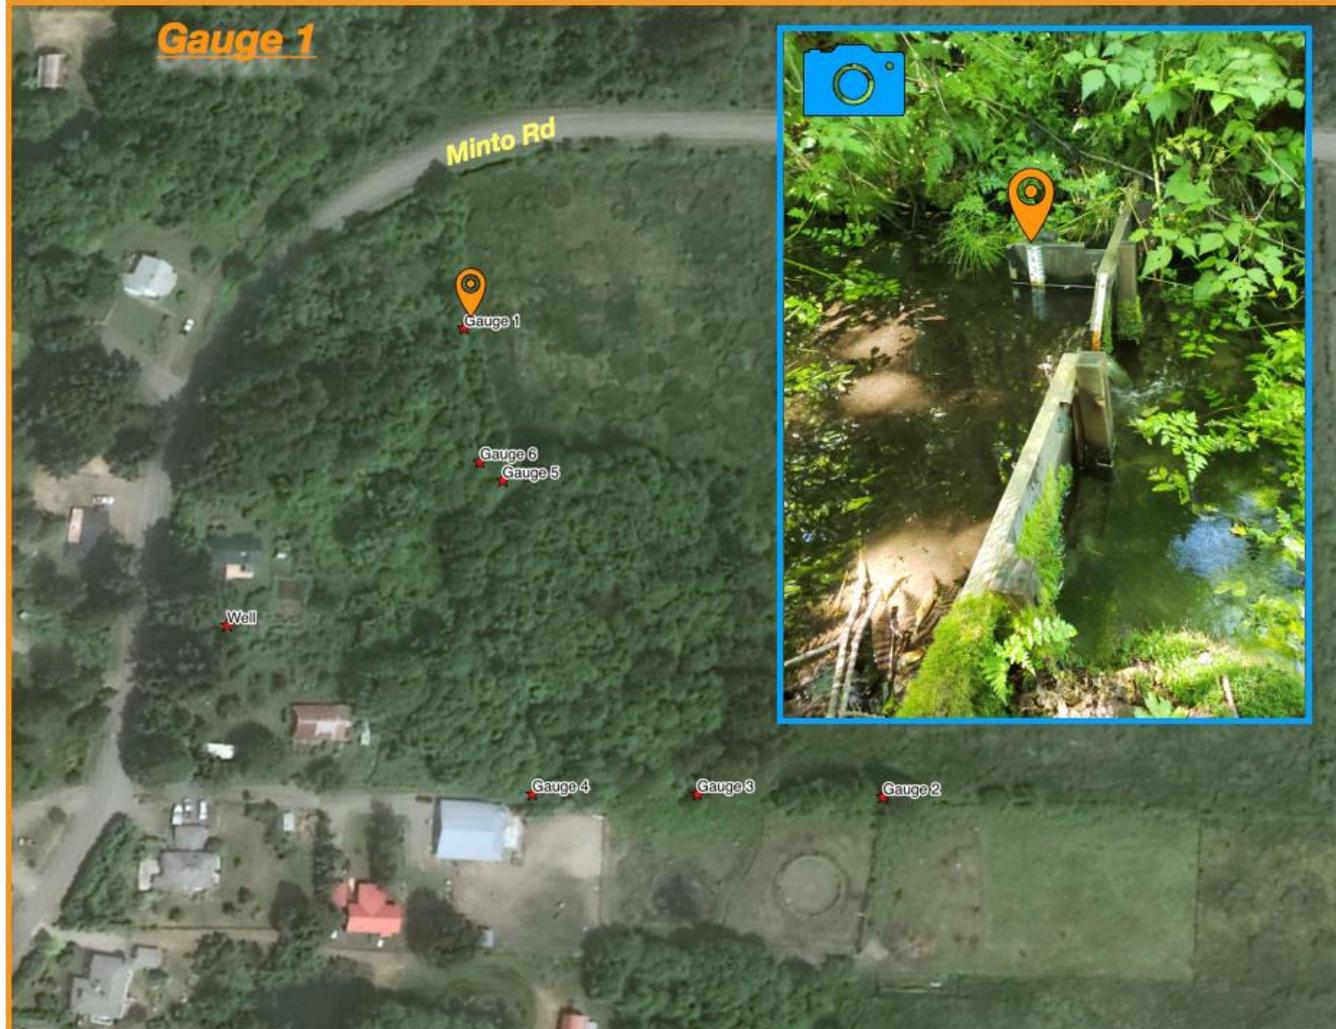
Figure 4: Gauge 1 monitoring station

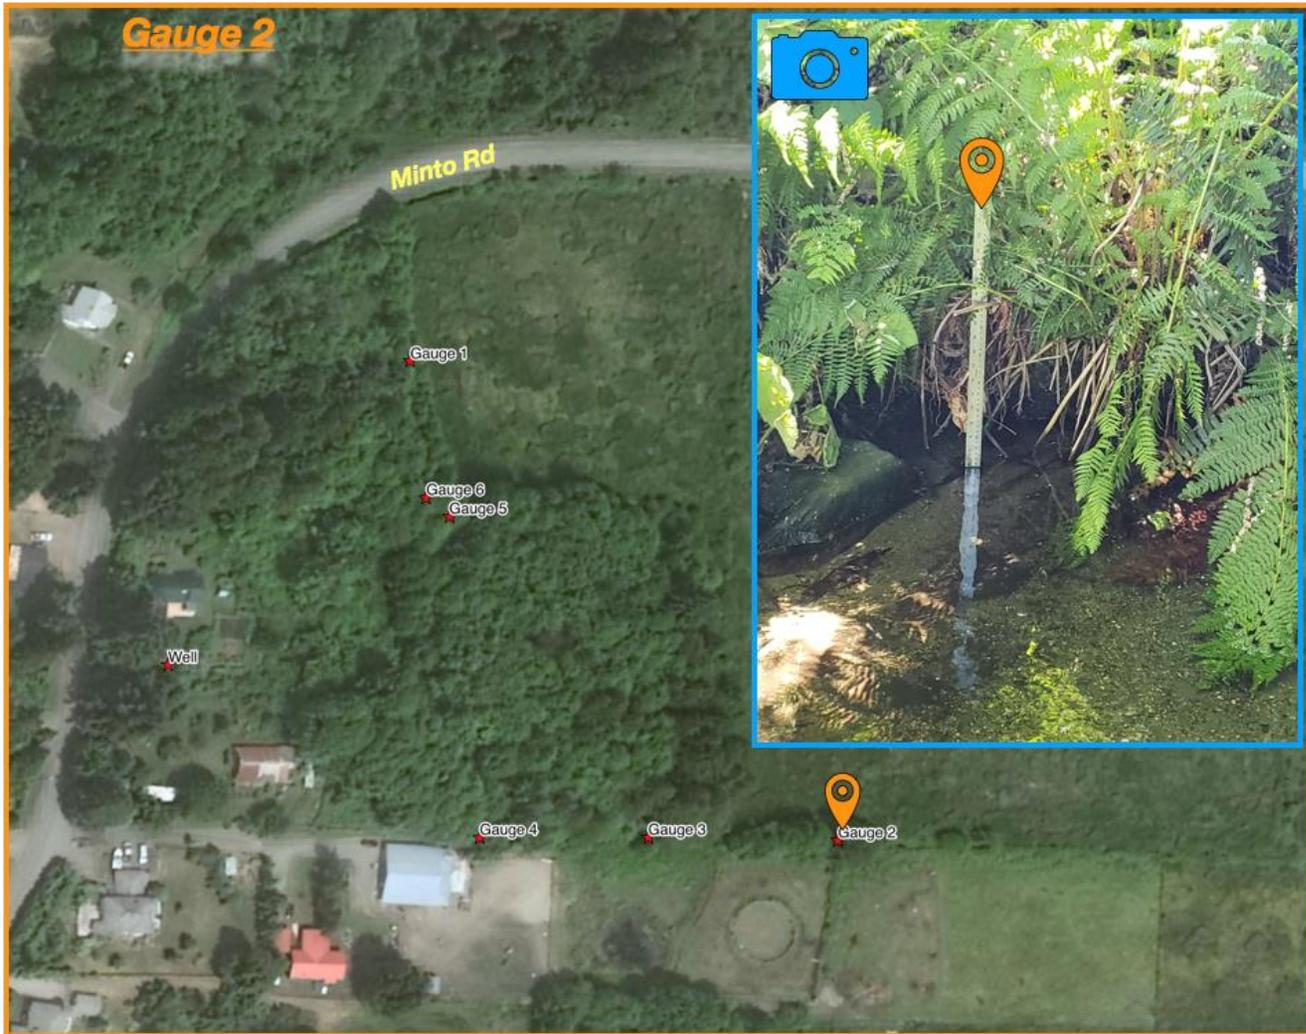
Figure 5: Gauge 2 monitoring station

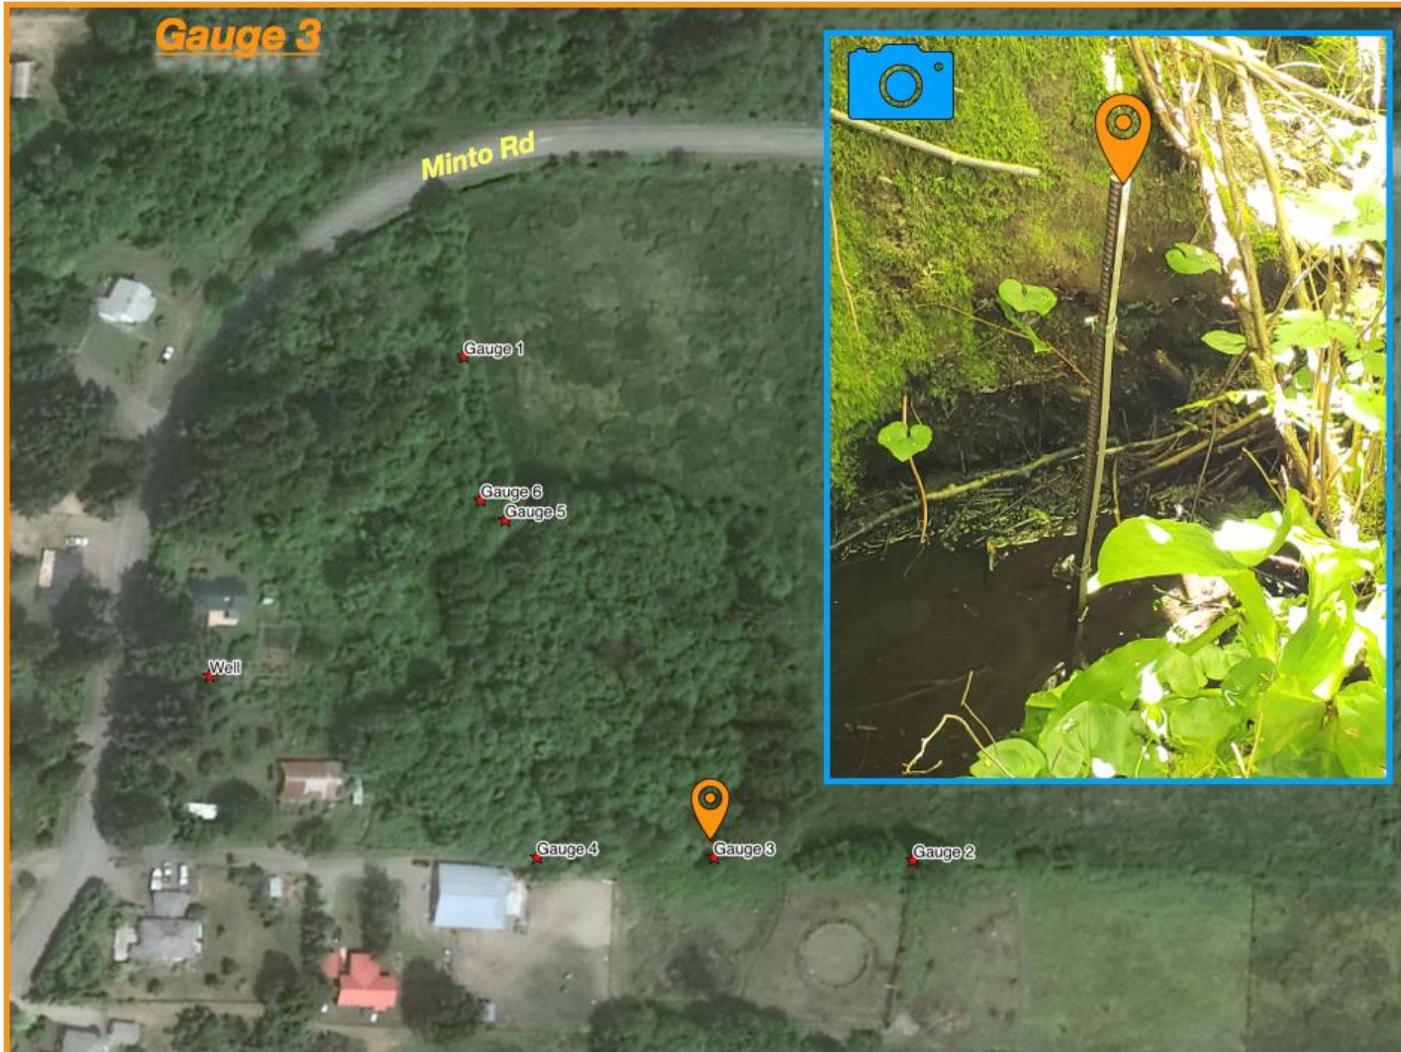
Figure 6: Gauge 3 monitoring station

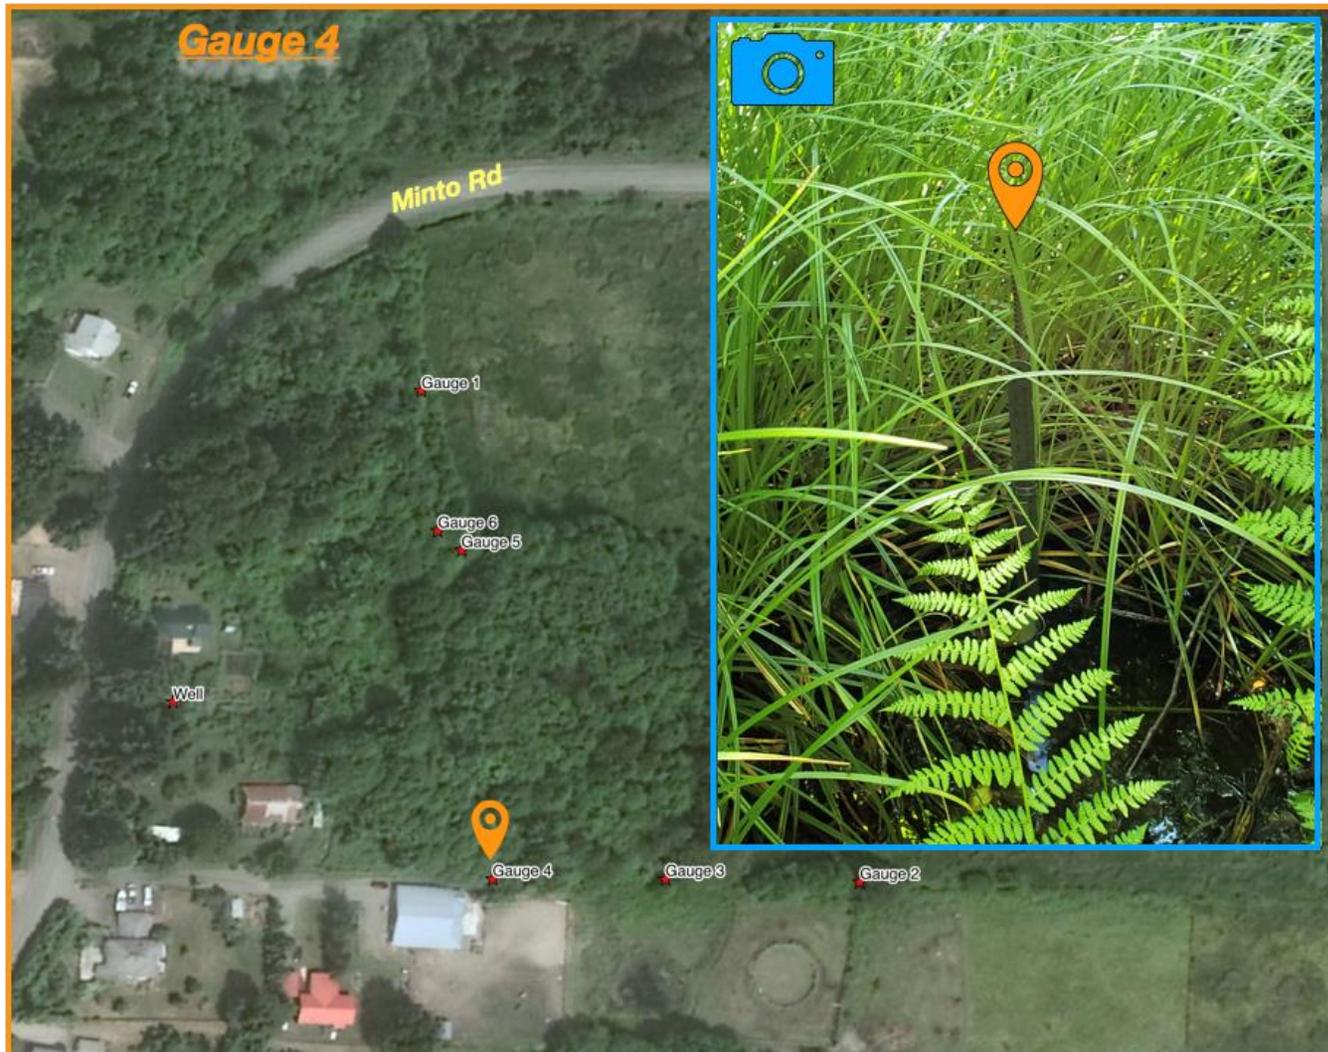
Figure 7: Gauge 4 monitoring station

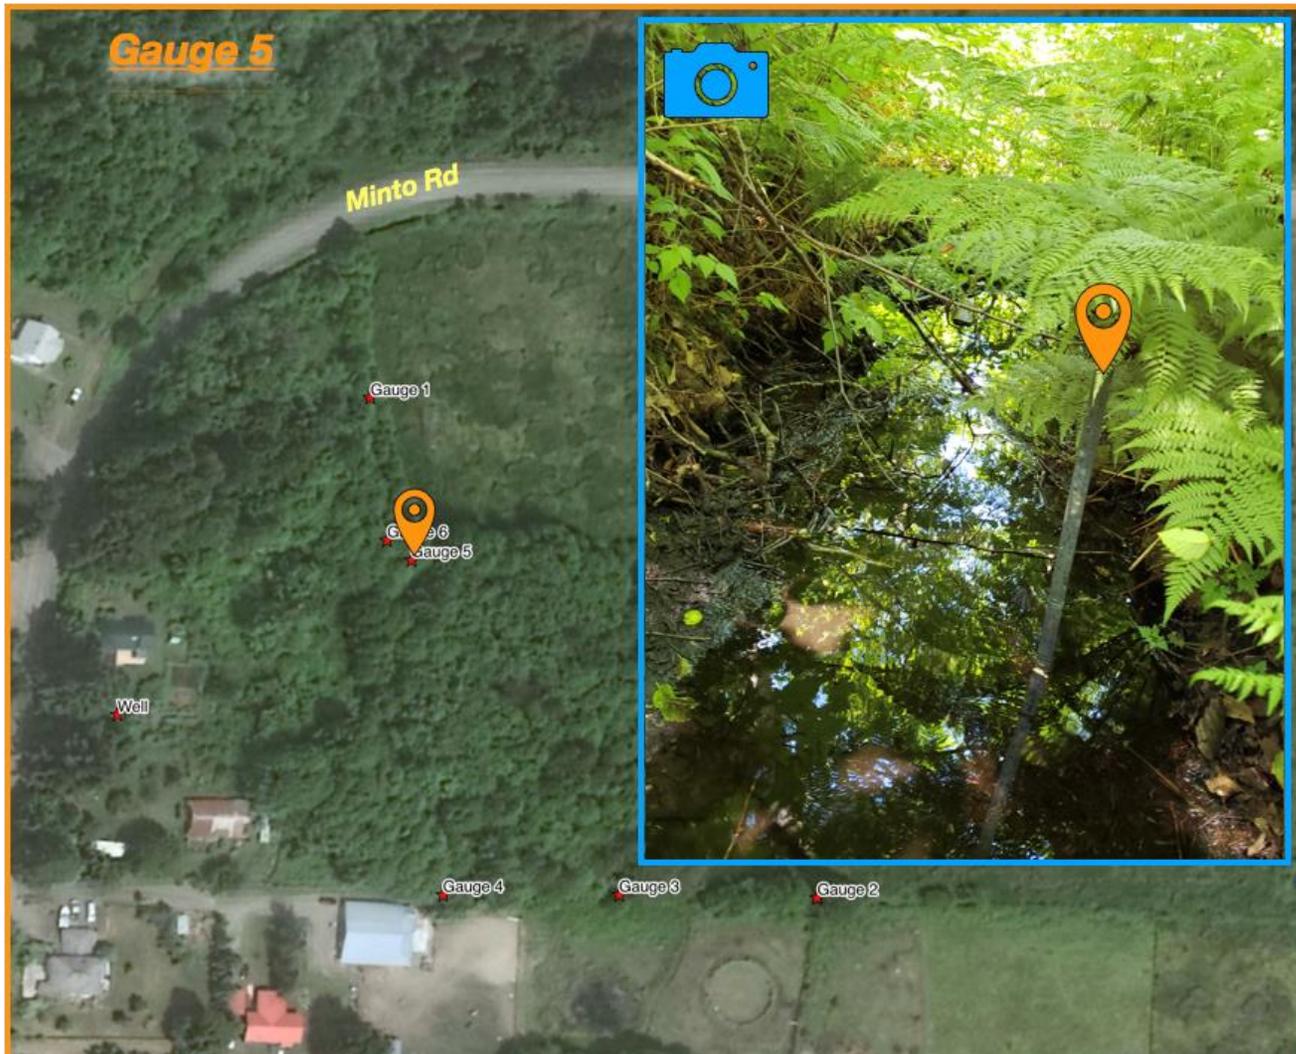
Figure 8: Gauge 5 monitoring station

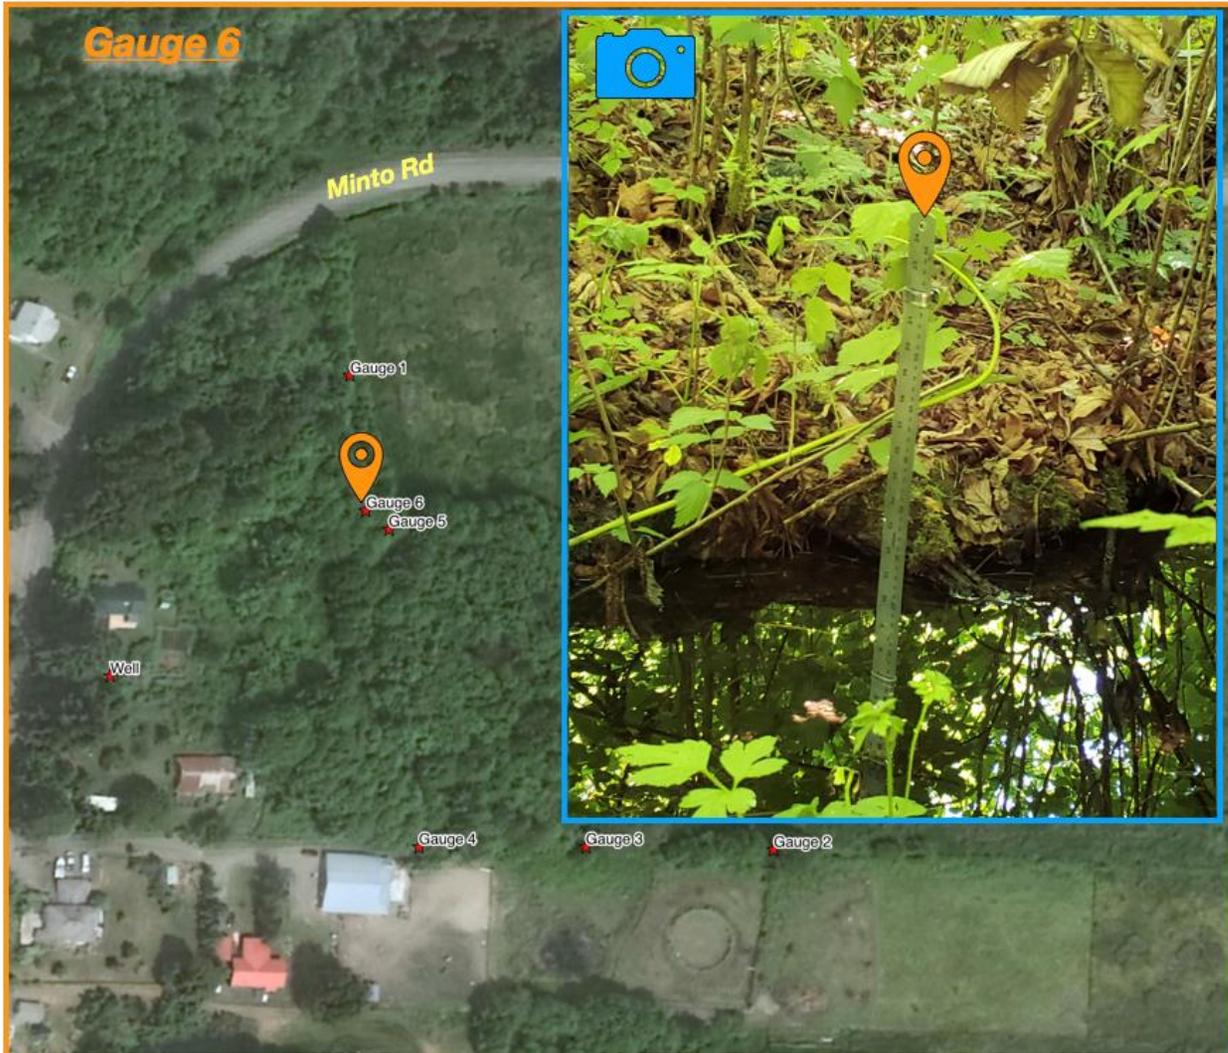
Figure 9: Gauge 6 monitoring station

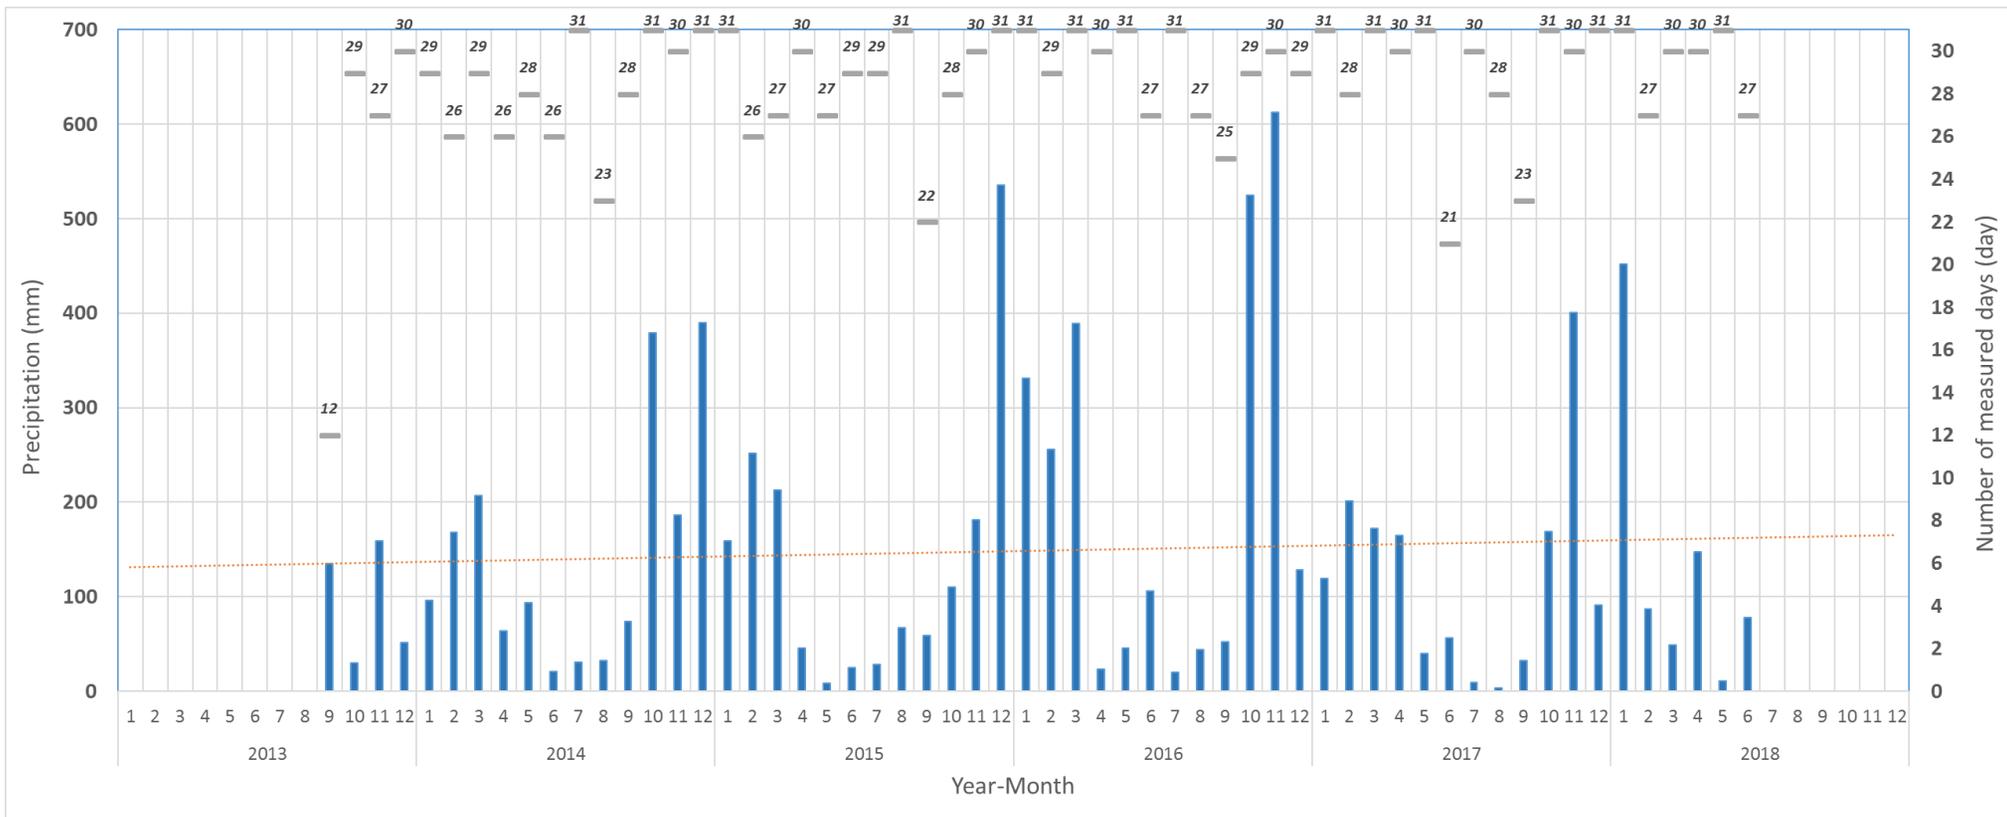
Figure 8 shows the recorded daily precipitation and the number of days when precipitation was measured. The maximum precipitation usually occurs in November, December or January. We observe an increasing trend in the last five years.

Figure 10: Measured daily precipitation

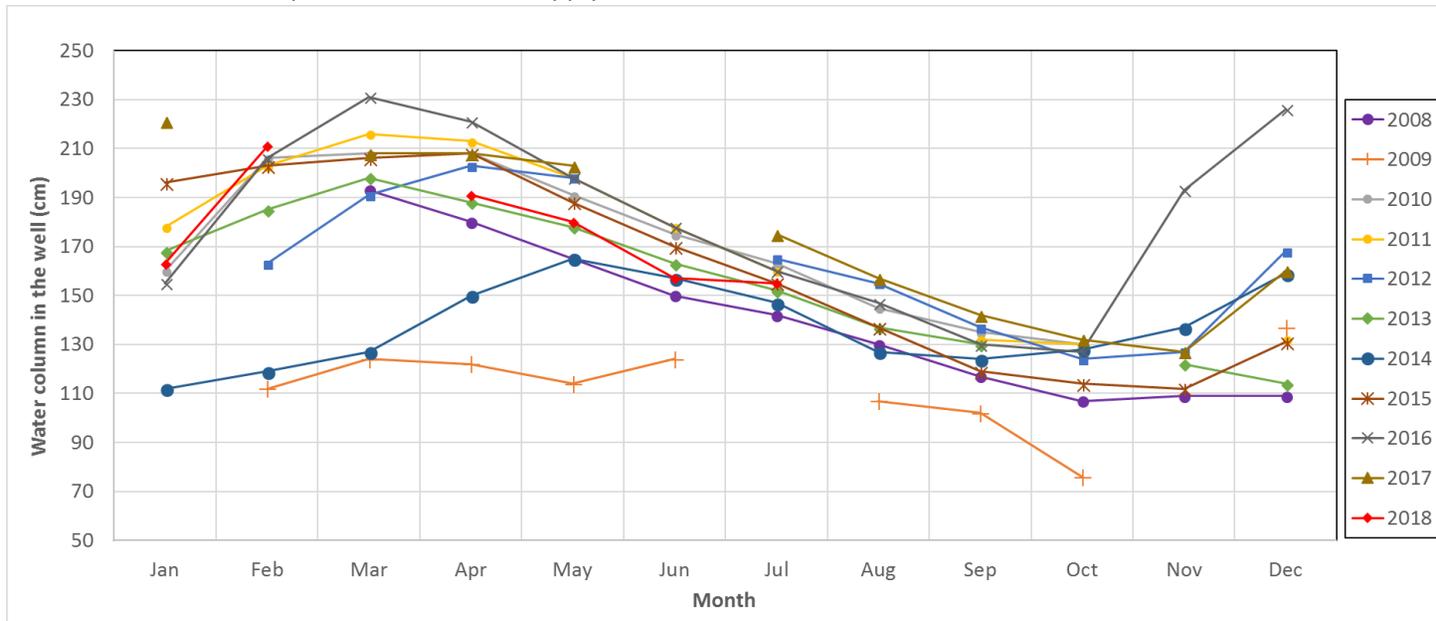
Figure 11: Water level fluctuation in the shallow water well

In 2009, water levels were lower when compared to other years. The lower water level in 2009 is of interest because two domestic water wells in the neighborhood ran dry that year. The Environment Canada weather station on the Puntledge River in Courtenay recorded a total precipitation of 243.8 mm in November 2008 through January 2009, 55% lower than the average for the same three months over the past nine years (Environment Canada 2013). This shows how important the late fall and early winter rains are in replenishing the shallow groundwater layer of the watershed. That two neighboring wells ran dry demonstrates how changes in the water table can adversely affect local residents and the plants, animals and fish that depend on a constant supply of water.

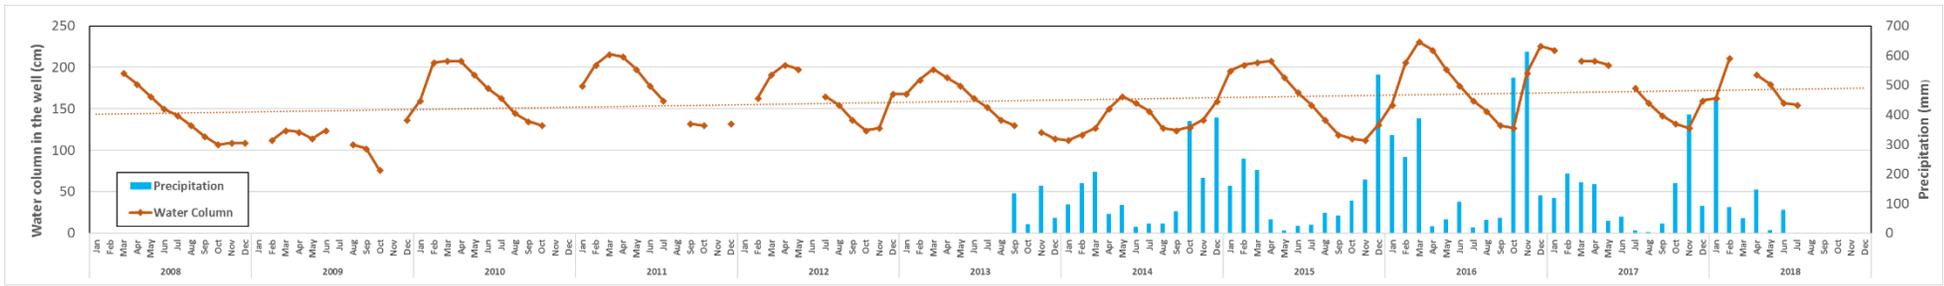
Figure 12: Water level fluctuation in the water well and recorded precipitation

There is a good correlation between precipitation and water level.

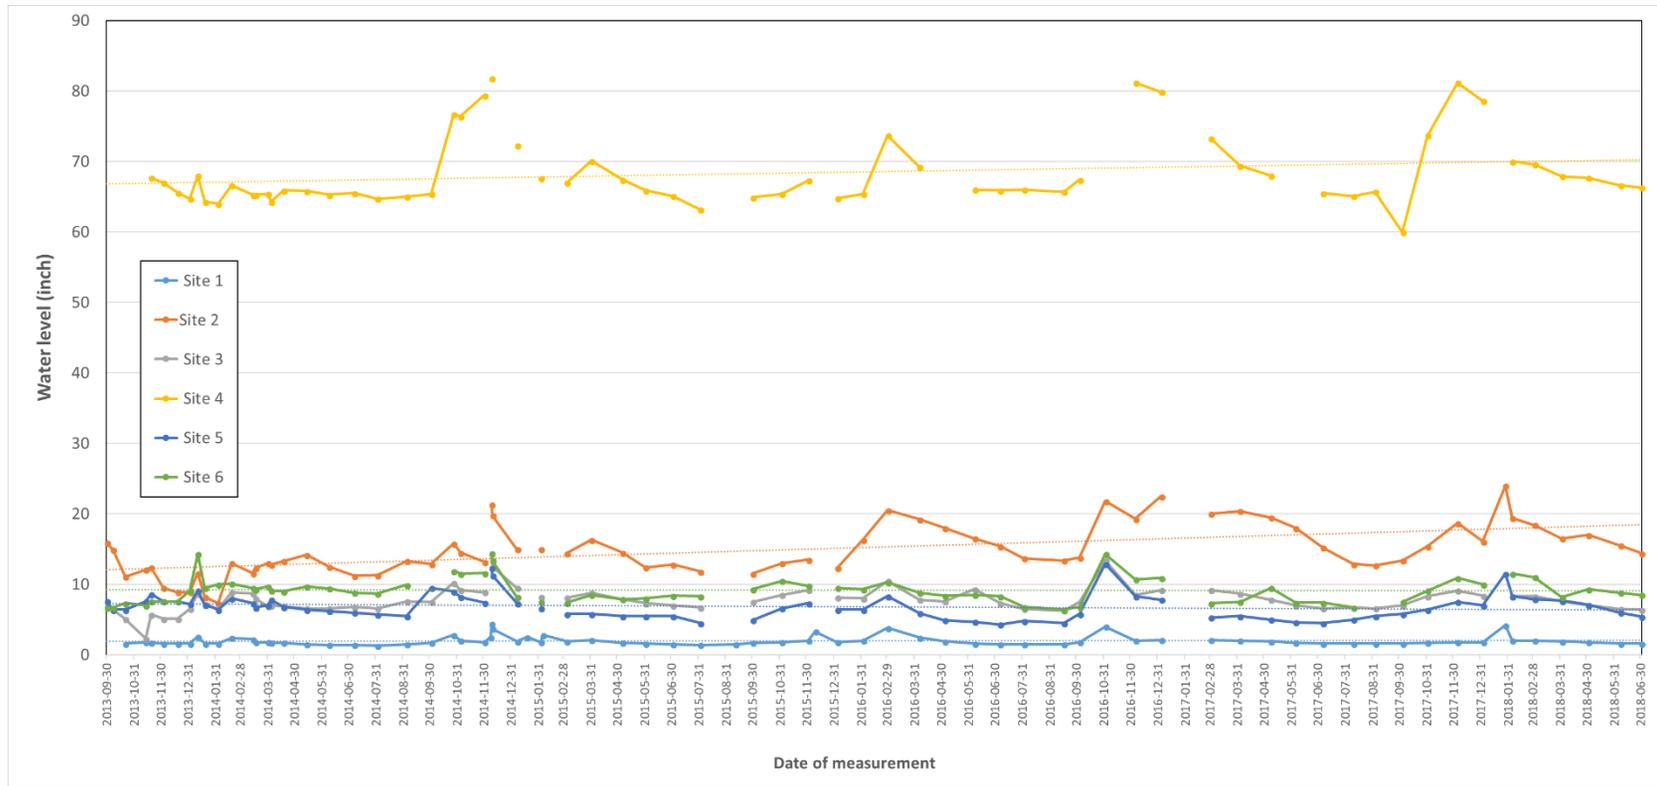
Figure 13: Recorded water levels for the six surface water monitoring stations/ gauges

Figure 11 illustrates the recorded water levels at the six monitoring stations. The water level fluctuations for these stations have followed a similar pattern. There is a moderate correlation between seasonal precipitation and the water levels, as the peak water levels for all stations have been happening during and following the wet season.
