Millard Creek Headwaters Long-term Ecological and Hydrological Study 2018

Comox Valley, BC

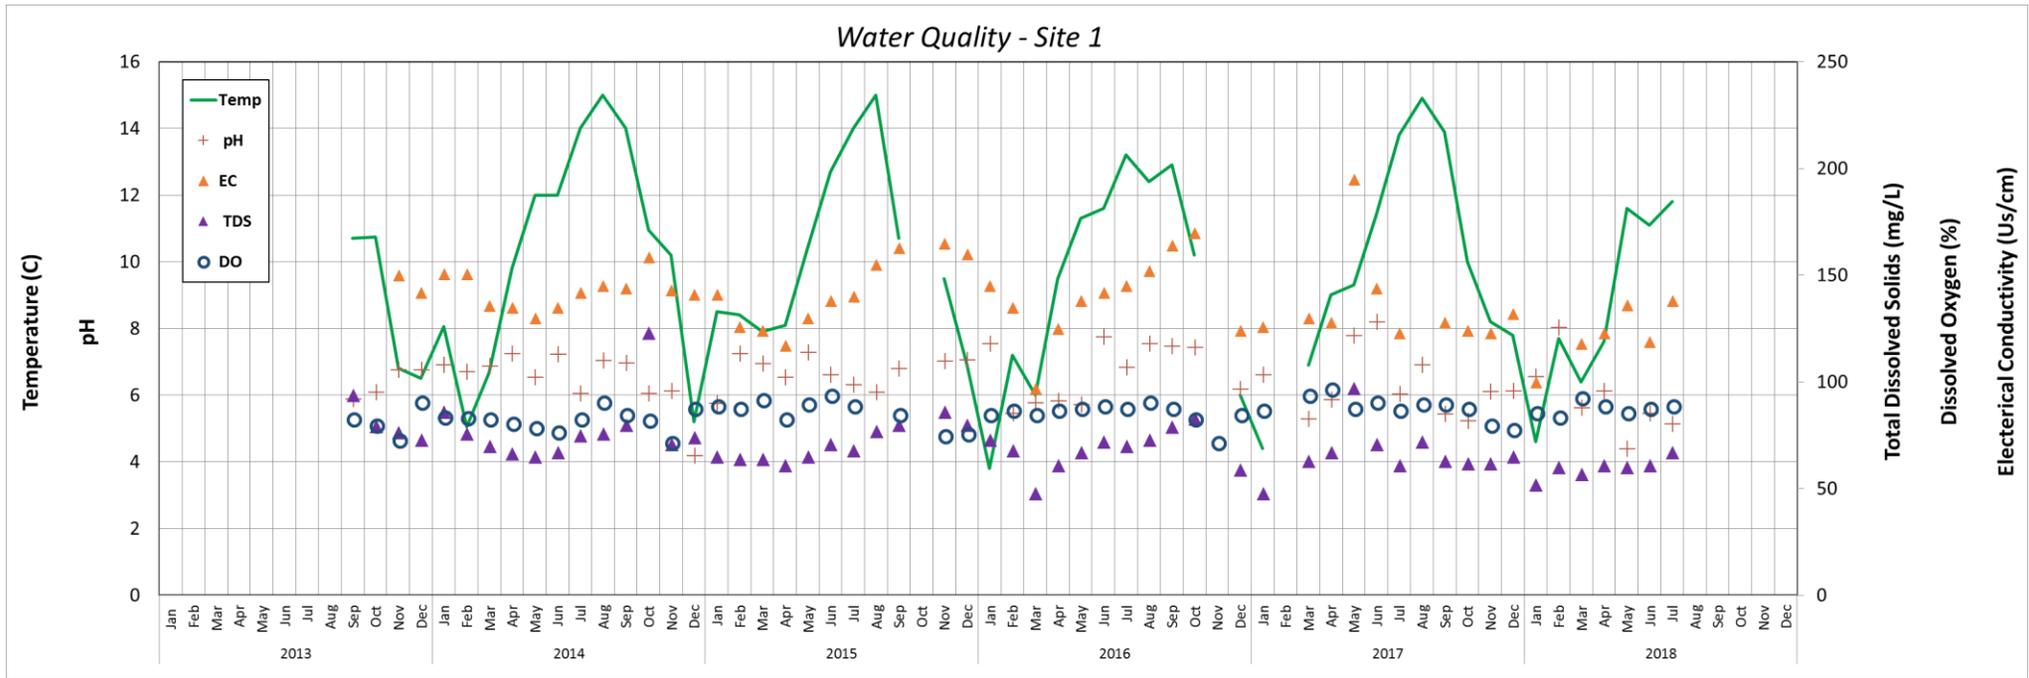
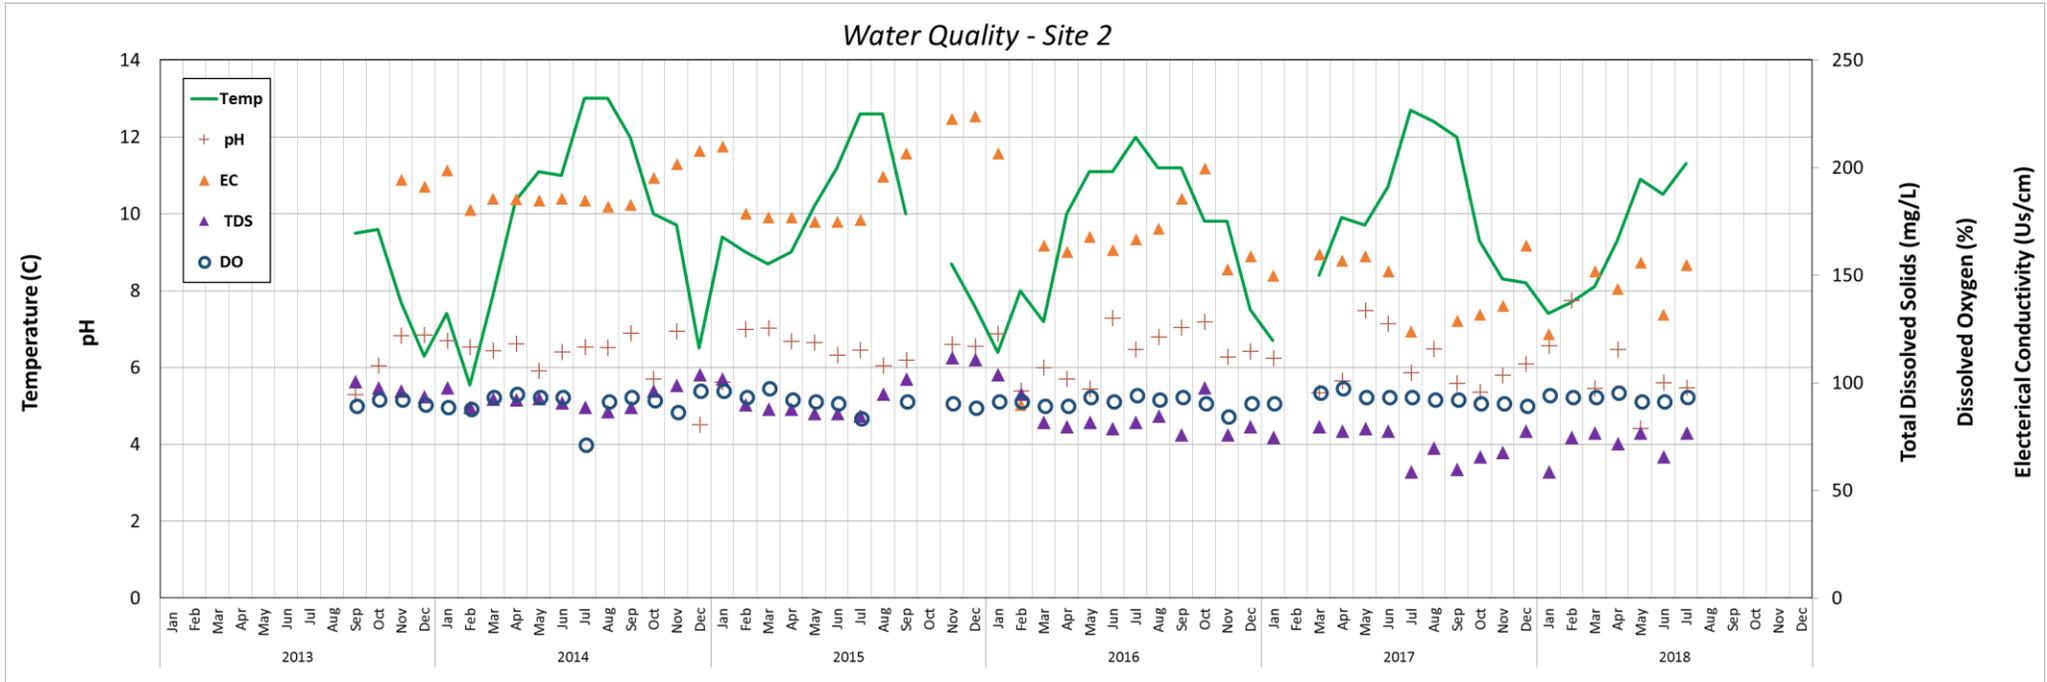
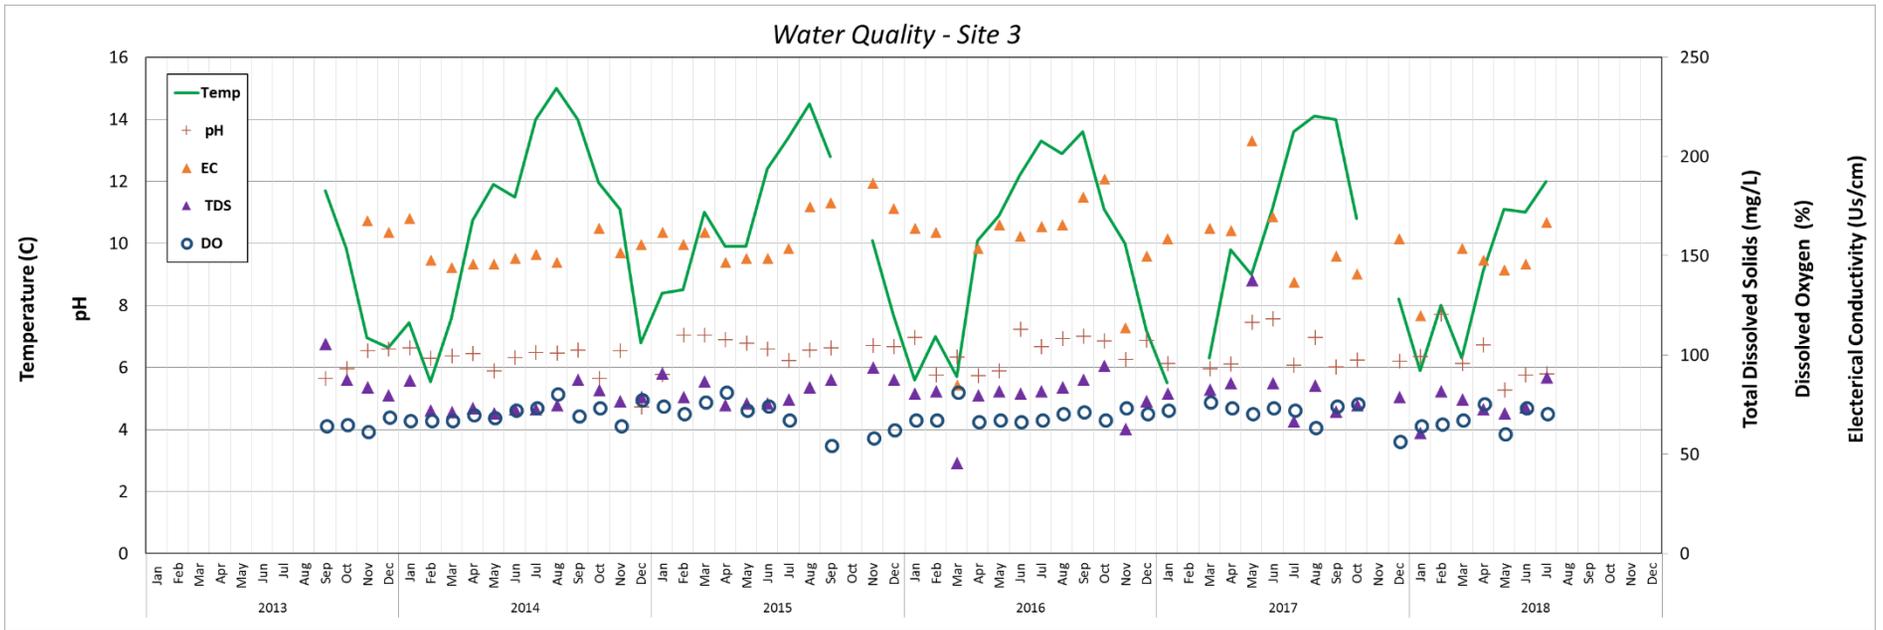
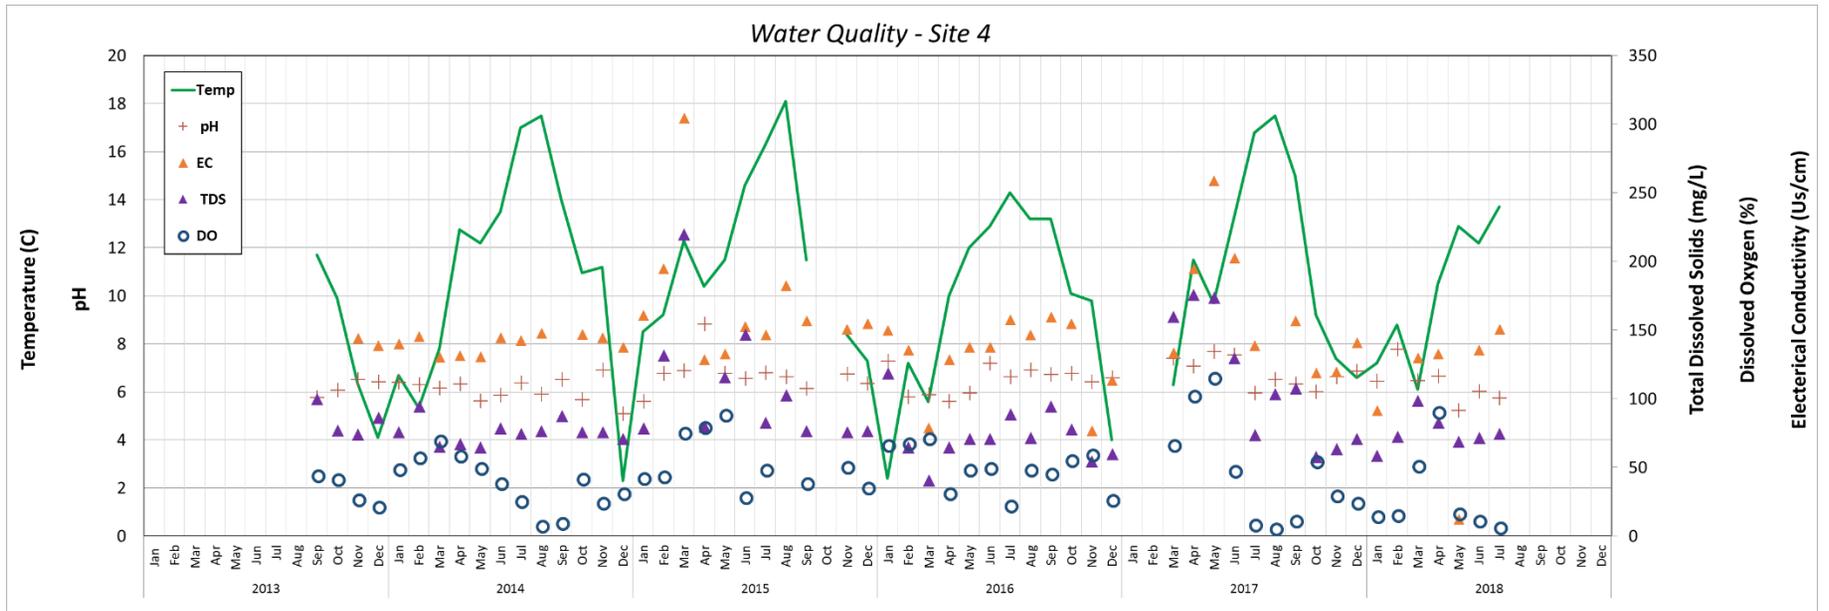
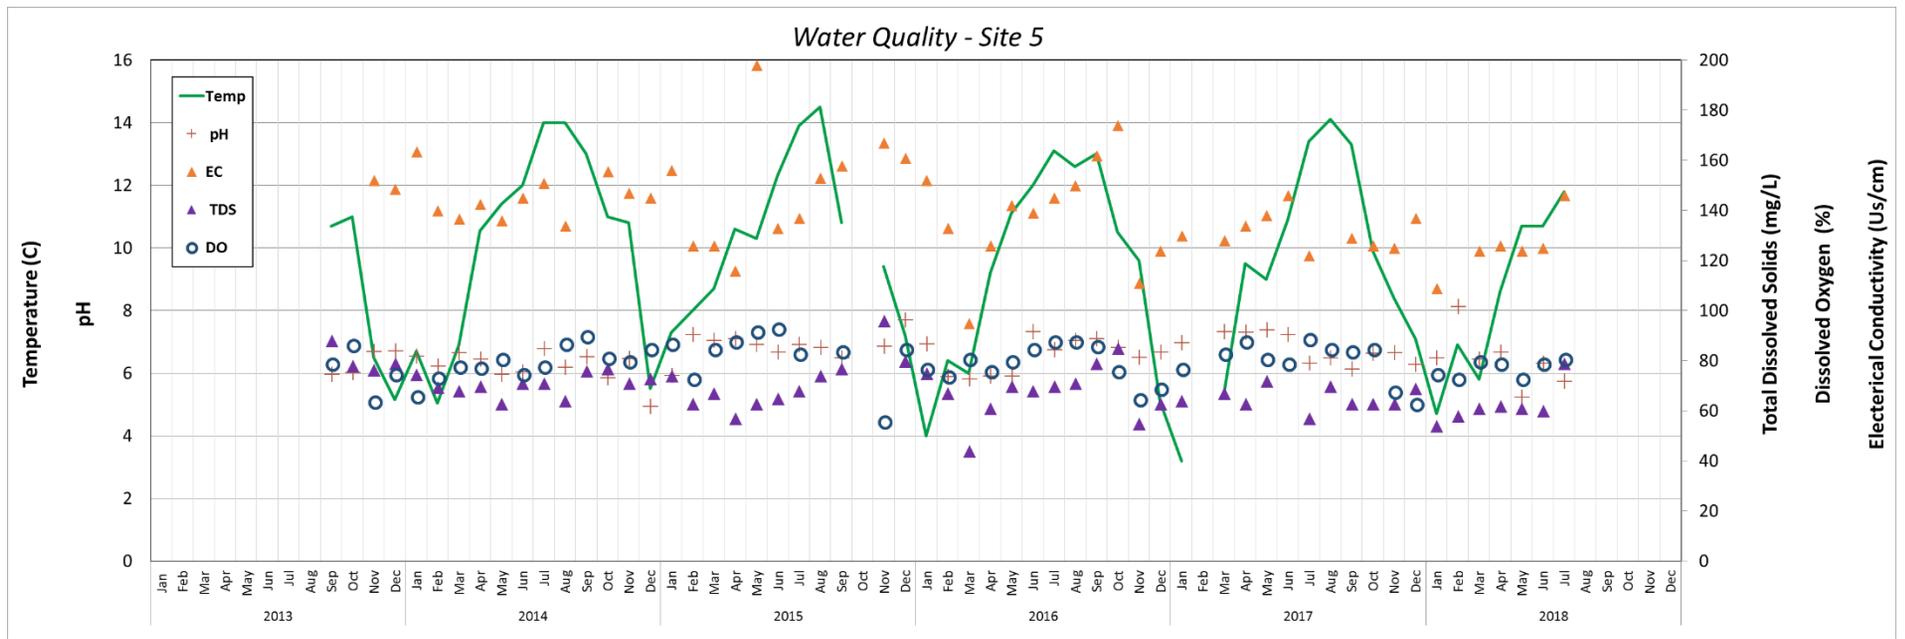
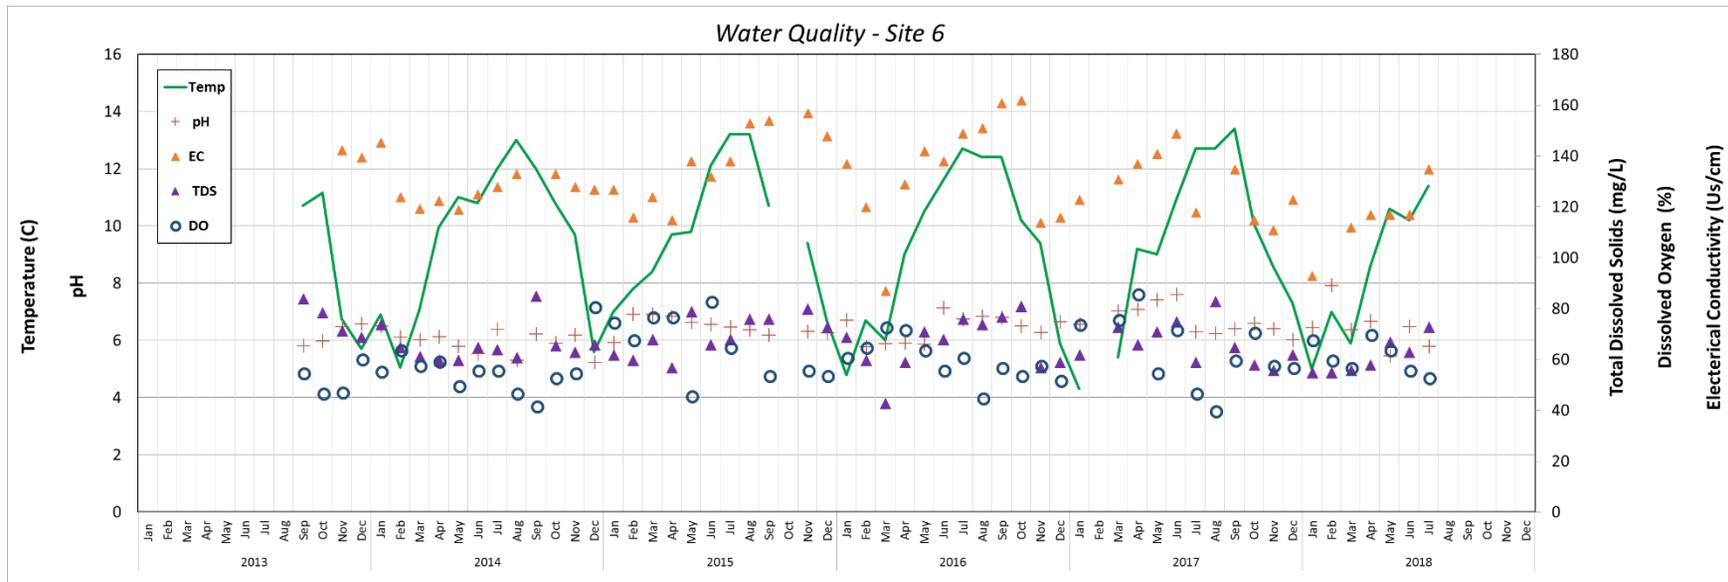
Figure 12 to Figure17 present the water quality parameters fluctuation during the last five years. The water quality parameters fluctuate seasonally, with a similar pattern over the monitoring period, for all the stations.

Figure 14: Water quality parameters for Gauge1

Figure 15: Water quality parameters for Gauge 2

Figure 16: Water quality parameters for Gauge 3

Figure 17: Water quality parameters for Gauge 4

Figure 18: Water quality parameters for Gauge 5

Figure 19: Water quality parameters for Gauge 6

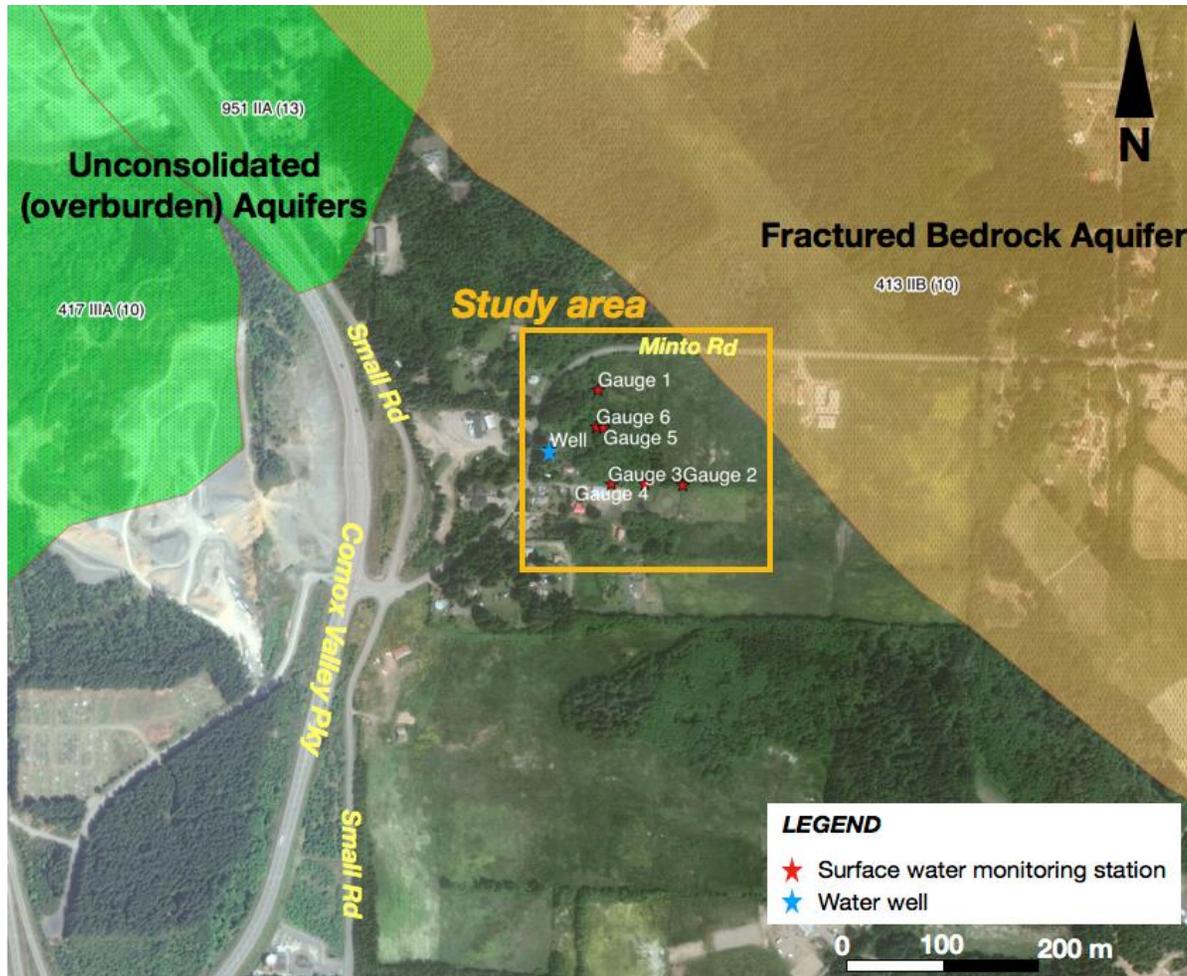
Figure 18 presents the extent of fractured bedrock aquifer (413IIB) and unconsolidated aquifers (951IIA and 417IIA) mapped by BC MoE (Ministry of Environment) close to the study area. Table 1 summarizes the characteristics of these aquifers in terms of vulnerability, productivity, size and etc.

Figure 20: The study area and mapped aquifers, according to ImapBC
