Millard Creek Rearing Channel

Fish Habitat and Productivity Report 2008

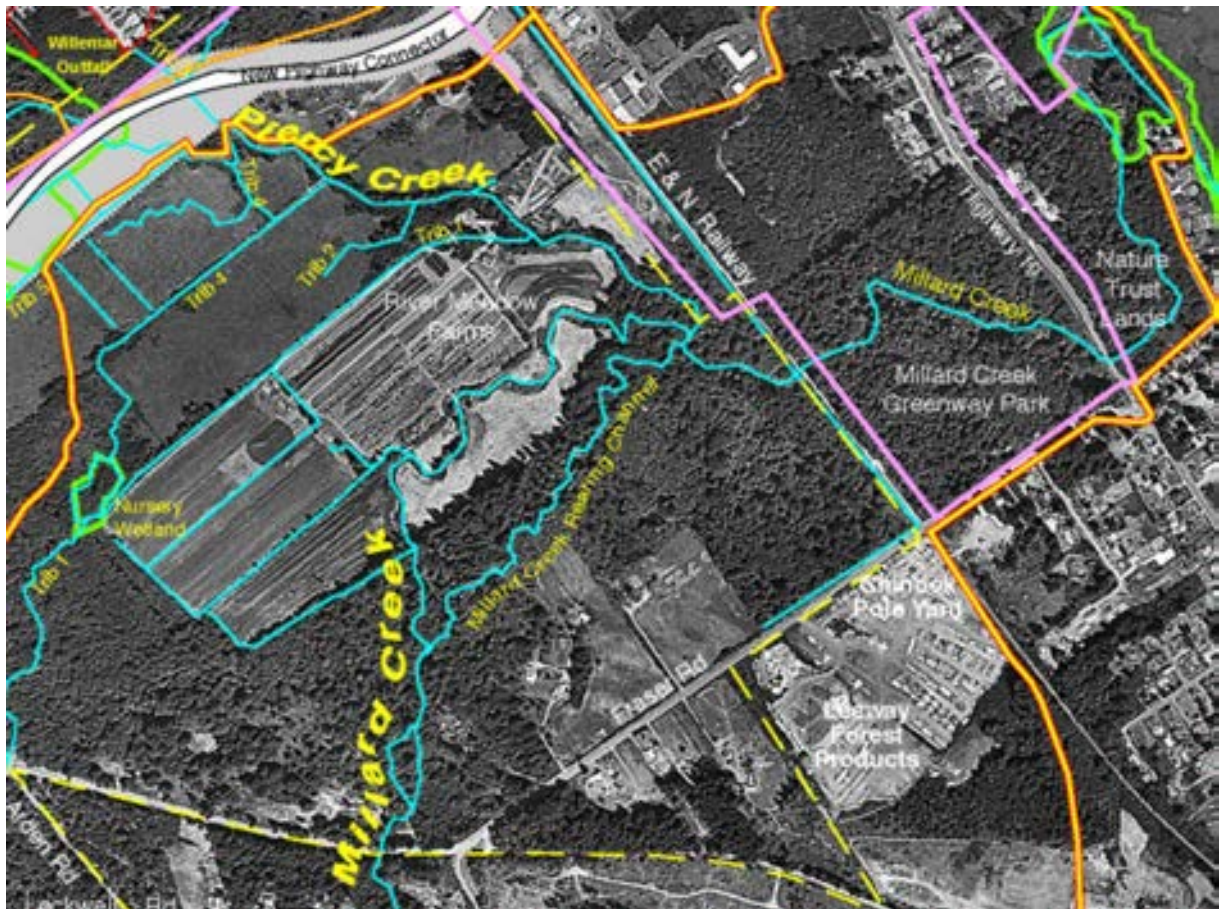
Figure 1: The Millard Side Channel is located upstream of the confluence of Millard and Piercy Creeks.

The Millard Side Channel was constructed by the Millard Piercy Watershed Stewards in 2006 and 2007. Located on the property of three private landowners the side channel provides stable rearing habitat for coho salmon and cutthroat trout. The banks of the channel are vegetated with a mixed forest and the channel is complexed with natural features.

Inflow to the rearing channel is from Millard Creek and there are no barriers to salmon migration located between the channel and the Courtenay estuary. Water quality and quantity in the channel is maintained year-round within the range suitable for salmonids.

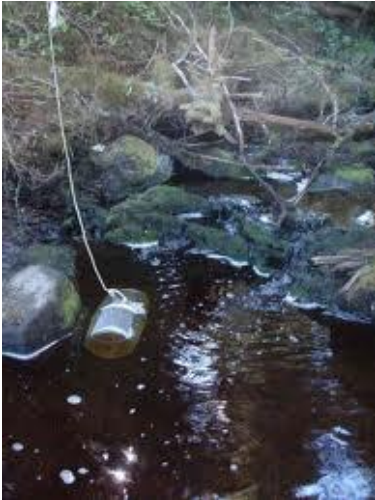
The productivity of the Millard Side Channel was evaluated with a mark recapture study undertaken in August 2008. Ten minnow traps baited with salmon roe were set along the length of the channel and left overnight. On the second day they were checked and then the traps were reset and checked on the third day.

The effectiveness of the traps is affected by:

- Location that traps are set
- Depth of the trap
- Trap orientation to current
- Bait type, freshness
- Time of day that trap is fishing
- Environmental conditions
