**Youth and Ecological Restoration Program
Ecological Inventory of the Upper Headwaters of the
South Millard Creek tributary**

30 August 2012

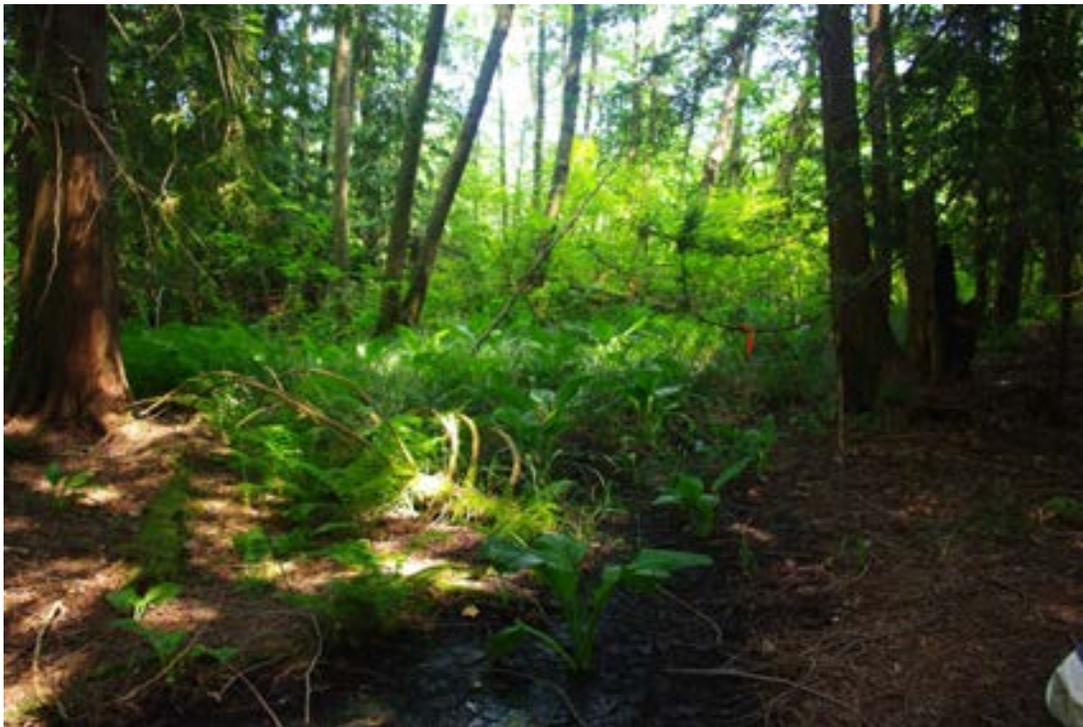
Photograph 1: Watercourse mapping near Study Plot One, looking downstream to the North-east (the orange ribbon is the SW corner of Study Plot One).

Exercise One was the mapping of a section of watercourse near Study Plot One (see Map 2 and Photographs 4 and 5). Using the south-west corner point of Study Plot One as a fixed point a tape was laid out along the magnetic north axis, 30m to the south and 10m to the north. At five metre intervals the boundaries of open water and saturated soil were measured and plotted on graph paper (Map 3). Using the plotted points as a guide, the boundaries of open water and saturated soil were sketched onto the map.

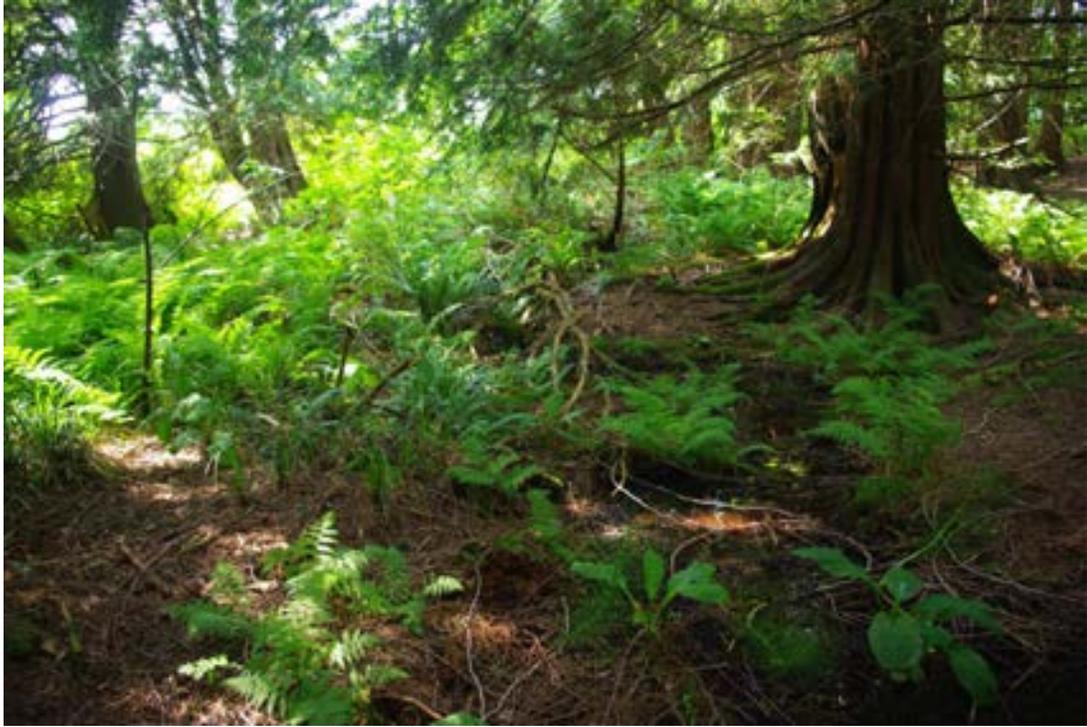
Photograph 2: Watercourse mapping near Study Plot One, looking south-west.

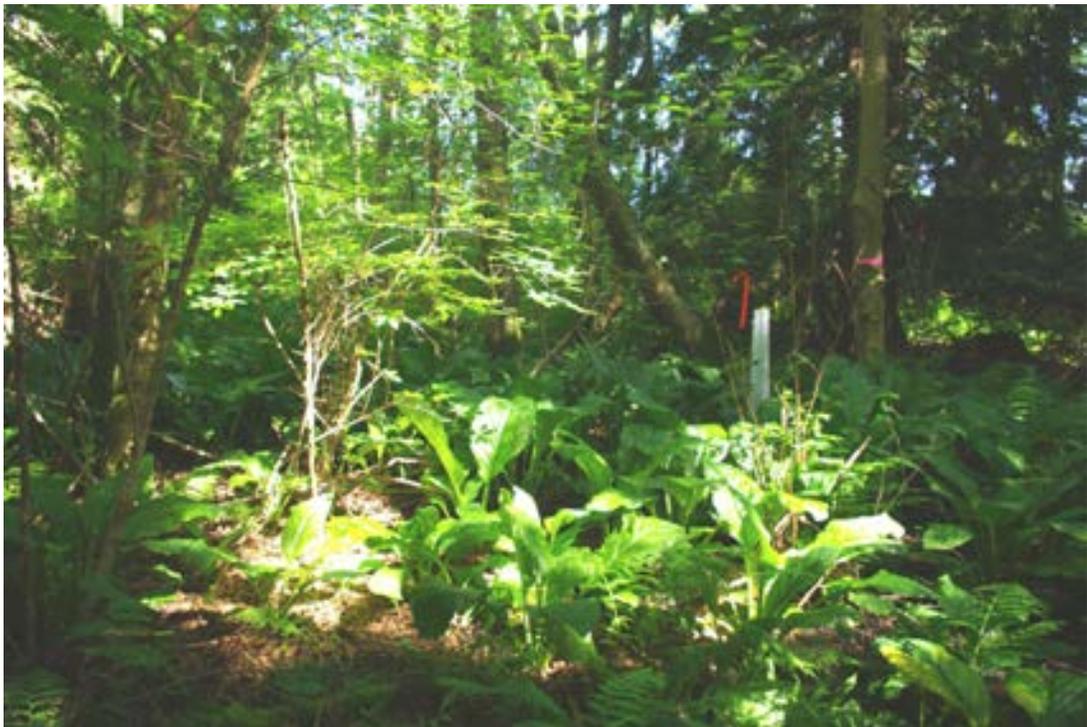
Photograph 3: Study Plot Three, looking north-north-east along the east boundary

Study Plot 3 (Maps 2, 3, and 4 and Photographs 6, 7 and 8) was chosen as an area that is slightly wetter than Study Plots One and Two that were inventoried in 2011. The dominant tree type was red alder, of a size that suggests these trees will begin to die out in the coming 20 years and likely be replaced by the second most common tree, the western red cedar. The most plentiful plant in the shrub layer is salmonberry; in the herb layer it is skunk cabbage. The site association/plant community best describing the study plot is Western redcedar – Sitka Spruce – Skunkcabbage (CWHxm1/12) (MOELP 1998), which is Blue Listed or vulnerable in BC (CDC 2012). That Sitka spruce not being found in the study plot does not exclude it from this plant community; Sitka spruce are found in the same forest within 100m to the north-east.

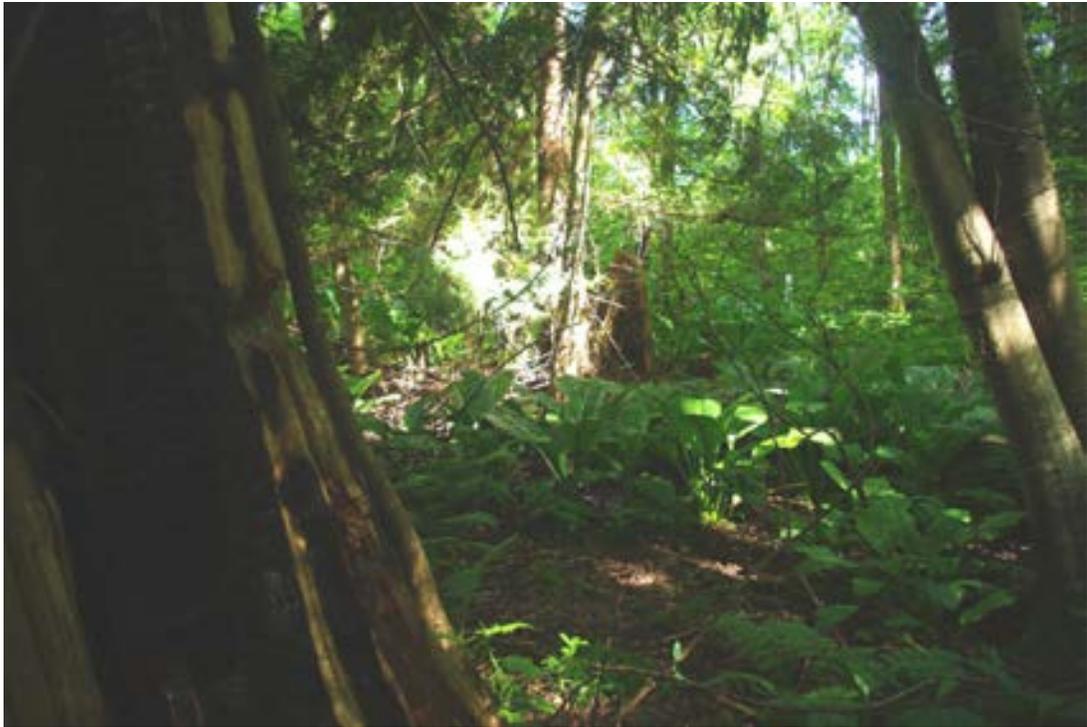
Photograph 4: Central portion of Study Plot Three

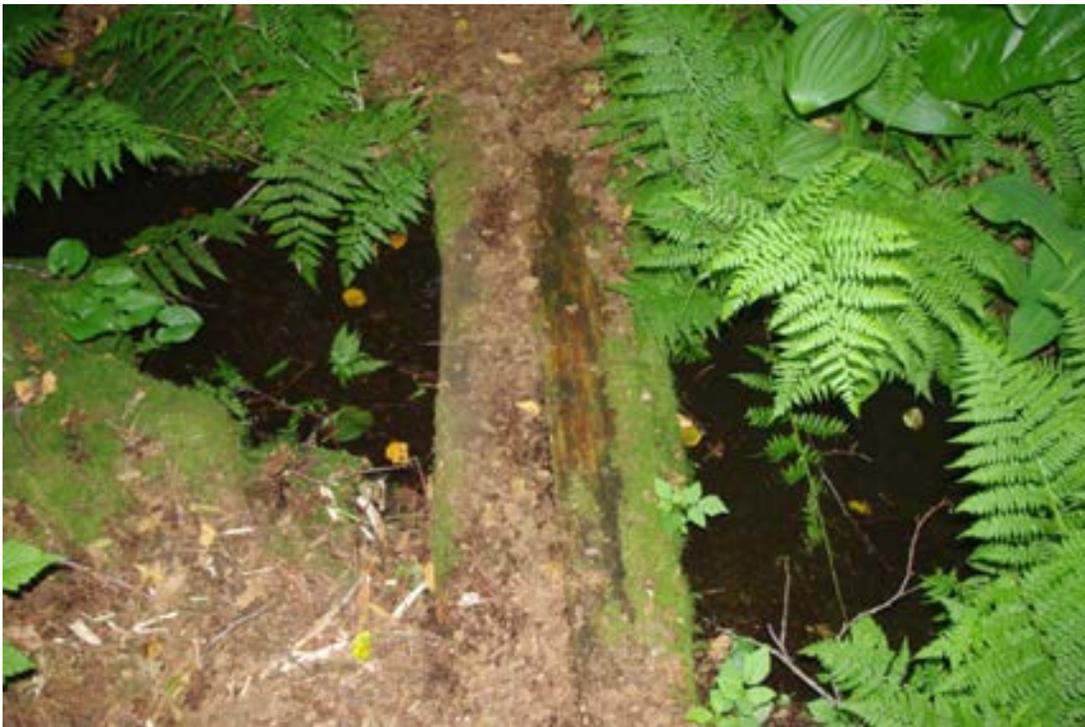
Photograph 5: Water flow under a path crossing in the south-west quadrant on Study Plot Three.
