8/31/2019

Ecological Inventory

Morrison Headwaters Nature Preserve

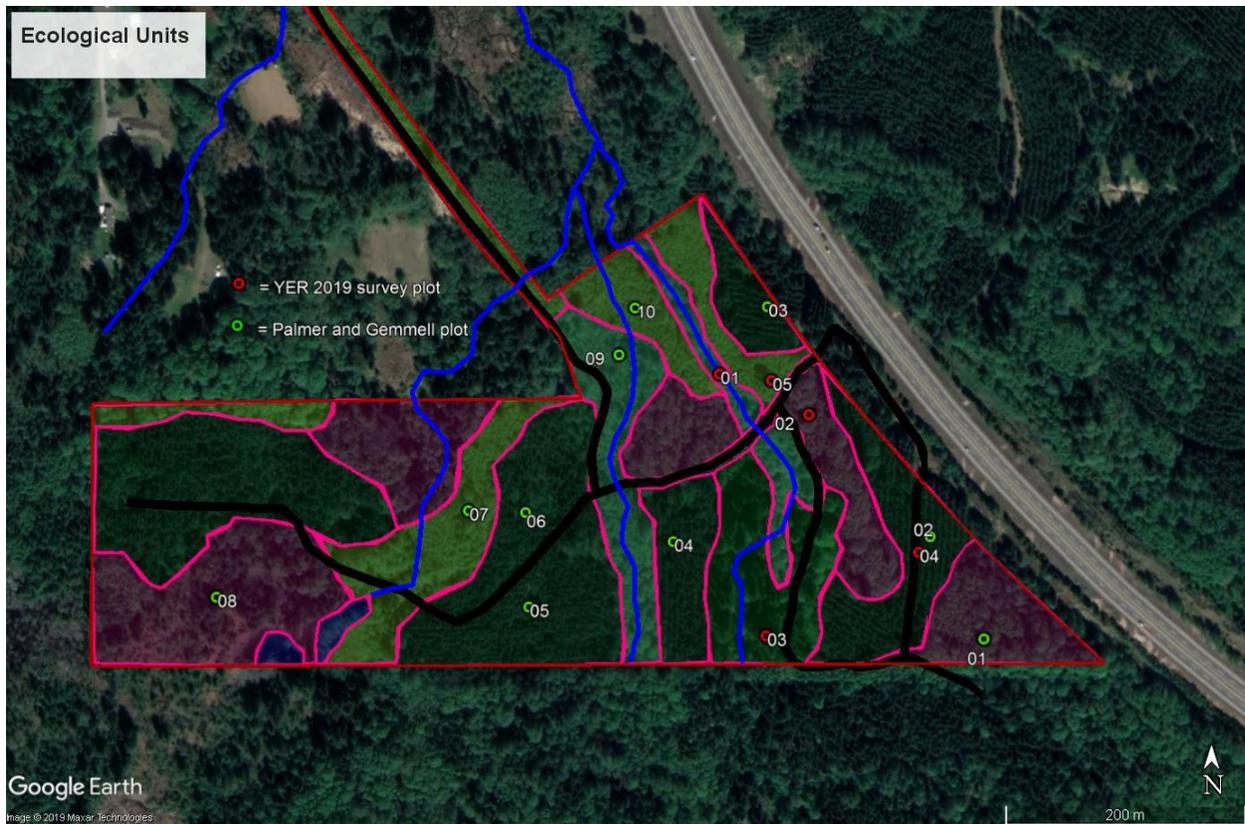
Figure 1. Ecological Units and study plots (adapted from Palmer and Gemmell)

Palmer and Gemmell delineated a total of 30 Ecological Units on the property, but these were aggregated to 21 by Ennis in July 2019. Of these, Palmer and Gemmell sampled 10 Ecological Units. In this study an additional 5 Ecological Units were sampled (Figure 1) including:

1. The riparian corridor of the mainstem of Morrison Creek (teal);
2. A mixed deciduous-coniferous upland forest (pink);
3. A mature coniferous up-land forest (olive green);
4. A young coniferous tree plantation, and (dark green);
5. A deciduous up-land forest (light green).

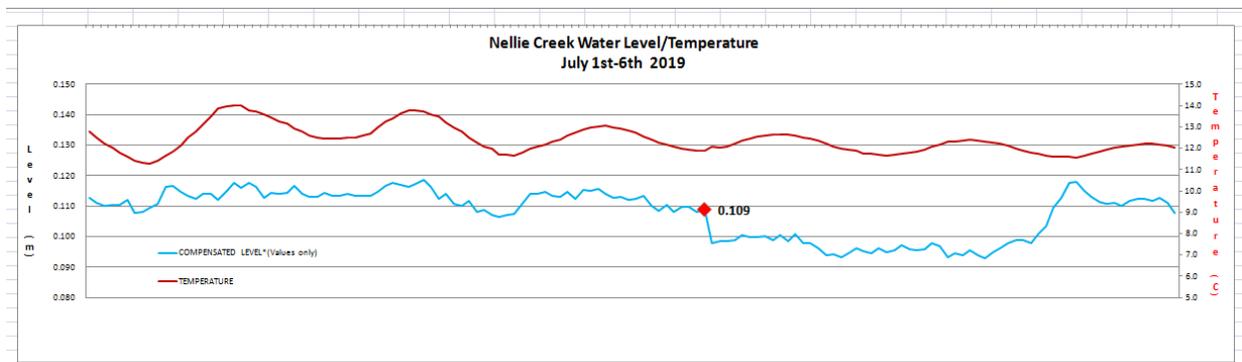
Figure 3. Water depth and temperature of Nellie Creek, July 1-6, 2019.

The youth also recorded the water depth from the electronic level-logger and determined the depth of the stream to be 0.109 m. The temperature of the stream was 11.9 degrees Celsius. Figure 3 below illustrates water depth and temperature during the period of July 1-6th 2019 in Nellie Creek as recorded by the level-logger. The specific moment that the youth measured the level of the stream is indicated by the red square. While this data was instructional for the youth to collect, the interpretation of these results is dependant on longer-term analysis and comparisons between Nellie Creek and other tributaries of Morrison Creek.
