**Watercourse and vegetation mapping in a tributary in the Upper
Millard Creek Headwaters**

YER Phase II Project June 1-5, 2022

September 2022

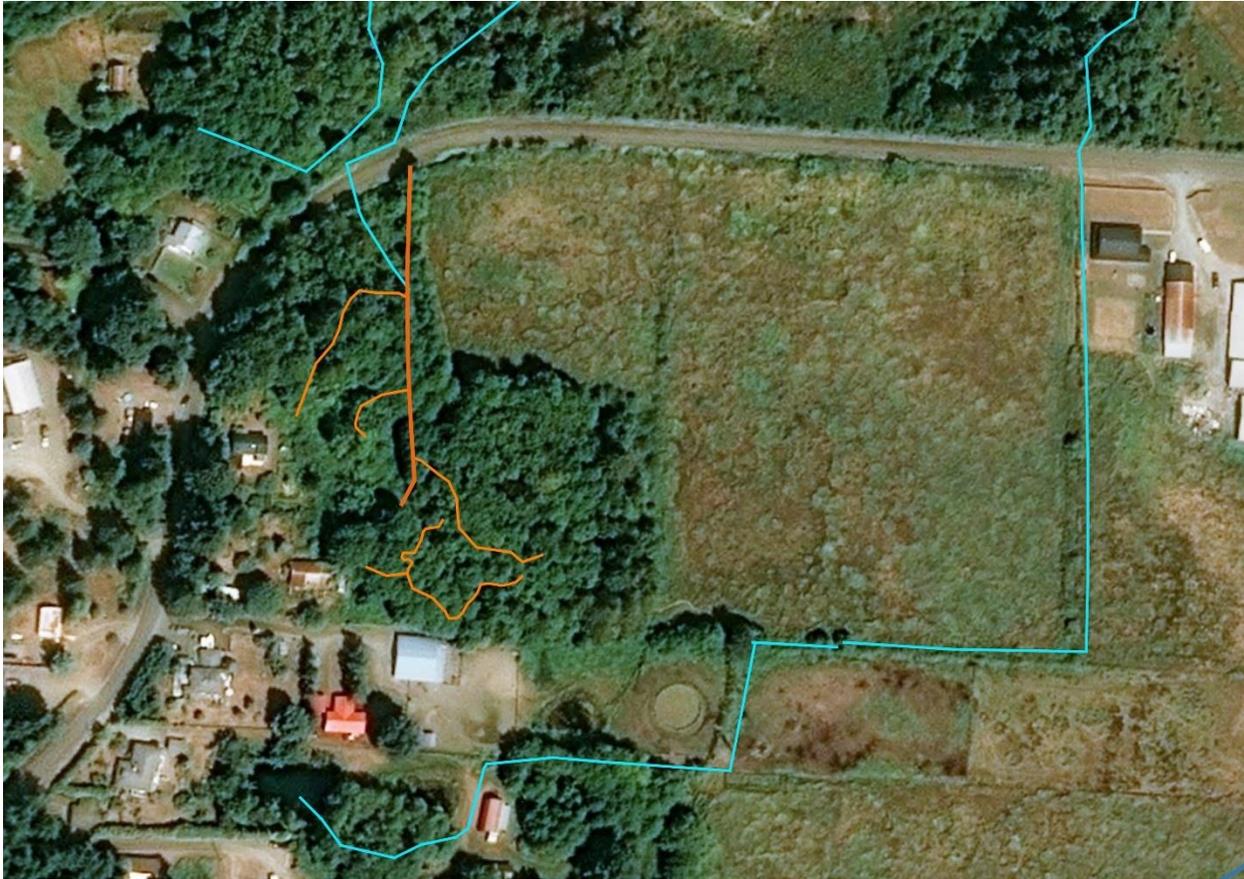
Figure 4: The new watercourse mapping is shown in orange, and the pre-existing CVRD mapping is shown in blue.

The locational data shown in Figure 4 was submitted to the Comox Valley Regional District (CVRD) for inclusion in their Geographic Information System, specifically the regional Sensitive Habitat Atlas dataset showing the location of Streams.

The purported level of accuracy for the equipment used is sub-metre, but the dense nature of the forest canopy in the survey area resulted in poorer position fixing capability than would occur in open areas. The Horizontal accuracy for all positions fixes recorded comprising the lines and points collected in the survey (1881 positions in total) averaged an accuracy of 1.8 m, with worst accuracy positions, in the >5m range stemming from 116 recorded positions. In the exported data provided, the locations of line features were adjusted by filtering out, and/or manually adjusting/ interpolating the location in the QGIS project, eliminating the inaccurate positions.

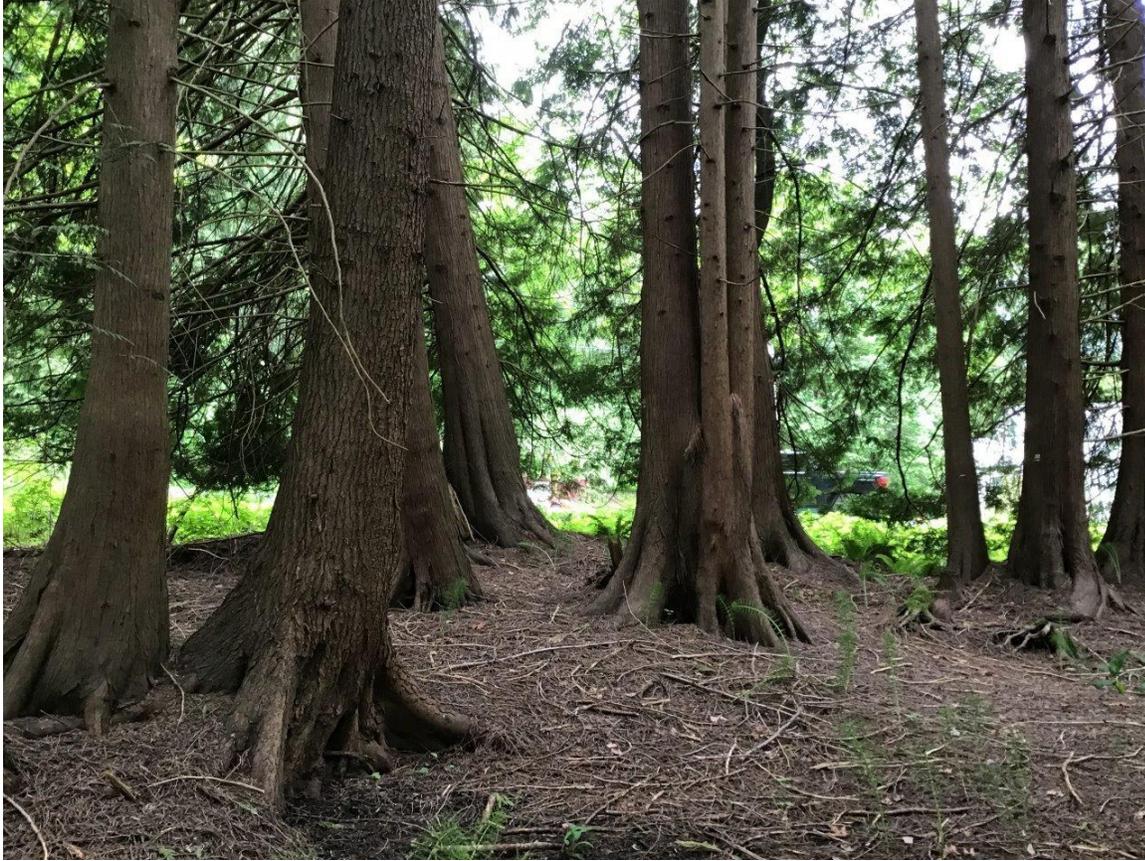
Figure 6: The cedar grove with mature (80+ year old trees), looking toward Minto Road. Not shown is a very large cedar stump with a springboard notch, logged between 80 and 120 years ago.

The forest structural stage (age) was mostly young, i.e., 40 to 80 years of age, except for the cedar grove sampled in Transect 1, where the trees were previously designated as mature (greater than 80 years old based on the tree size and past logging between 80 and 120 years ago) (Ennis and Kotilla 2018).

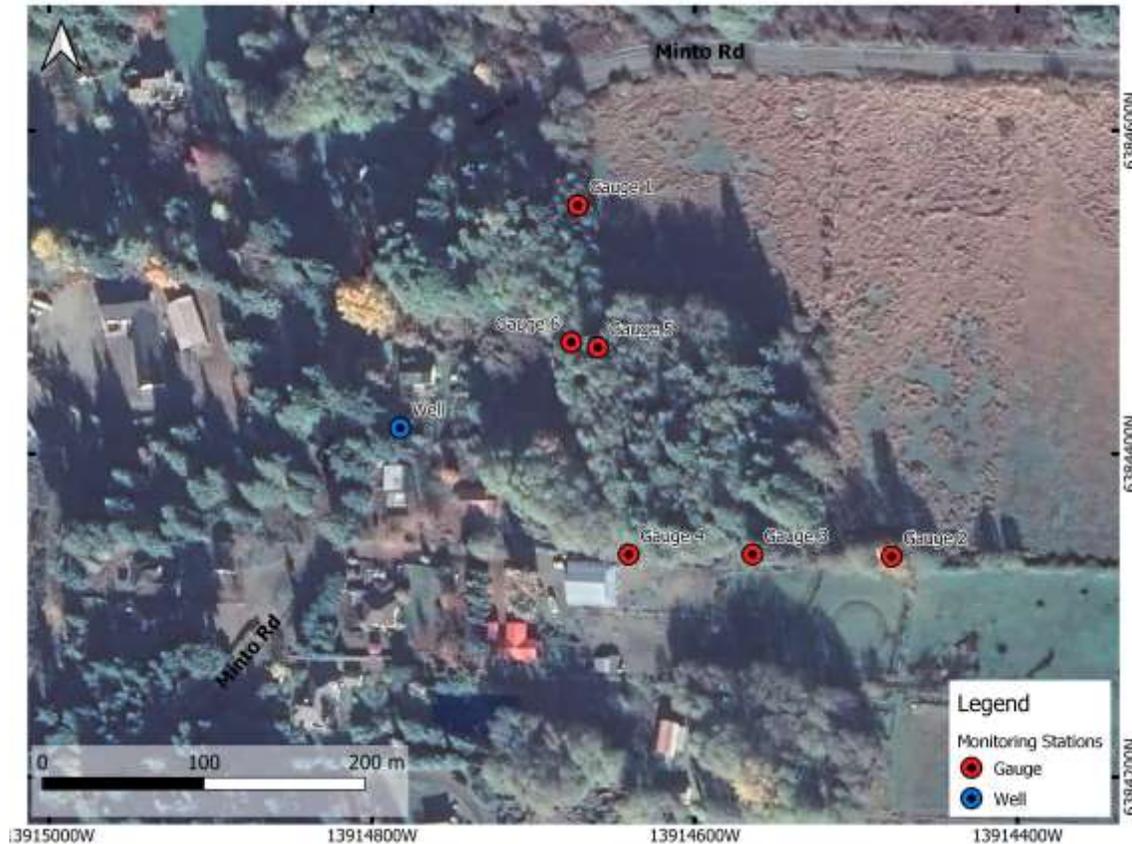
Figure 2: Location of monitoring stations

The existing water well is used for monitoring the groundwater level and its fluctuations within the shallow zone. The well has a 97 inches depth and drilled in unconsolidated material mainly alluvial. Gauge 1 to 6 are surface water stations to monitor the water quality and surface water fluctuation (see Figure 2).

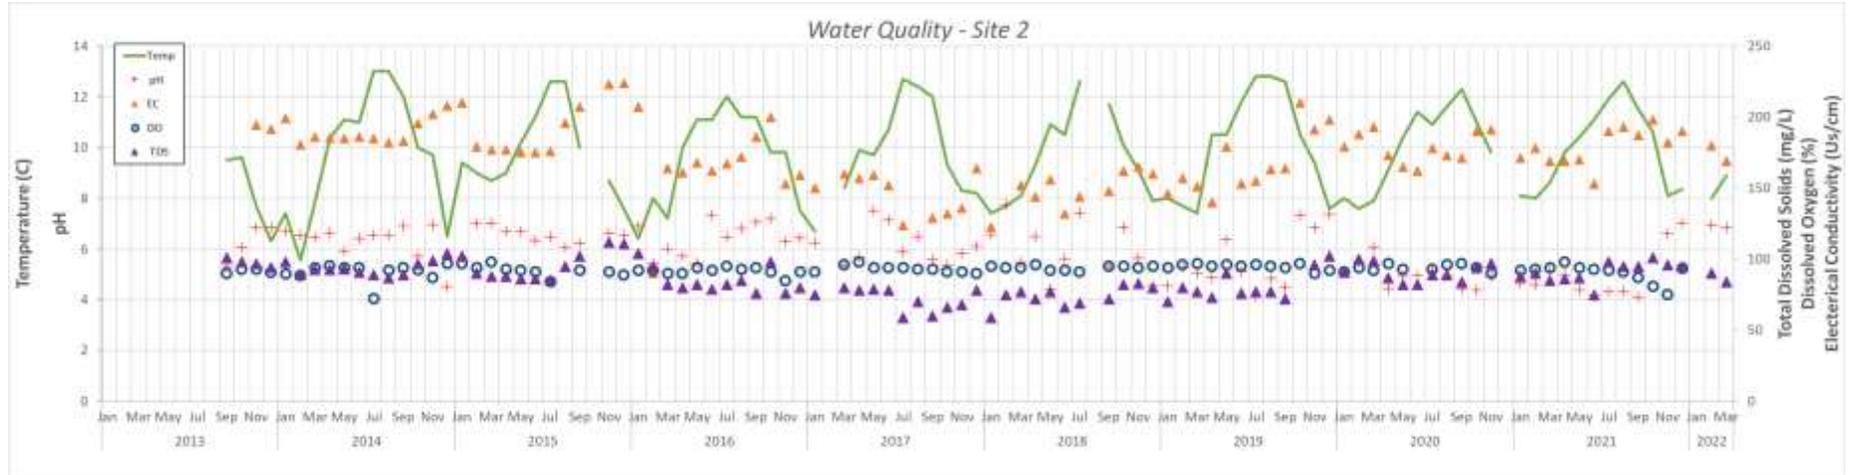
Figure 7: Water quality parameters for Gauge1

Figure 8: Water quality parameters for Gauge 2

Figure 9: Water quality parameters for Gauge 3

Figure 10: Water quality parameters for Gauge 4

Figure 11: Water quality parameters for Gauge 5

Figure 12: Water quality parameters for Gauge 6

Figure 7 to Figure 12 present the water quality parameters fluctuation during the monitoring period ending February 2022. The water quality parameters fluctuate seasonally, with a similar pattern over the time, for all the stations. The Water quality parameters stay at the same level during the monitoring time. In all the stations, the groundwater temperature trend is as same as that of air temperature. It indicates that the well is shallow, and the groundwater temperature is influenced by the surface air temperature.

According to the measurements, the groundwater started to become acidic. As the Figure 7 to Figure 12 show, in all the sites pH started to decrease to a value of lower than 6 since 2018 onwards. Particularly, in Site 1 the decreasing trend of pH is more remarkable. Moreover, testing EC and TDS shows there is a falling trend over the monitoring period. Other water quality parameters are roughly steady.
