Spike Road Regional Park Vegetation Types and Disturbance History: An Overview Survey

YER Phase II Project August 14-18, 2023

December 2023

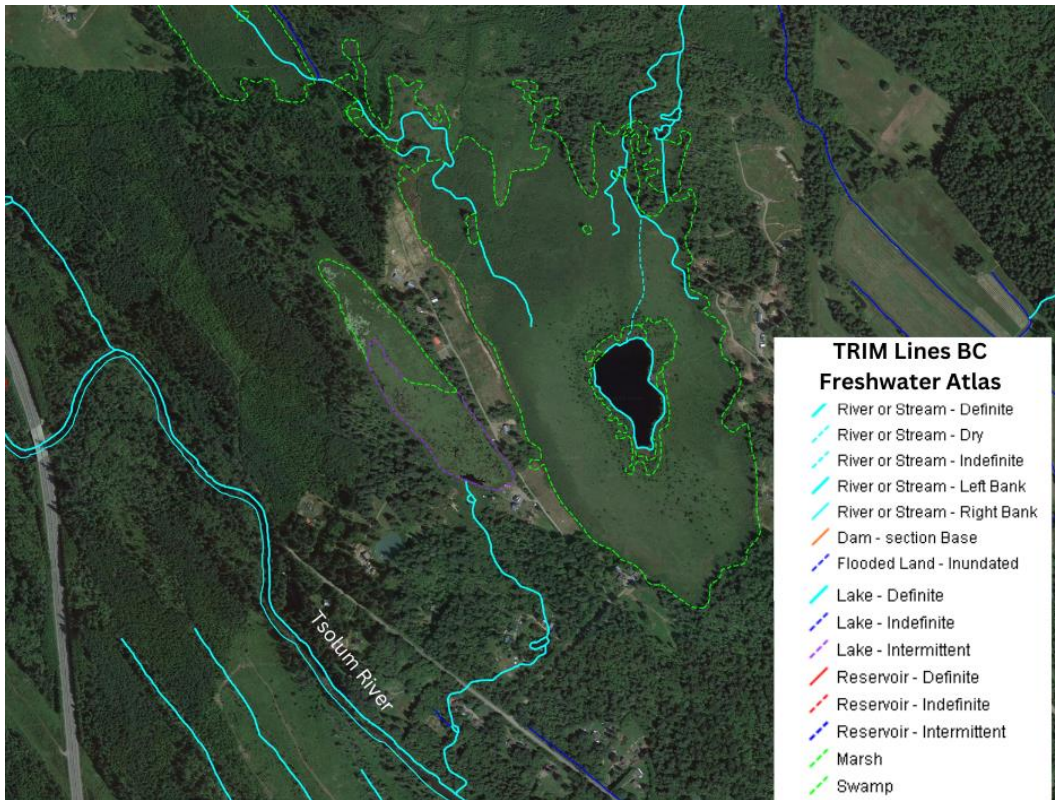
Figure 2: The wider context of the Spike Road property showing provincially mapped wetlands, drainage to the Tsolum River from the west part of the property, and drainage north towards Black Creek from the eastern wetland, part of which is within the Spike Road property.
